## **Forest Resource Evaluation**

### **Eastside Parkway Project**

### **Monterey, California**

**September, 2011**

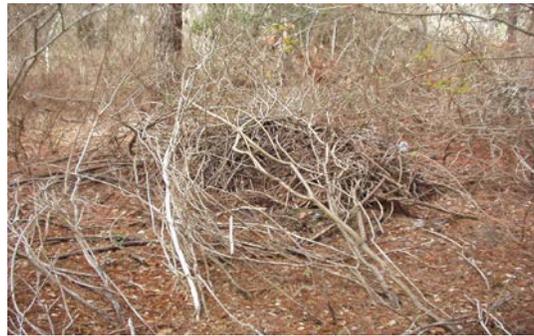
Photo 1. Example of Presumed Monterey Dusky-Footed Woodrat Nest.

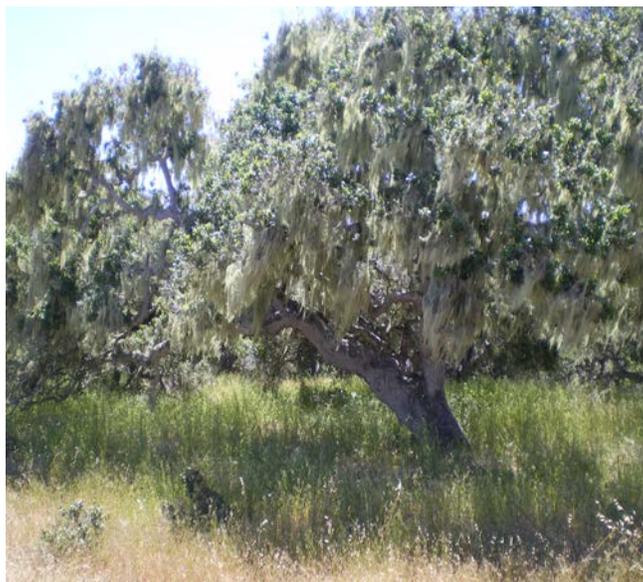
Photo 2. Example of a Landmark Tree with Lace Lichen Draping its Canopy.

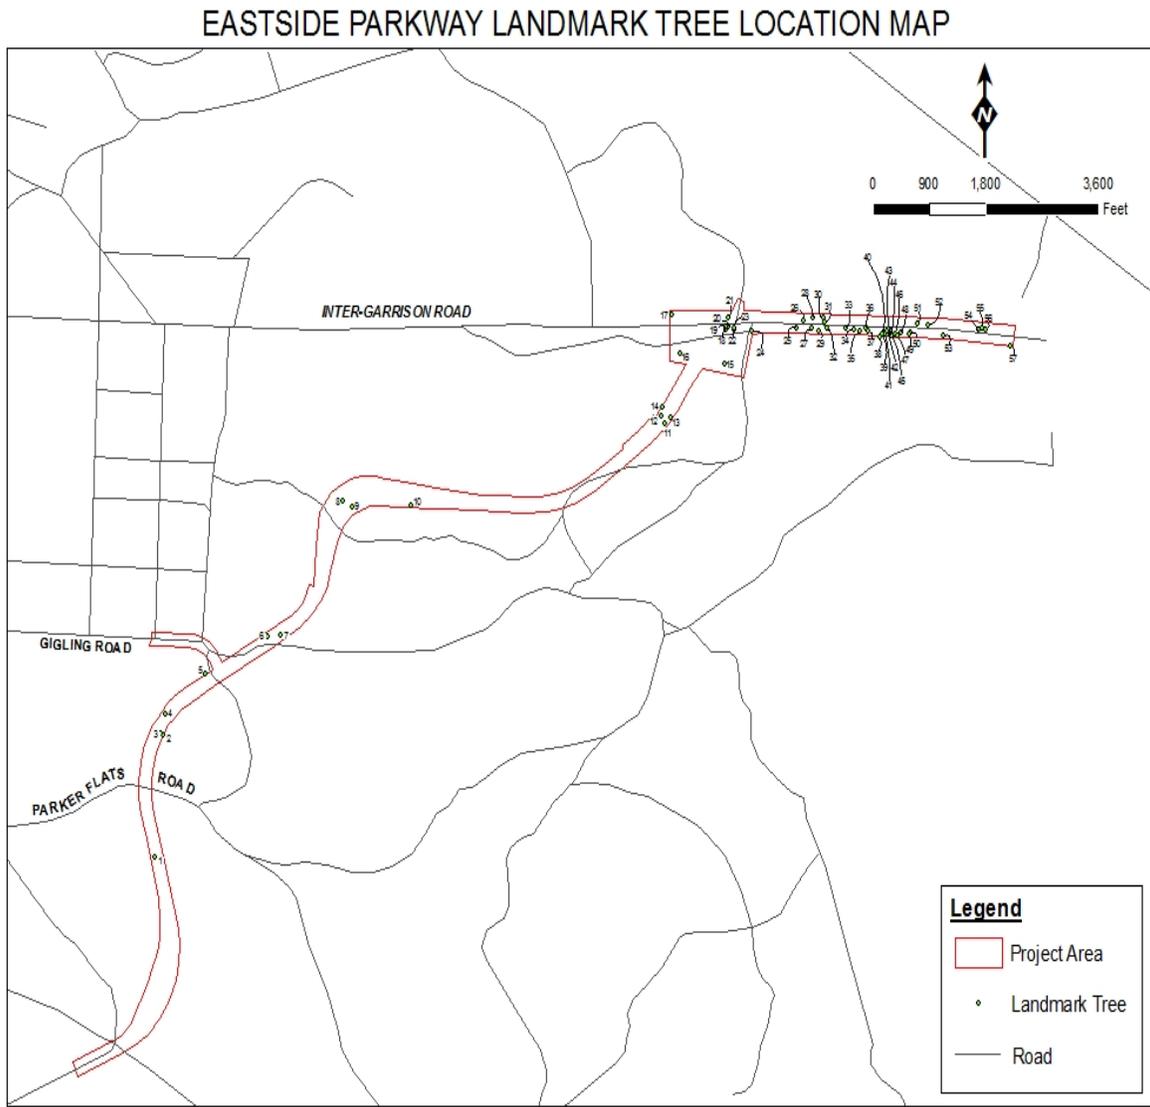
Figure 3. Landmark Tree Location Map

The survey for this report measured a total of 57 coast live oak trees which meet the 24 inch diameter threshold which defines Landmark trees in *Monterey County Zoning Ordinance Title 21* based on their size (See Table 3; and Figure 3 attached).

Tree Number	DBH	Condition	Notes
1	26	F	trending to good, some rot present
2	28	F	on margin of road construction
3	28	F	Decumbent, some rot
4	26,17	G	
5	24,22,22	F	
6	24,14	F	Heavy lace lichen, pockets of rot
7	32	P	
8	26	P	Heavily defoliated
9	28	F	Trending to poor, basal rot
10	26	F	some rot
11	30	P	Rot, small crown, extensive lace lichen
12	28	P	Large Base-rotten
13	26	F	Nest 2/3 away from stem in lower branch
14	32	P	multi-stem, abundant lace lichen
15	38	G	
16	28	P	Rot, small crown, extensive lace lichen
17	29, 19	F	Rat nest at base of tree
18	40	G	
19	30	G	
20	34	G	
21	28, 16	F	
22	30	P	
23	40	G	some rot
24	28	G	
25	24,16,20	F	
26	26	F	
27	30	G	some lace lichen
28	30	P	
29	24,16	P	
30	23, 22	F	
31	24	G	
32	24,24	F	lace lichen
33	26,20,14	F	multi stem, trending to poor
34	29	G	
35	24,14,12	F	multi stem
36	24,20,22	F	limb rot
37	30	F	rot
38	30	G

39	26,18,10	G	
40	36	G	trending to fair, some rot present
41	27	G	
42	30	G	
43	26	F	
44	30	G	excellent health, very good appearance
45	34	G	some rot present
46	34,32,30	F	trending to poor, broken limbs
47	28	F	
48	30	G	very large healthy crown
49	24	F	rot present
50	24	G	
51	31, 27	G	
52	23.4	G	
53	30	G	evidence of wildlife use
54	28, 21	F	
55	30	F	
56	27, 16	F	
57	36	P	nearly dead, hollow trunk
