**MARINA COAST WATER DISTRICT**

**SEWER  
MASTER PLAN**

**Subject: 2019 Sewer Master Plan – Draft Report**

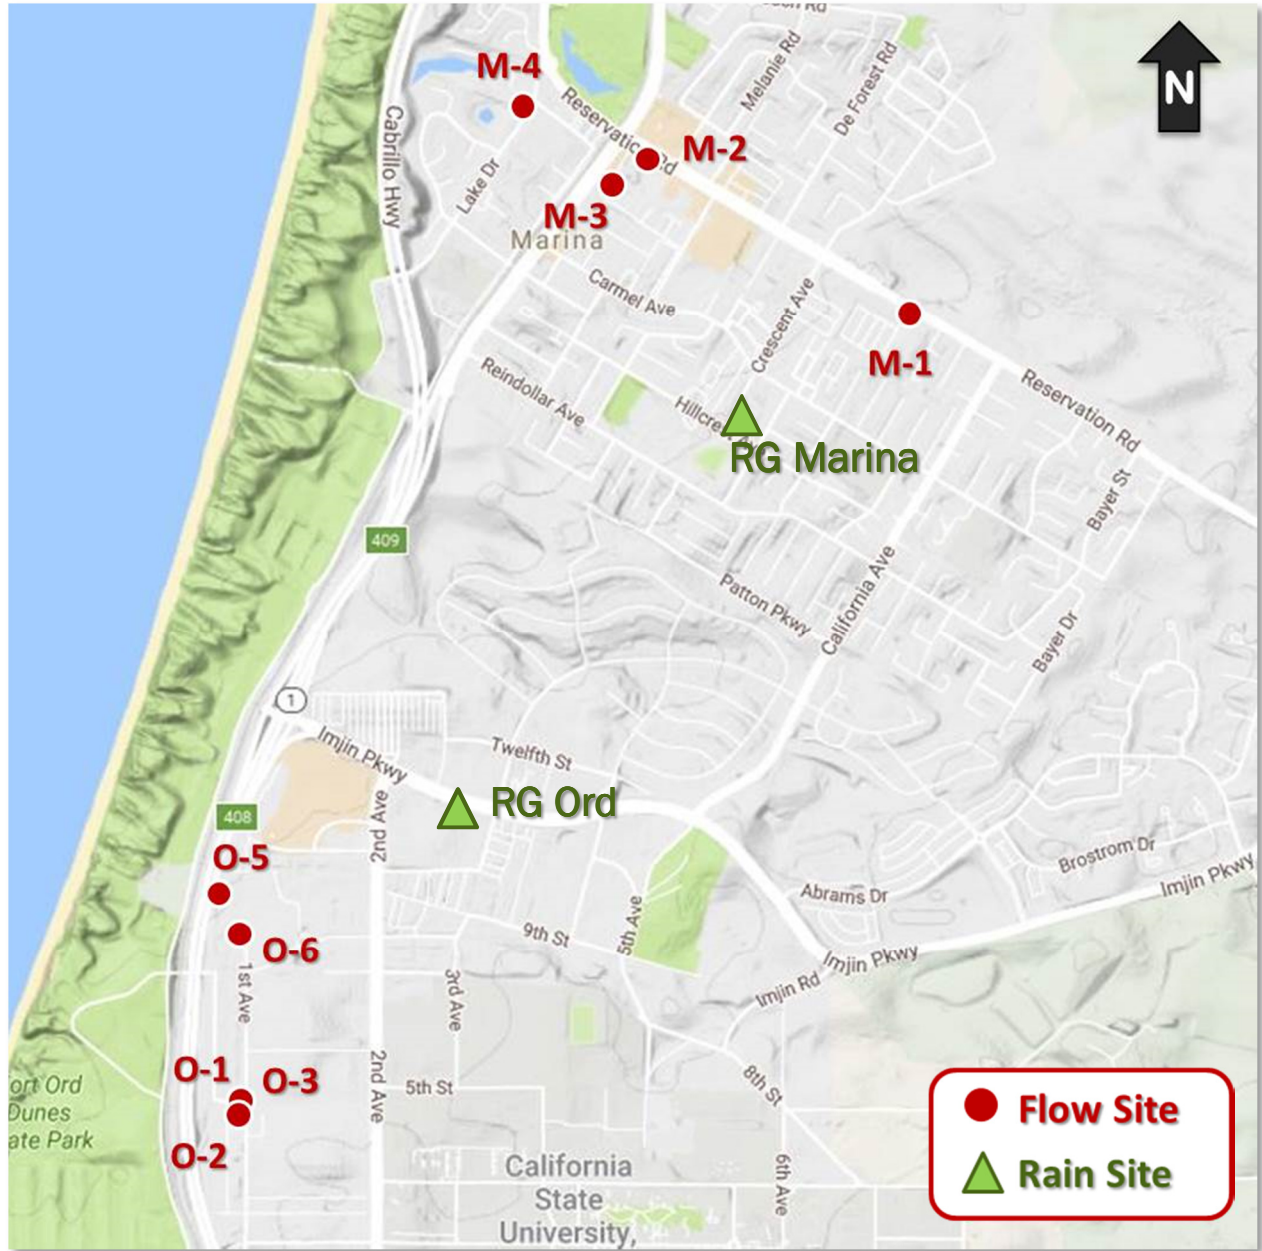
Figure ES-1. Map of Flow Monitoring Sites

Site / Basin	District Manhole No.	Monitored Pipe	Pipe Dia. (in)	Location	Basin Isolation Equation	Basin Area (acres)
M1	K606	SW Inlet	11.5	358 Reservation Road	= $Q_{M1}$	197
M2	L638	SE Inlet	12	210 Reservation Road	= $Q_{M2} - Q_{M1}$	103
M3	G421	SW Inlet	12	3148 Del Monte Boulevard	= $Q_{M3}$	152
M4	E331	South Inlet	10	Robin Drive at Hilo Avenue	= $Q_{M4}$	163
O1	J306	South Inlet	18	Lot northwest of intersection of 1st Avenue and 5th Street	= $Q_{O1}$	879
O2	D452A	South Inlet	12	Open space southwest of intersection of 1st Avenue and 5th Street	= $Q_{O2}$	215
O3	J306	East Inlet	15	Lot northwest of intersection of 1st Avenue and 5th Street	= $Q_{O3}$	243
O5	UVA1	NE Inlet	29.5	Northwest corner VA Clinic parking lot	= $Q_{O5}$	1,518
O6	UVB1	East Inlet	14.5	VA Clinic parking lot, near motorcycle parking	= $Q_{O6}$	235

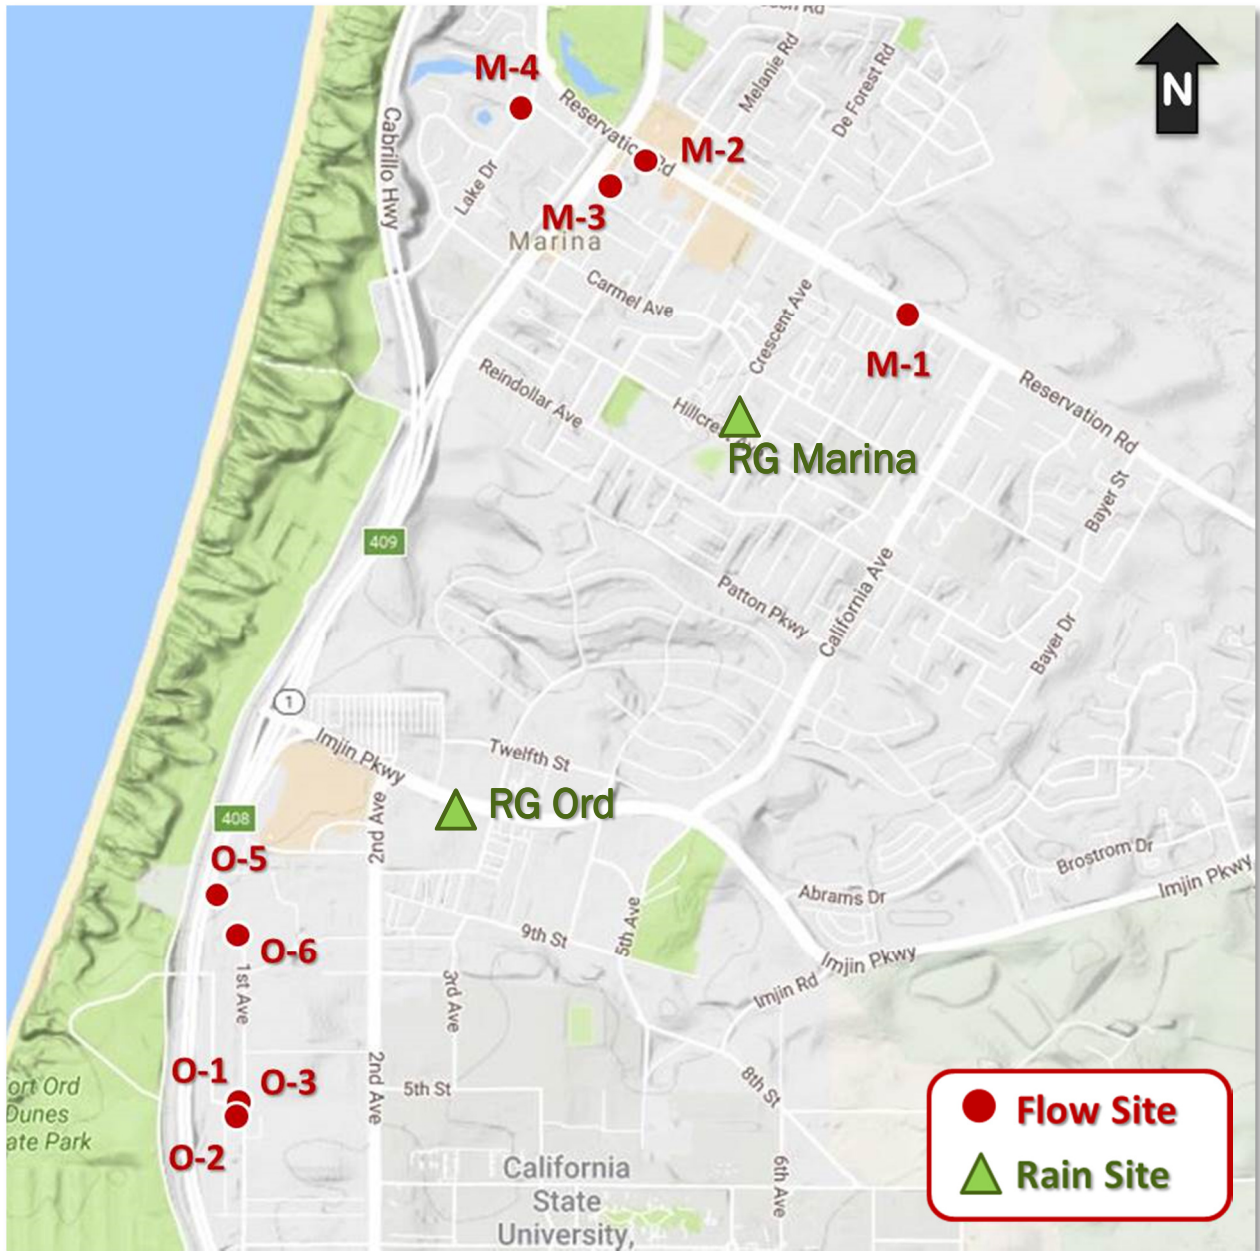
Figure 1-1. Map of Flow Monitoring Sites

Site / Basin	District Manhole No.	Monitored Pipe	Pipe Dia. (in)	Location	Basin Isolation Equation	Basin Area (acres)
M1	K606	SW Inlet	11.5	358 Reservation Road	$= Q_{M1}$	197
M2	L638	SE Inlet	12	210 Reservation Road	$= Q_{M2} - Q_{M1}$	103
M3	G421	SW Inlet	12	3148 Del Monte Boulevard	$= Q_{M3}$	152
M4	E331	South Inlet	10	Robin Drive at Hilo Avenue	$= Q_{M4}$	163
O1	J306	South Inlet	18	Lot northwest of intersection of 1st Avenue and 5th Street	$= Q_{O1}$	879
O2	D452A	South Inlet	12	Open space southwest of intersection of 1st Avenue and 5th Street	$= Q_{O2}$	215
O3	J306	East Inlet	15	Lot northwest of intersection of 1st Avenue and 5th Street	$= Q_{O3}$	243
O5	UVA1	NE Inlet	29.5	Northwest corner VA Clinic parking lot	$= Q_{O5}$	1,518
O6	UVB1	East Inlet	14.5	VA Clinic parking lot, near motorcycle parking	$= Q_{O6}$	235

The FM sites and associated basins (including basin flow equations) are listed in Table 1-1. The FM sites and associated basins and shown in Figure 1-1 and Figure 1-2, respectively. Detailed descriptions of the individual flow monitoring sites, including photographs, are included in Appendix A.

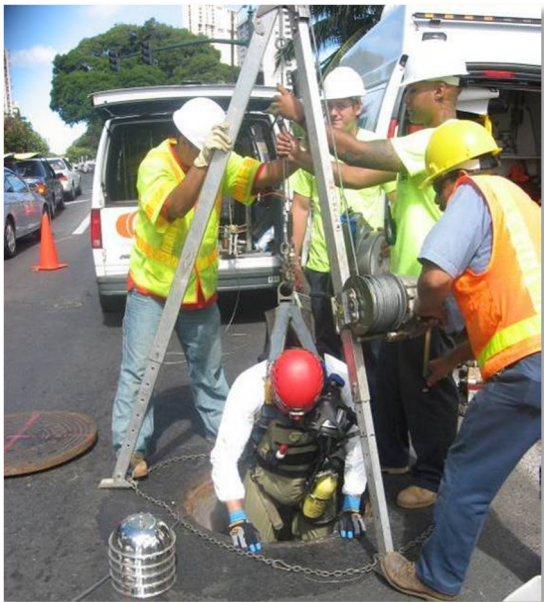
Photo 2-1. Confined Space Entry

A confined space (Photo 2-1) is defined as any space that is large enough and so configured that a person can bodily enter and perform assigned work, has limited or restricted means for entry or exit and is not designed for continuous employee occupancy. In general, the atmosphere must be constantly monitored for sufficient levels of oxygen (19.5% to 23.5%), and the presence of hydrogen sulfide (H<sub>2</sub>S) gas, carbon monoxide (CO) gas, and lower explosive limit (LEL) levels. A typical confined space entry crew has members with OSHA-defined responsibilities of Entrant, Attendant and Supervisor. The Entrant is the individual performing the work. He or she is equipped with the necessary personal protective equipment needed to perform the job safely, including a personal four-gas monitor (Photo 2-2). If it is not possible to maintain line-of-sight with the Entrant, then more Entrants are required until line-of-sight can be maintained. The Attendant is responsible for maintaining contact with the Entrants to monitor the atmosphere using another four-gas monitor and maintaining records of all Entrants, if there is more than one. The Supervisor is responsible for developing the safe work plan for the job at hand prior to entering.

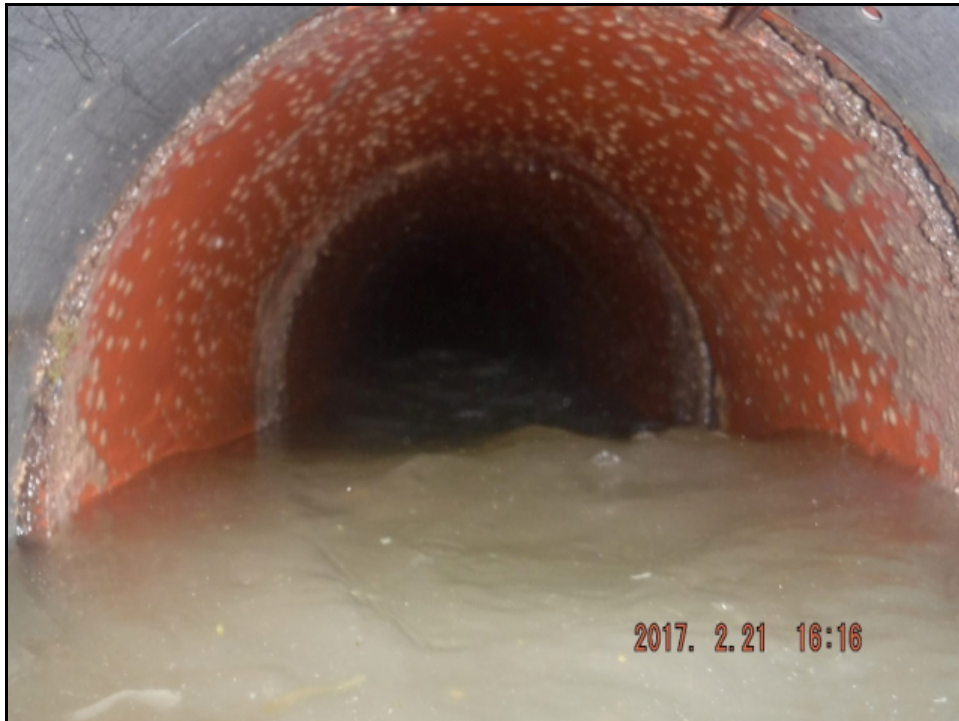
**Influent Pipe**

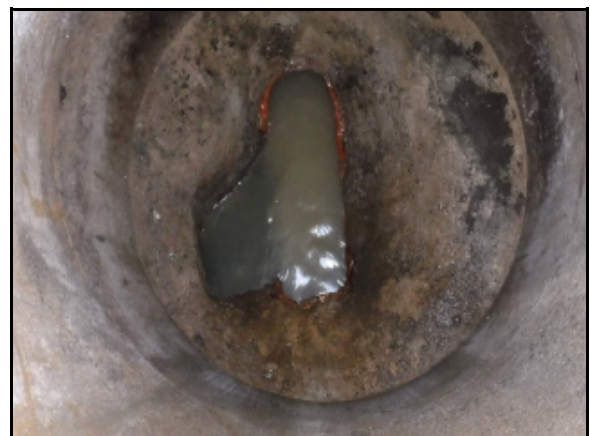
Plan View

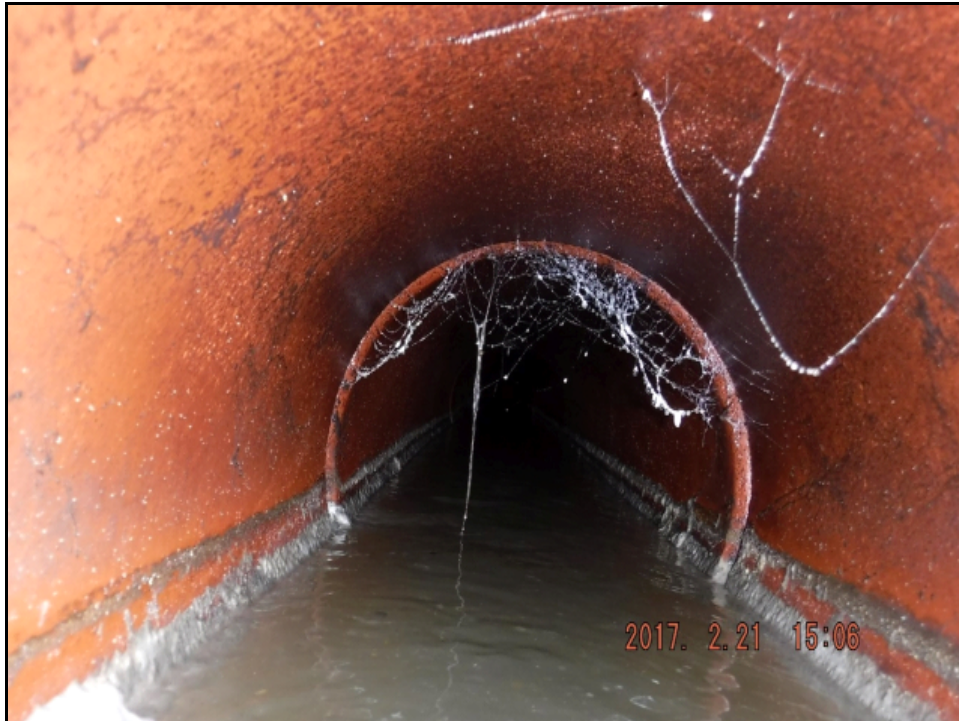
**Effluent Pipe**

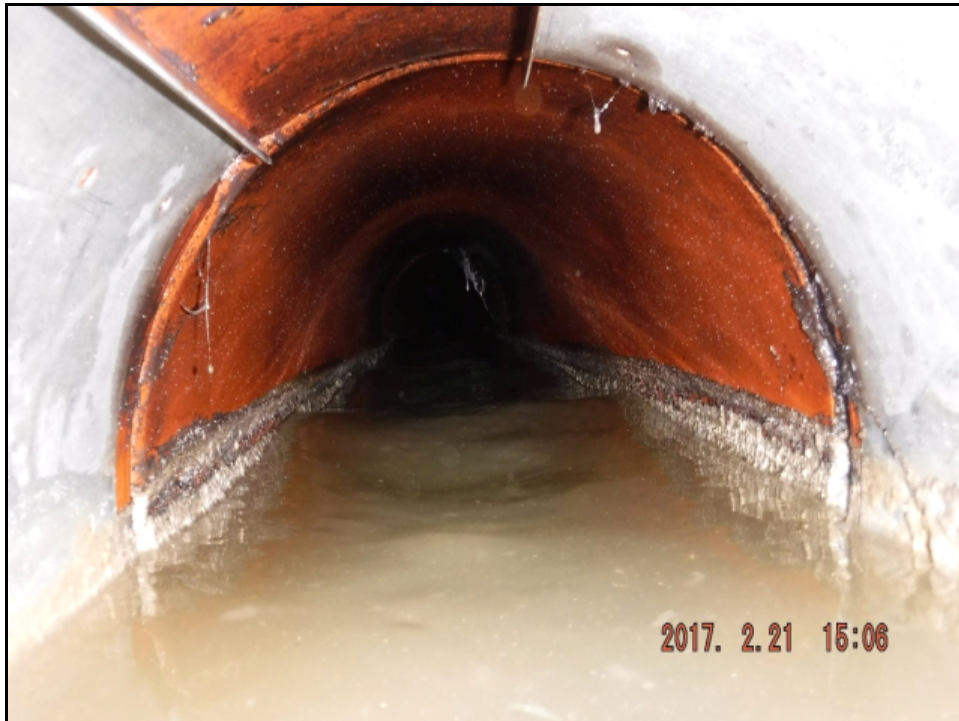
**South Influent Pipe**

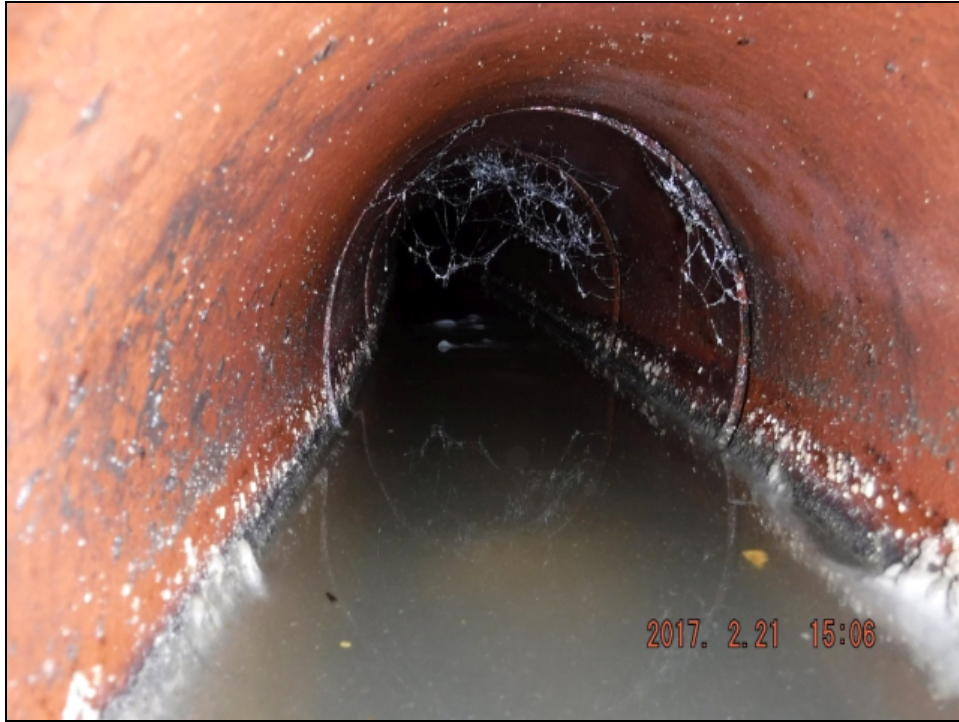
**West Influent Pipe**

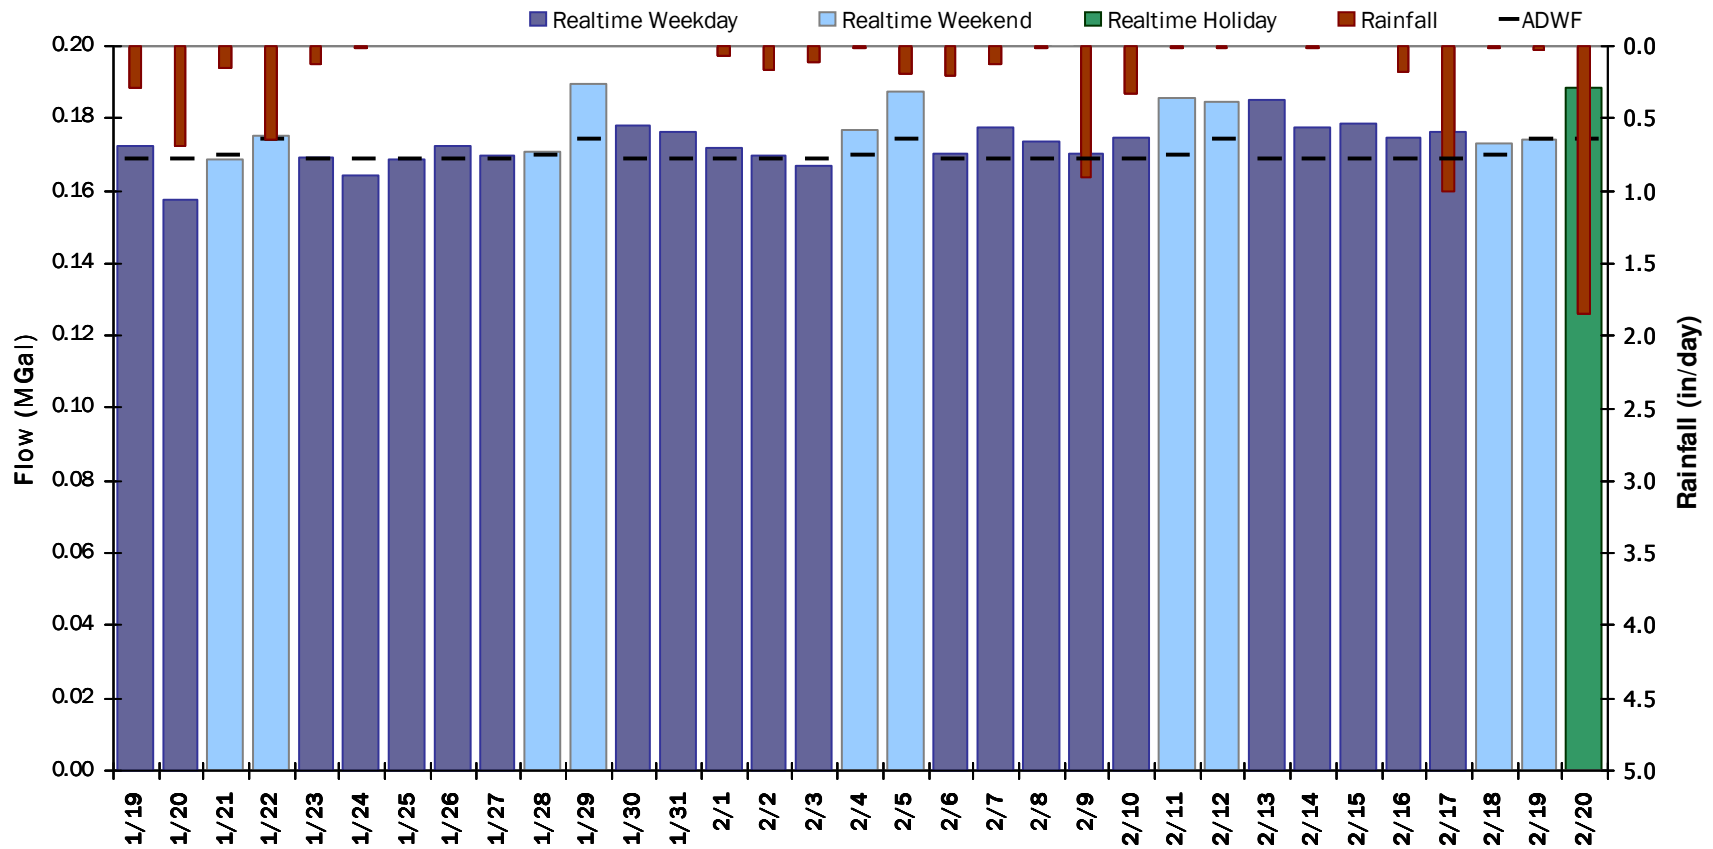
Avg Period Flow: 0.175 MGal    Peak Daily Flow: 0.190 MGal    Min Daily Flow: 0.158 MGal

Total Period Rainfall: 7.11 inches

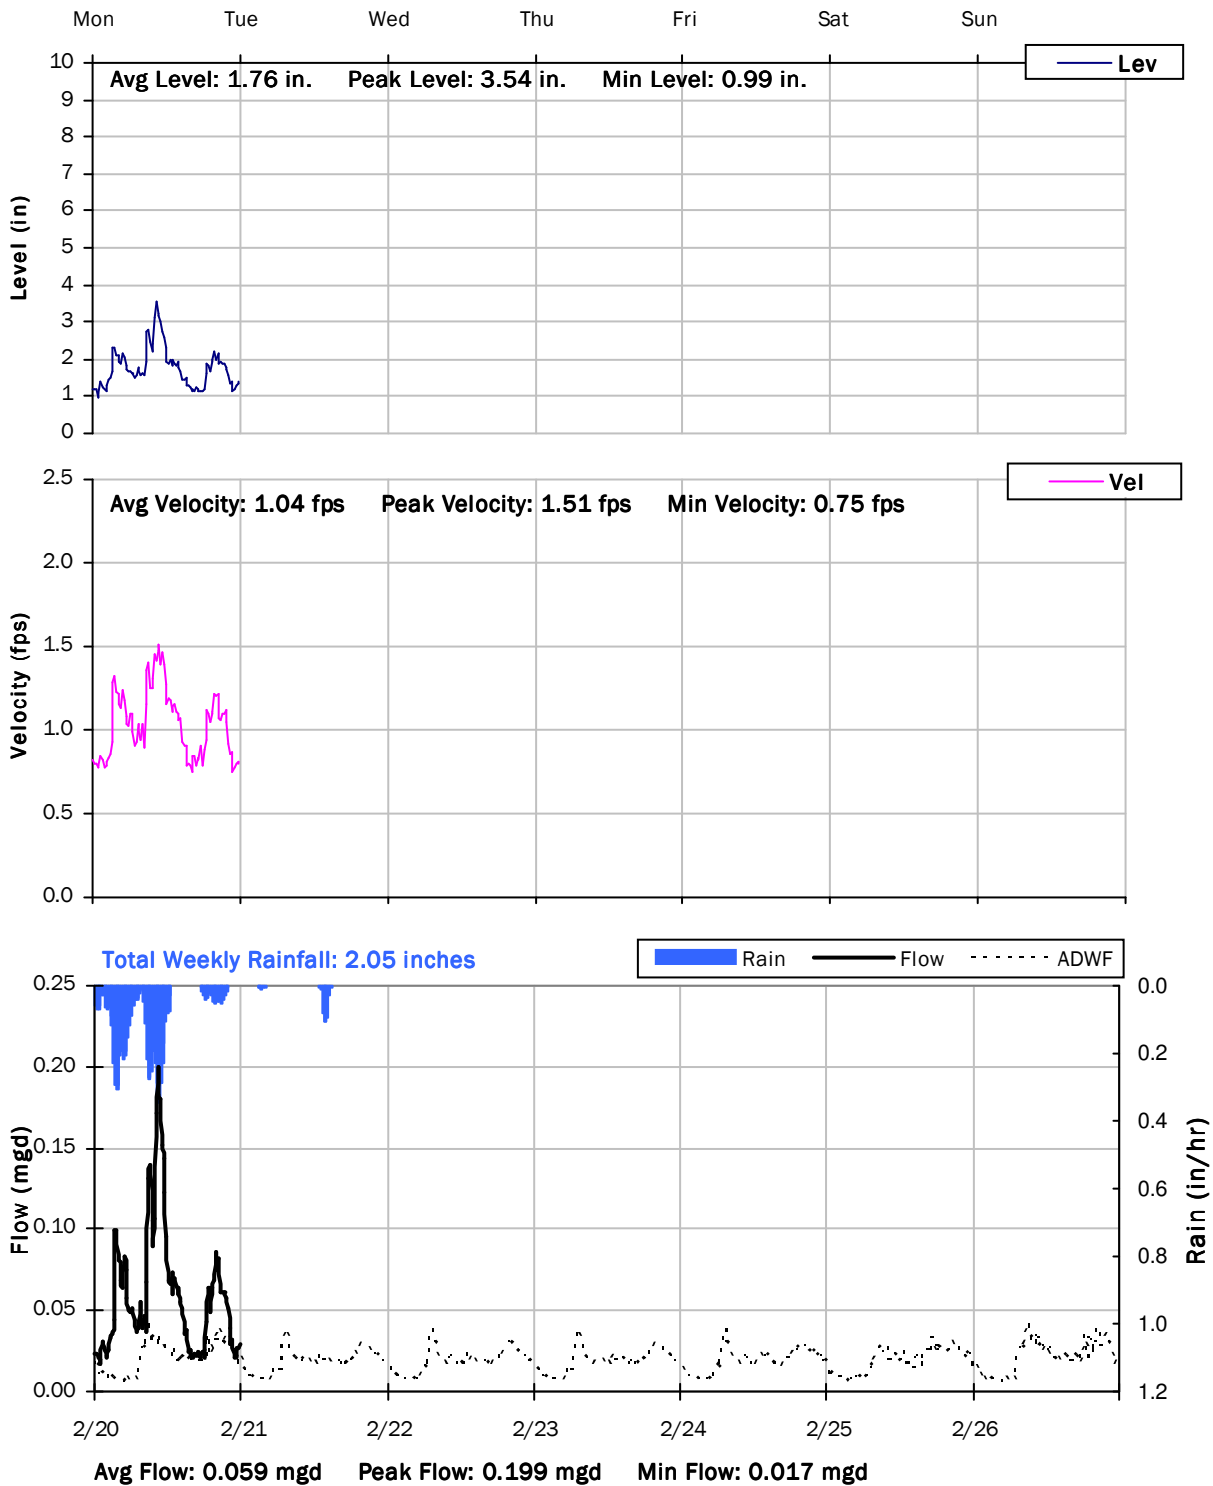
**SITE 06**  
**Weekly Level, Velocity and Flow Hydrographs**  
**2/20/2017 to 2/27/2017**

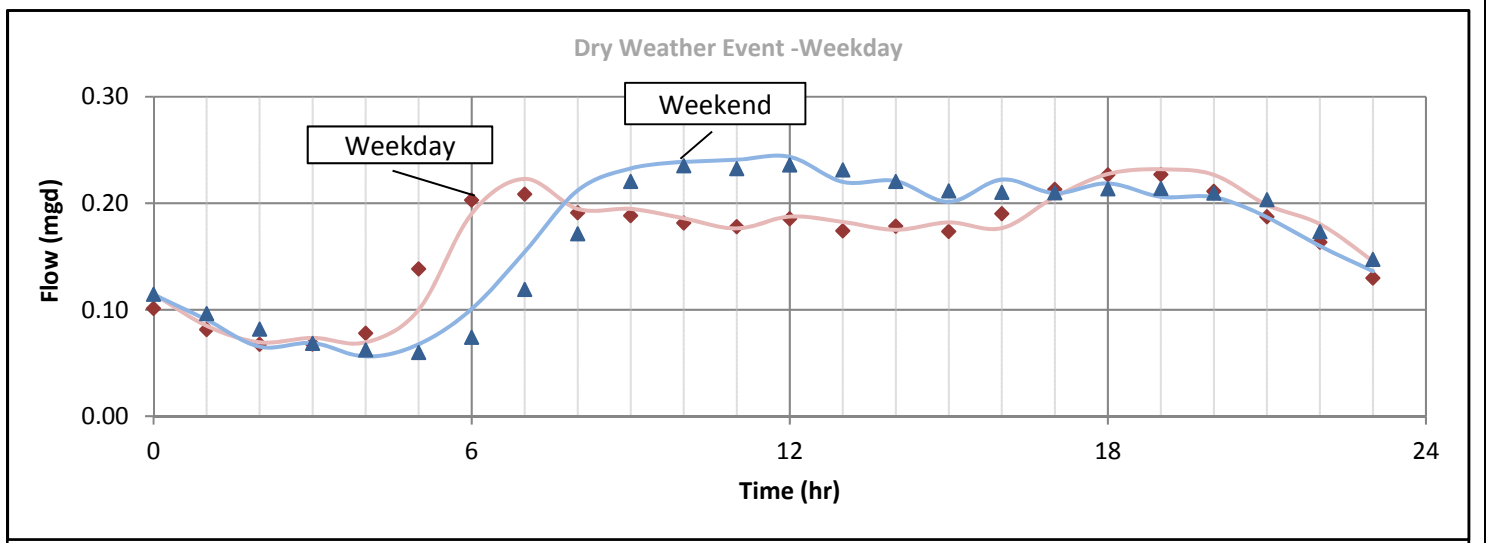
**Figure 4**  
**M-3 Marina**  
 Sewer Master Plan  
 Marina Coast Water District

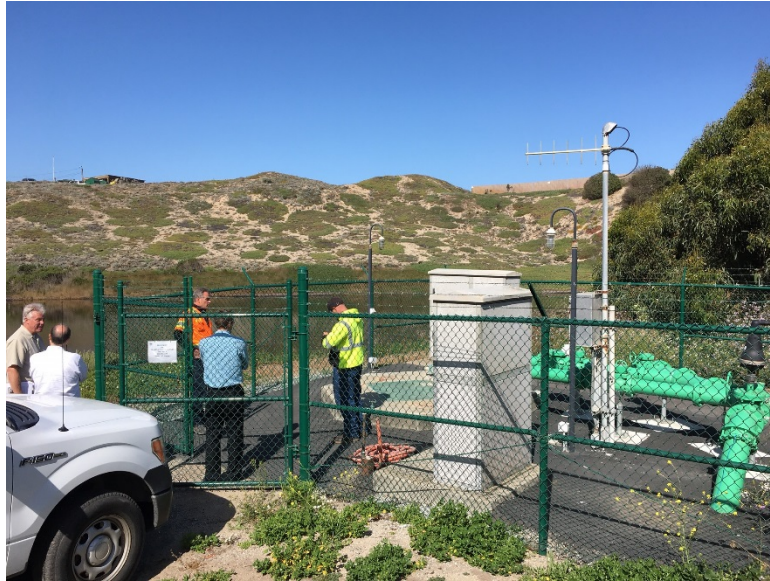
The Dunes Lift Station is a wet well submersible lift station with no building. Valves and pipes are above grade. Electrical cabinets are also above grade. The entire lift station is fenced in.

The Dunes Lift Station is located at Dunes Drive, next to the Marina Dunes Resort, west of Highway 1. The lift station was originally built in 1969, with the pumps upgraded in 1987. Capacity with both pumps running is 0.79 MGD.

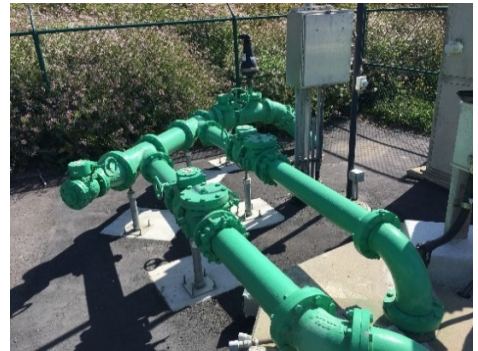
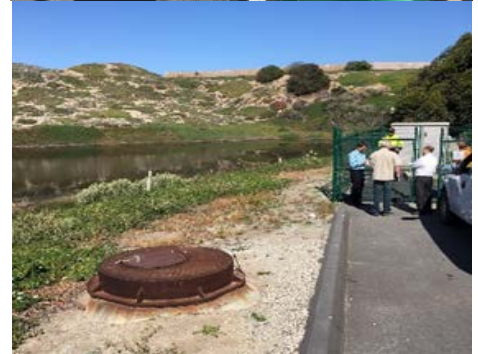
Component
Discharge piping and valves
Score
2
Reason
Recently upgraded and functions well, though access is difficult to remove the valves with a lifting device.

Piping was replaced from the flange out of the wet well up to the ductile iron force main discharge at the intersection nearby. The original pipe routing went up to the old treatment plant, and came back down the hill to a gravity feed. When two pumps were on and stayed on too long it would end up flooding a cleanout near a residence, through the lateral. The piping was rerouted through check valves to a manhole approximately 40 feet near the wet well, which adds capacity.

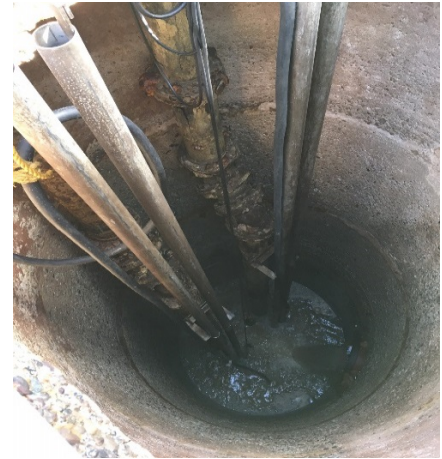
Component
Pump Guide Rails
Score
1
Reason
Appears to be in good condition with no signs of corrosion

Inside the wet well, the stainless steel pump lifting guide rails appear to be in good condition.

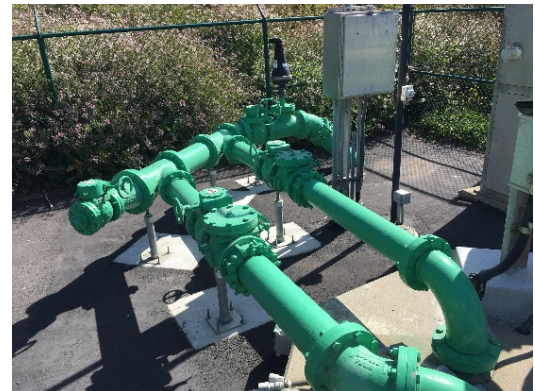
Component
Pipe and Equipment Support
Score
1
Reason
Appear to be in good condition. No issues noted by the operator.

Pipe and equipment support appears to be new and in good working condition.

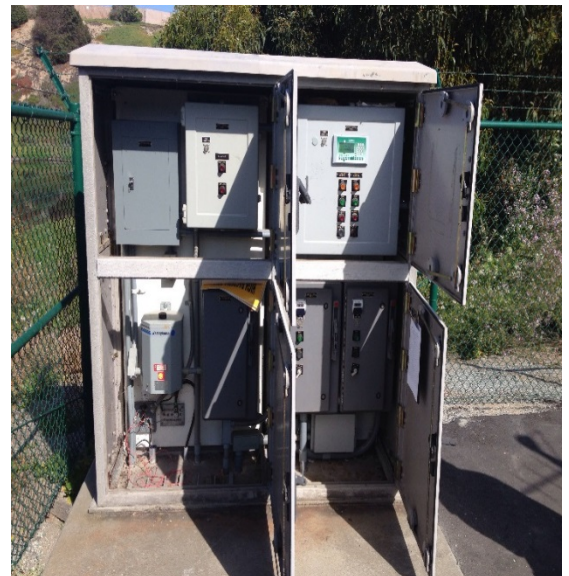
A 100-amp receptacle for connecting a portable generator is mounted to the exterior of this enclosure. Two pump motor starters, a pump control panel, a 480-240/120-volt step-down transformer, and a 240/120-volt lighting panel are located in another fiberglass outer enclosure located on top of the wet well slab. While the

NEMA 3RX fiberglass enclosures are moderately weathered, the individual painted steel components inside show no signs of weathering or corrosion.

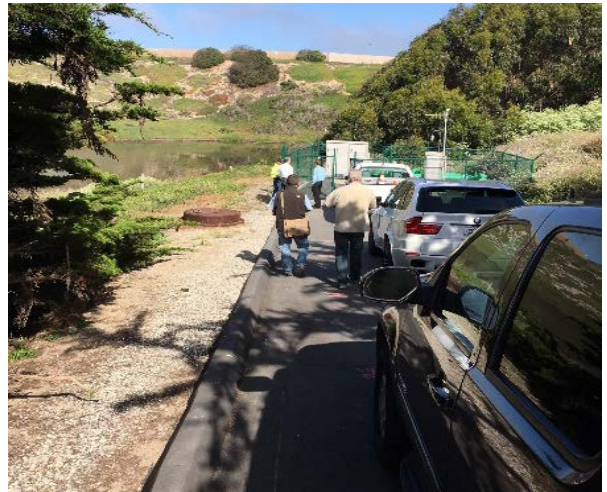
Component
Road Space
Score
2
Reason
There is not sufficient space for vehicle turnaround, but the short length of the access road makes this a minor issue.

The site is paved and is adjacent to an existing storm water detention pond. There is no space for vehicle turnaround, requiring vehicles to exit in reverse, uphill along the access drive onto the street. There is no parking space other than the access road.

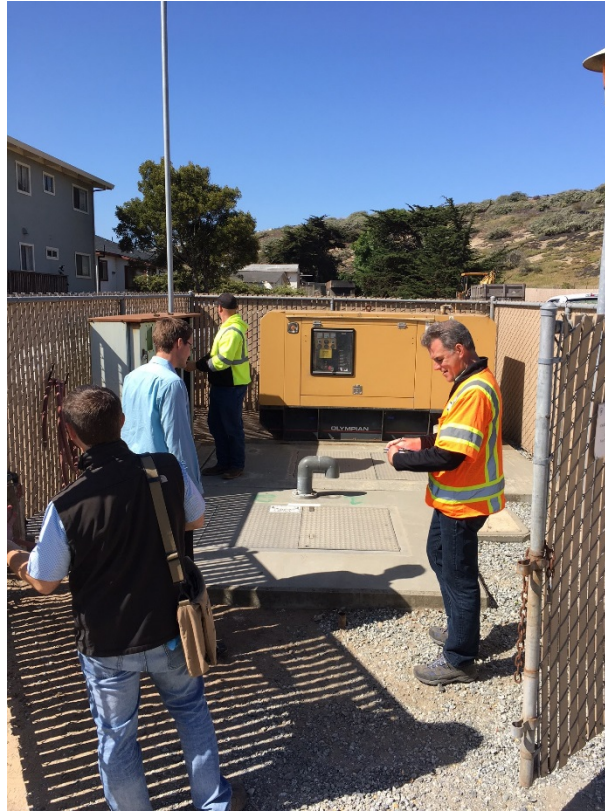
## 4.2 SAN PABLO

The San Pablo Lift Station is a wet well submersible lift station with no building. Valves and pipes are below grade. Electrical cabinets are above grade. The entire lift station is fenced in.

For Additional Photo - See Overview Photo at the beginning of Section 4.2

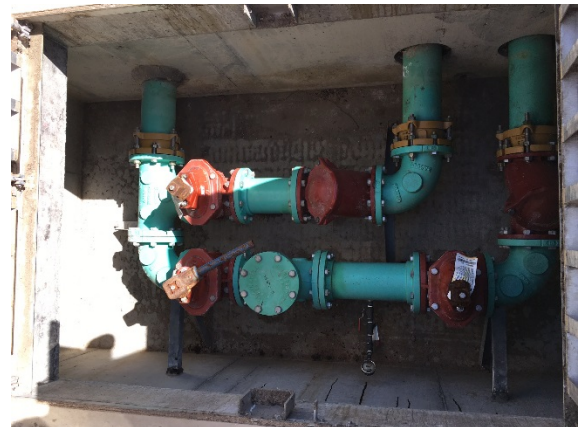
Component
Valve Vault
Score
2
Reason
Valves and piping are in good condition, but valve vault has short clearance to fences.

Within the valve pit, a check valve and gate valve are provided on each discharge pipe. The discharge pipes then combine to form a common 6-inch force main leaving the lift station to the west. The valve pit is located behind the wet well at the rear of the site next to the generator, with very little clearance to the side fences.

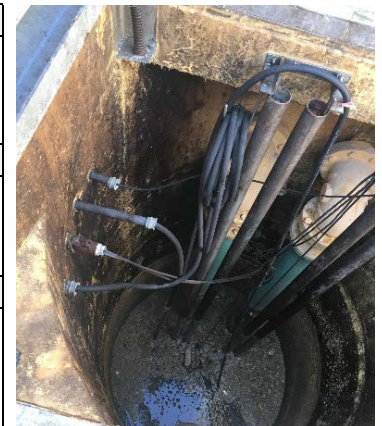
Component
Guide Rails
Score
2
Reason
Minor surface deterioration.

Inside the 6-ft diameter, 13-ft deep concrete wet well, there is surface deterioration visible on the pump guide rails. There is no lifting device on site for pump removal.

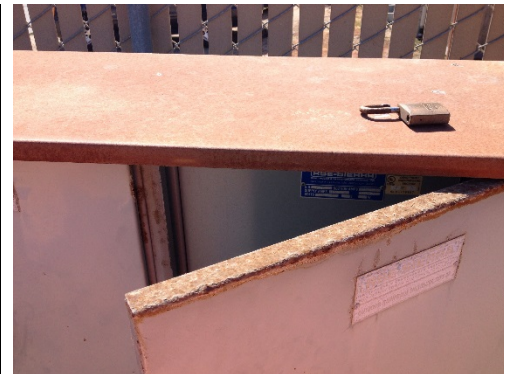
Component
NEMA 3R equipment enclosure
Score
3
Reason
Weathered, faded, and moderate rust.

The exterior surface of the NEMA 3R equipment enclosure is weathered and faded with a uniform layer of light rust on the top surface. The edges around the top of the enclosure and around the access doors have moderate rust, but the enclosure is otherwise in serviceable condition.

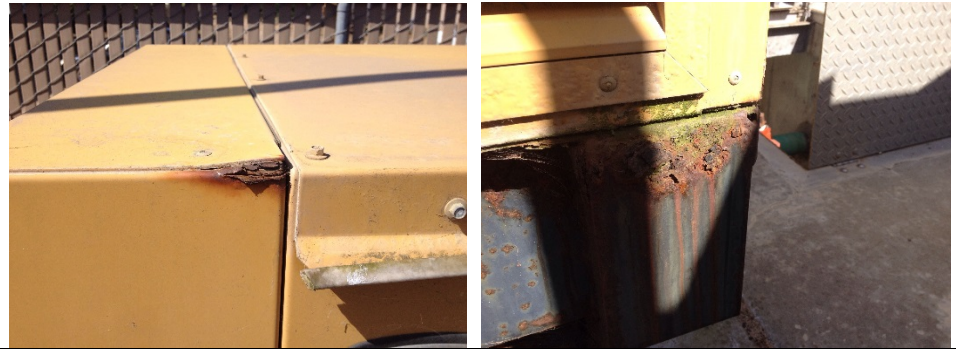
Component
Generator
Score
3
Reason
Moderate to heavy rust

An Olympian model D20P2 diesel engine-generator set, rated at 20 kilowatts/ 25 kilovolt-amps, is located on an adjacent side of the valve pit at the rear of the site. The generator is equipped with a 60-gallon, UL-listed dual-wall subbase tank, and a sound-attenuating enclosure. The generator enclosure and tank have localized areas of moderate-to-heavy rust.

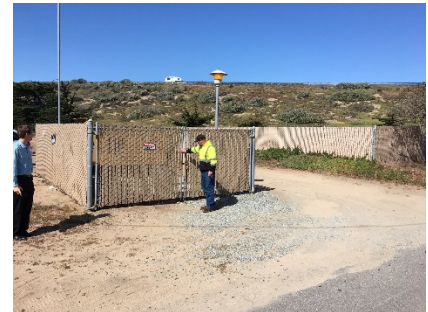
Component
Road Space
Score
2
Reason
Access to valve pit and backup generator is difficult

The site is unpaved and is close to a residential area and San Pablo Court. Since there is adjacent open area to the lift station, there is adequate space for vehicle turnaround. However, access to the valve pit and backup generator is difficult since they are located behind the wet well. The wet well hatch is not strong enough to support a service vehicle (See Hatches in Section 4.2.2), and the gooseneck ventilation outlet on top of the wet well impedes truck access to the back of the site.

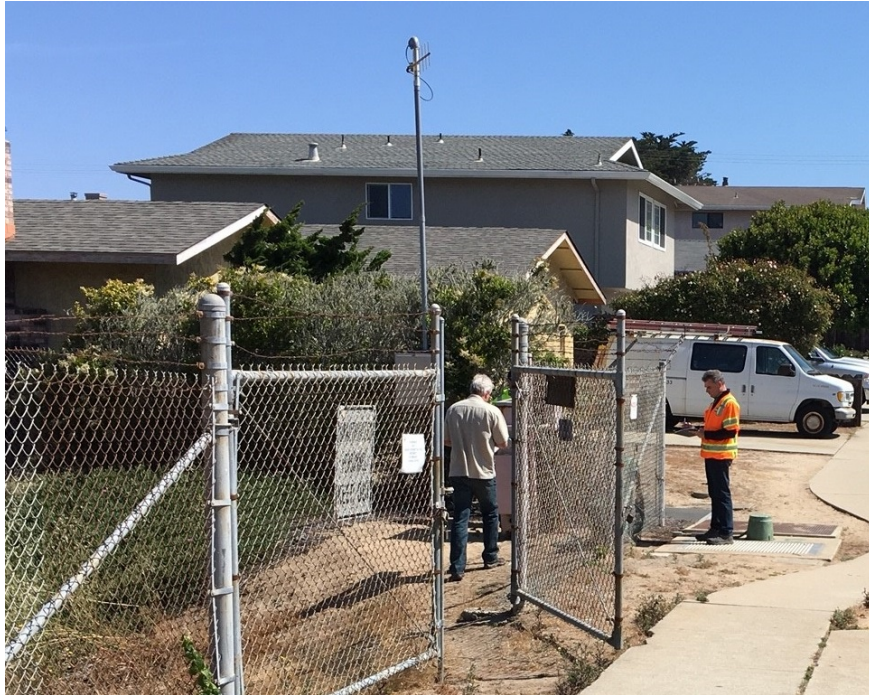
### 4.3 CRESCENT

The Crescent Lift Station is a wet well submersible lift station with no building. Valves and pipes are below grade. Electrical cabinets are above grade. While the electrical cabinets are fenced off, the wet well and valve pit are located outside the fence near a residential sidewalk.

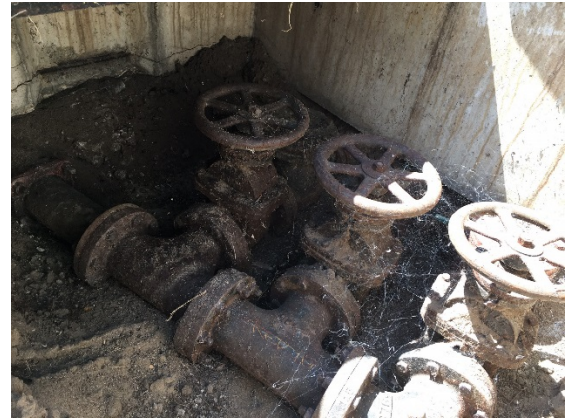
Component
Valve Pit
Score
4
Reason
Valve pit and components within need to be replaced.

The interior of the valve pit shows signs of cracking and surface damage. The valve pit hatch and the hatch rim are rusty. The bottom of the valve pit is filled with sand. The valve pit should be replaced.

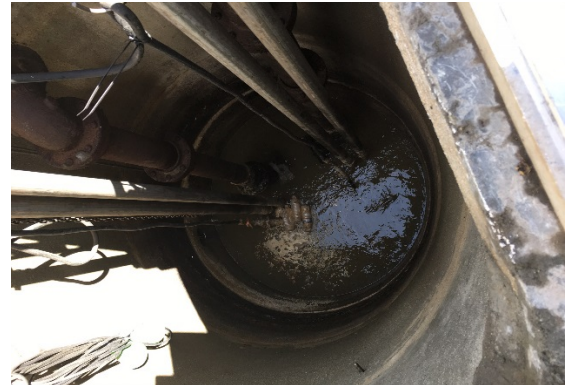
Component
Discharge Pipe and Guide Rails
Score
2
Reason
Discharge pipes show signs of corrosion.

The discharge pipes inside the wet well show signs of corrosion, while the pump lifting guide rails appear to be in good condition.

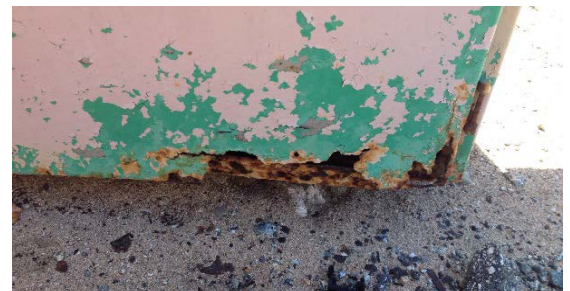
Component
Pump Control Panel
Score
3
Reason
Lower corner of front door is rusted through.

The lower corner of the pump control panel front door is rusted through.

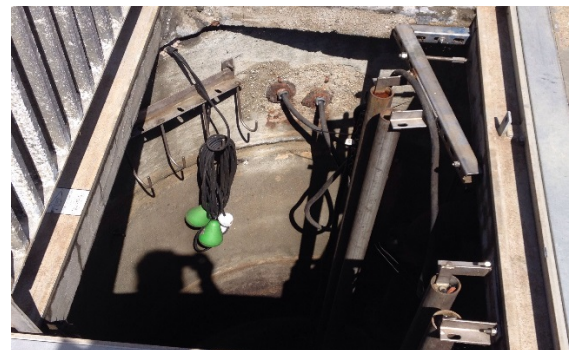
Component
Float Switches
Score
4
Reason
Cables are coiled up and hung above the wet well operating range.

High-level and low-level float switches are installed, but the cables are coiled up and hung on a hook well above the wet well operating range.

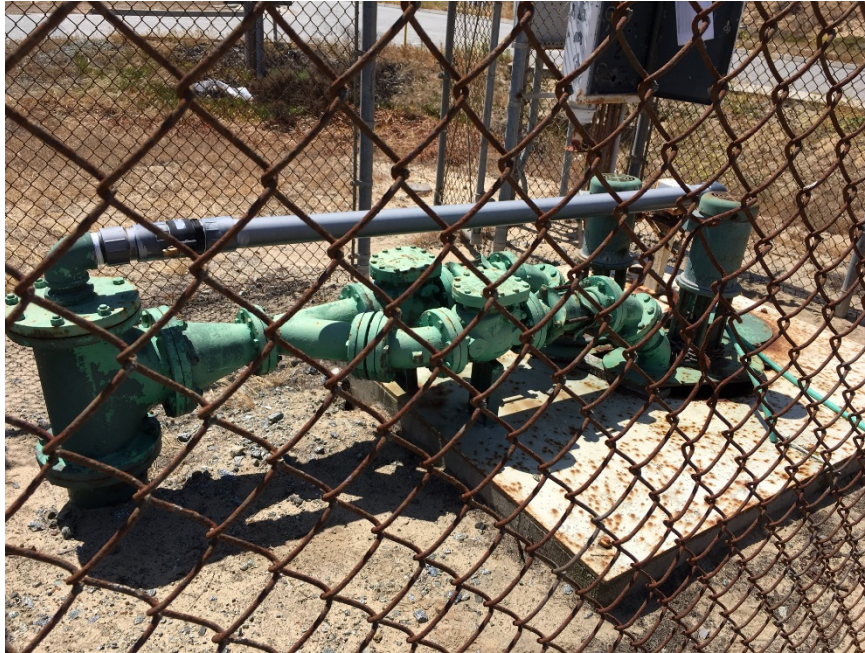
## 4.4 NEESON

The Neeson Lift Station is a wet well submersible lift station with no building. Valves and pipes are above grade. Electrical cabinets are above grade. The entire lift station is fenced in with limited space.

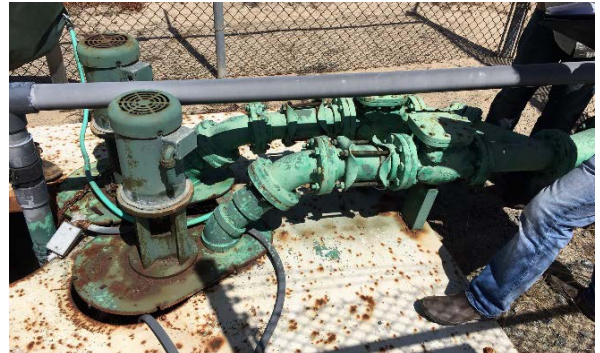
Component
Pump Bypass
Score
5
Reason
Bypass is permanent. Not recommended.

The lift station appears to be in permanent bypass, which is not recommended

Piping and valves show signs of corrosion both inside the well and on the discharge side (For Photo - See Bypass Pump in Section 4.4.1.) of the pump station.

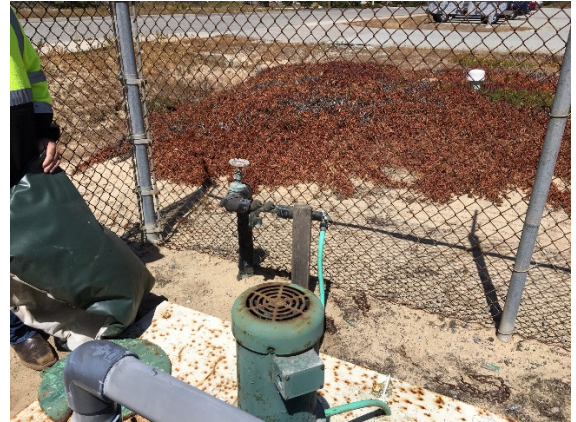
Component
Domestic Water Hose Bib
Score
1
Reason
Backflow Prevention Device was installed.

The domestic water hose bibb within the fence did not have a backflow prevention device accepted by the California Code; this was corrected as of the 2005 Wastewater Collection System Master Plan.

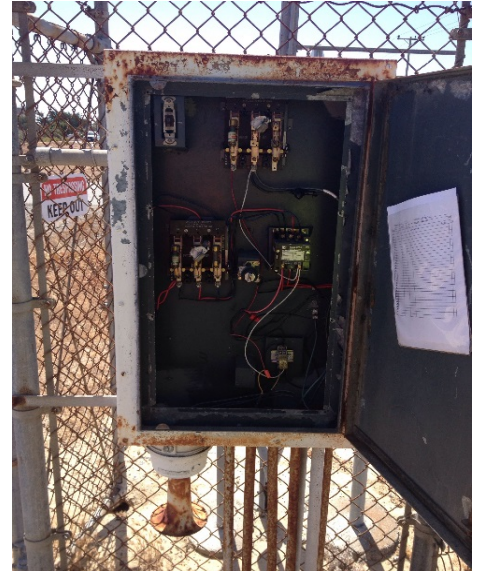
Component
General Electrical Equipment
Score
5
Reason
In poor condition and not functioning.

Electrical equipment appears to be in poor condition and not functioning.

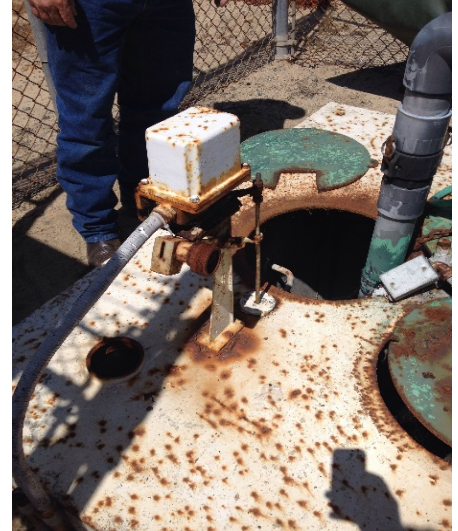
Component
Level Control
Score
4
Reason
Appear to be in poor condition and in need of replacement.

Level control is provided by a float on a vertical rod, which actuates a switch that is mounted above the wet well cover. The level control appears to be in poor condition and in need of replacement.

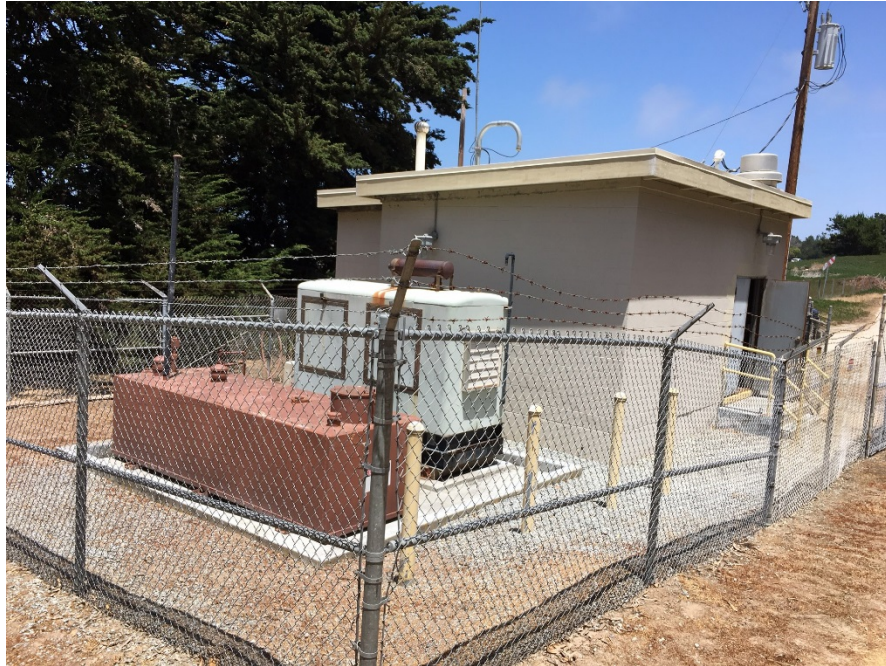
## 4.5 GIGLING

The Gigling Lift Station is a dry pit/wet well lift station with a building. Valves and pipes are in the dry pit below the building. Electrical cabinets are inside the building. The entire lift station is fenced in.

Maximum Capacity is 1.22 MGD (850 gpm).

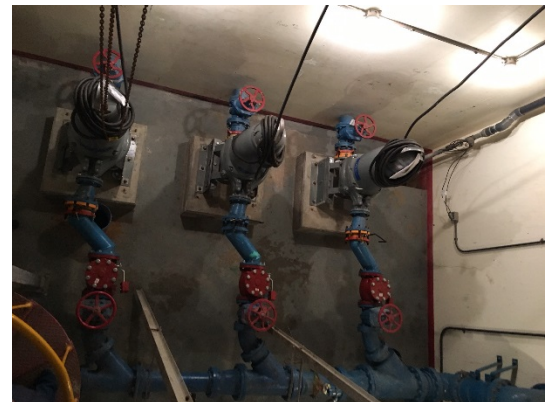
Component
Pumps
Score
1
Reason
No issues observed.

The lift station has three pumps that together run at a maximum capacity of 1.22 MGD (850 gpm), and a TDH of 100 ft. The Flygt submersible pumps were converted to dry pit service. A sump pump in the dry pit has a capacity of 0.07 GPD (50 gpm).

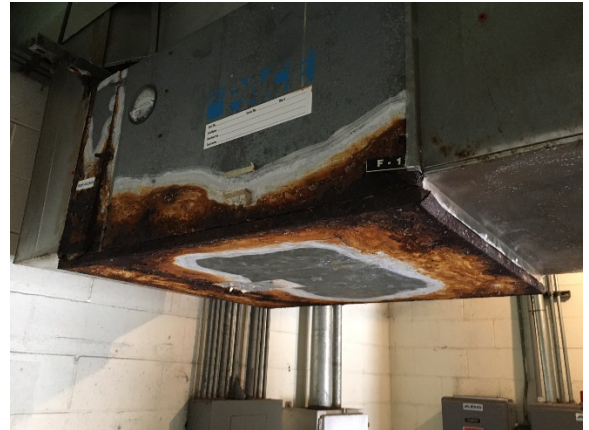
Component
Metal Ducts
Score
3
Reason
HVAC reported to work properly, but there are signs of corrosion.

Though the HVAC was reported to be working properly, there appears to be signs of corrosion.

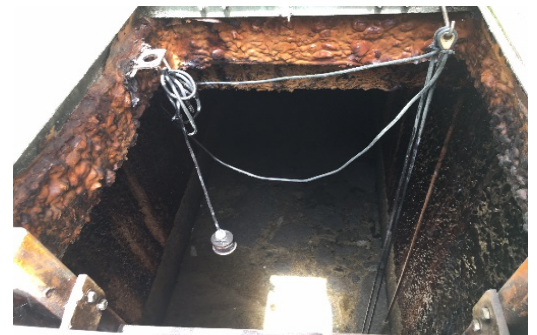
Component
Wet Well Walls
Score
1
Reason
Appear to be in good condition, though covered with an epoxy coating.

The wet well was epoxy coated, and although there is a bumpy coating to the walls, the walls are in good condition, and may have had coating over rough aggregate. The wet well dimensions are 22-ft long, 8-ft wide, and 16-ft deep.

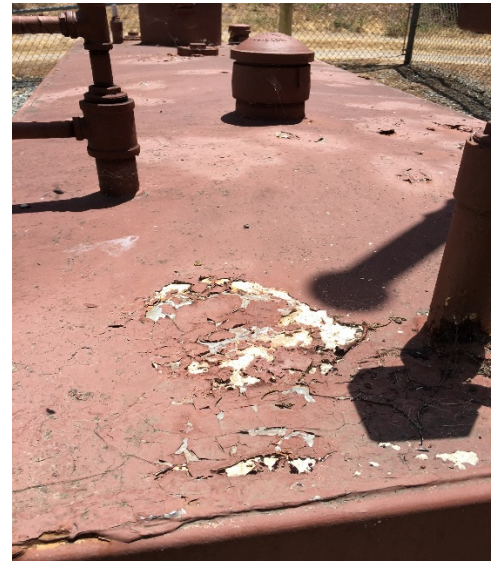
Component
Bulk Tank
Score
3
Reason
Signs of paint deterioration observed.

Signs of paint deterioration were observed on the top of the bulk fuel tank.

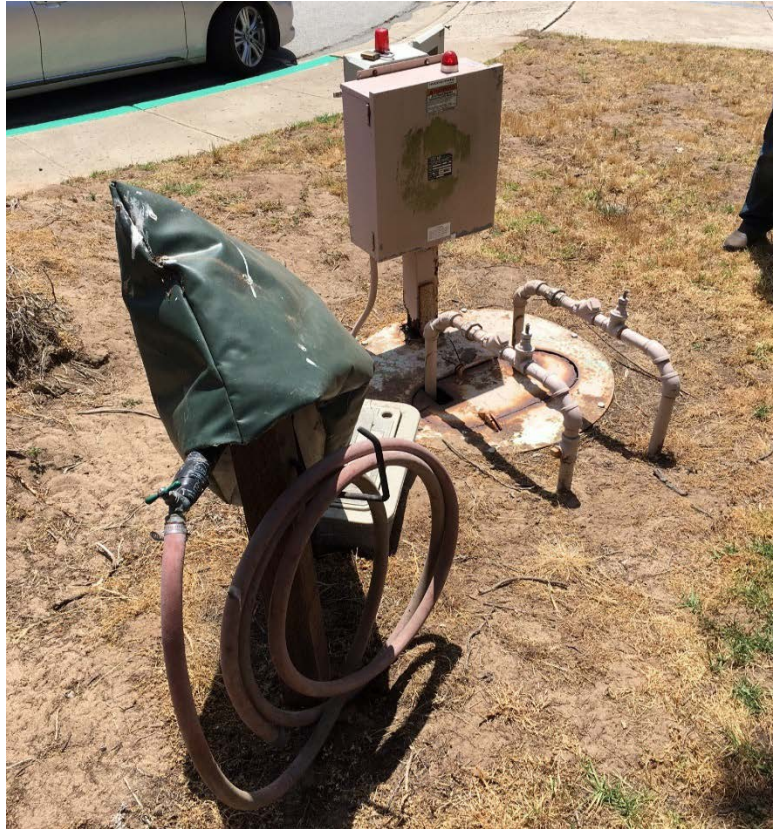
## 4.6 HATTEN

The Hatten Lift Station is a packaged duplex submersible lift station with no building. Valves and pipes are above grade. Electrical cabinets are above grade. The entire lift station has no fence, and is located at the end of the front yard of a residential home. The Hatten Lift Station was construction in 1966, and is controlled by a float system with a capacity of 40 gpm.

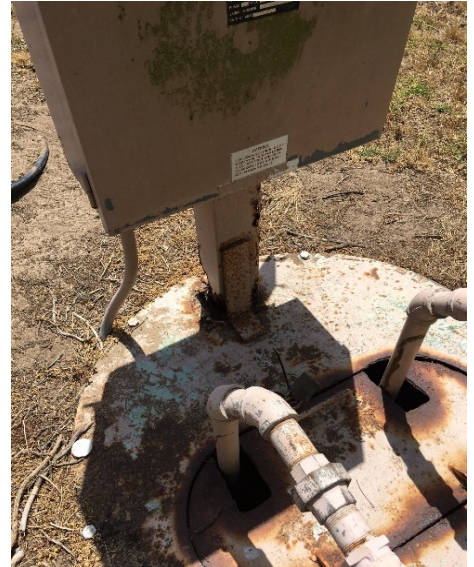
Component
Base Support
Score
5
Reason
Panel is corroded at the base, in danger of falling over. No concrete slab

Structural support is inadequate. It is recommended to have a concrete slab for proper pipe support. In addition, the packaged lift station panel appears to be corroded at the base and is in danger of falling over.
