**MARINA COAST WATER DISTRICT**

**SEWER  
MASTER PLAN**

**Subject: 2019 Sewer Master Plan – Draft Report**

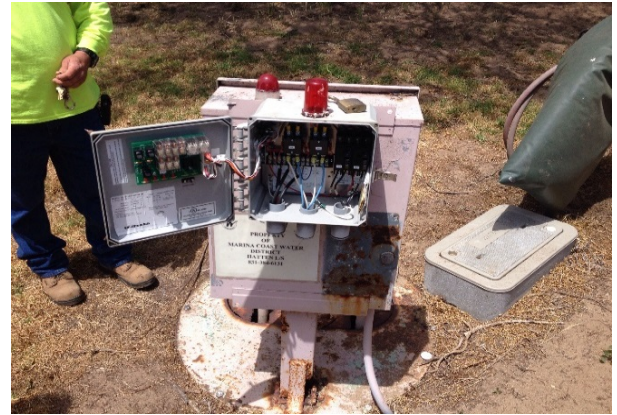
Component
PLC/Telemetry
Score
3
Reason
No PLC/telemetry package. No audible device for alarm notification.

This site is not equipped with the PLC/telemetry package that is present at the other pump stations. The control panel is equipped with two red lights for alarm notification. The presence of an audible device was not noted.

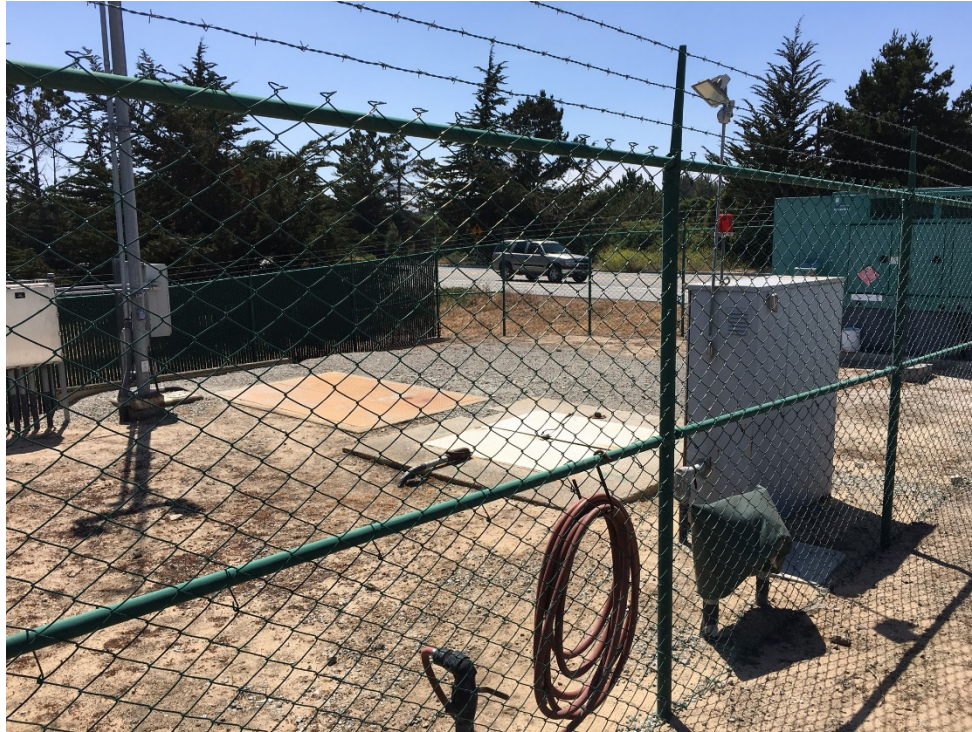
## 4.7 IMJIN

The Imjin Lift Station is a wet well submersible lift station with no building. Valves and pipes are below grade. Electrical cabinets are above grade. The entire lift station is fenced in.

The Imjin Lift Station is currently the largest lift station in the Ord Community sanitary sewer system, and is projected to more than double in size in the future. This key lift station is a critical facility for proper system operation. The Imjin Lift Station was built in 1970, replaced in 1982, and renovated in 2003 with an upgrade of two new 1,490-gpm pumps and associated pump 7 control equipment<sup>2</sup>. It is located alongside Imjin Road east of Abrams Drive. The arrangement of multiple gravity and force main inlets make isolation of the wet well for cleaning or maintenance very difficult.

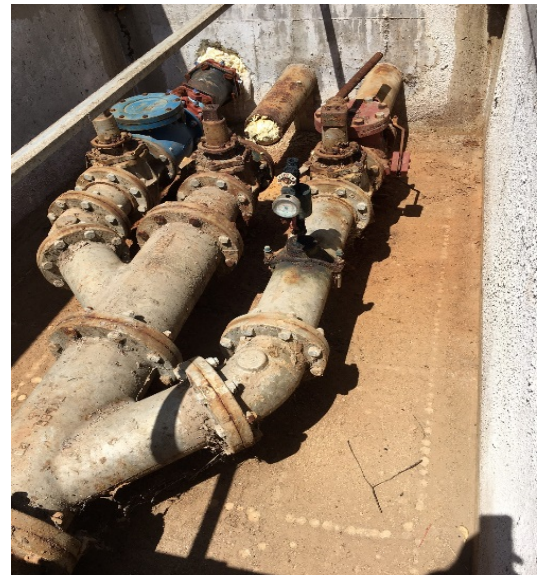
Component
Valve Vault Piping and Valves
Score
4
Reason
High amounts of corrosion. Recommended replacement.

Two new Flygt pumps have a 6-inch diameter ductile iron discharge pipe with a gate valve and a check valve. The discharge pipes combine in a valve pit, and a 10-inch diameter force main conveys flow to the Abrams Trunk Sewer. Only one of the discharge pipes are currently used, thus emergency bypass is not possible. The piping and valves in the valve vault show high amounts of corrosion, and it is recommended to replace all parts within the vault.

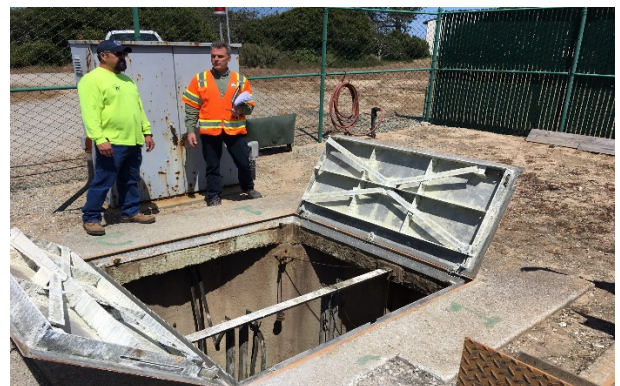
Component
Fall Protection
Score
3
Reason
Fall Protection is recommended for safety.

The wet well hatch cover is in fair condition, but fall protection is recommended.

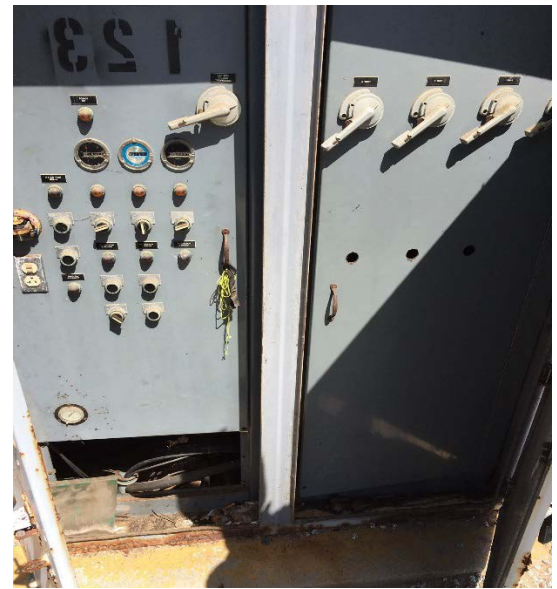
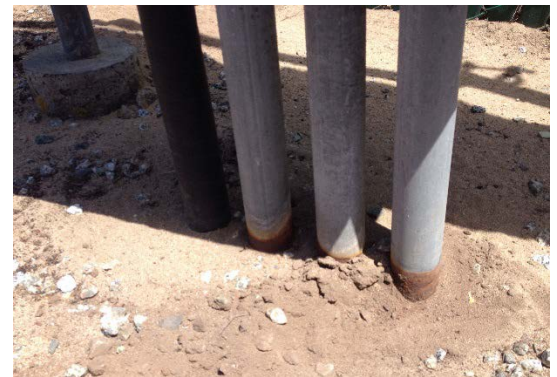
Component	Score	Reason
Meter/main panel	1	No issues observed.
Component	Score	Reason
Automatic Transfer Switch	1	No issues observed.
Component	Score	Reason
Pump Control Panel – prior to 2003 upgrades	3	Consider removing in favor of an underground pullbox or handhole.
Component	Score	Reason
Current Pump Control Panel	3	Conduits have rust where in contact with the soil.
Component	Score	Reason
480:208/120V unit power center	1	No issues observed.

The electrical equipment consists of a meter/main panel, automatic transfer switch, pump control panel, and a 480:208/120V unit power center with stepdown transformer and breaker panel. The pump control panel contains a Zenith Pulsar level controller and combination full-voltage, non-reversing two motor starters. The pump control panel is weathered, but in otherwise good condition. Galvanized conduits extending from underground were not properly wrapped during installation, causing the conduits to rust where in contact with soil.

The pump control panel that existed prior to the 2003 upgrades has been repurposed essentially as a pullbox for the generator and pump motor feeders. It is in fair-to-poor condition, but serves the current purpose. The District should consider removing this panel in favor of an underground pullbox or handhole.

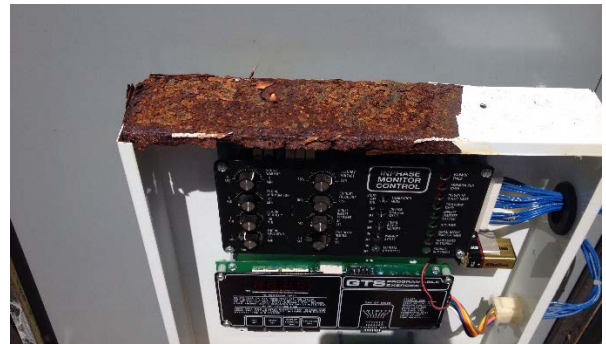
Component
Outer enclosure of the automatic transfer switch.
Score
3
Reason
Severe rust to the metal enclosures that protects the ATS control boards.

The outer enclosure of the automatic transfer switch is rusted through in two places at the drip edge above the door. Water is dripping inside, causing severe rust to the metal enclosure that protects the ATS control boards. It is a matter of time before the rusted metal no longer protects the control boards from the dripping water.

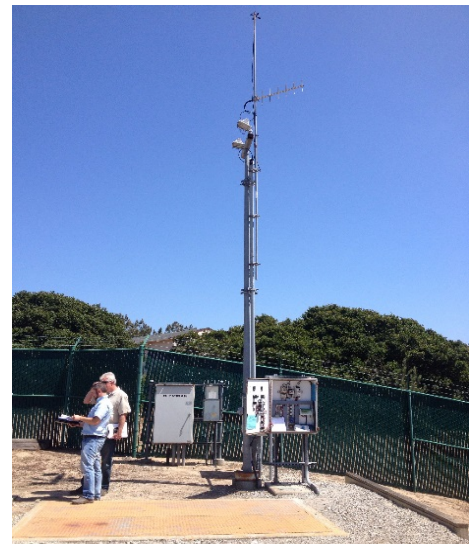
Component
Second Antenna
Score
3
Reason
Unknown purpose from District personnel

A second antenna, appearing similar to a remote cellular antenna, is mounted at the top of the mast. Cabling from this antenna is routed in underground conduit, and could not be traced. The antenna cable was not observed in any of the equipment enclosures. District personnel also were unsure of its purpose.

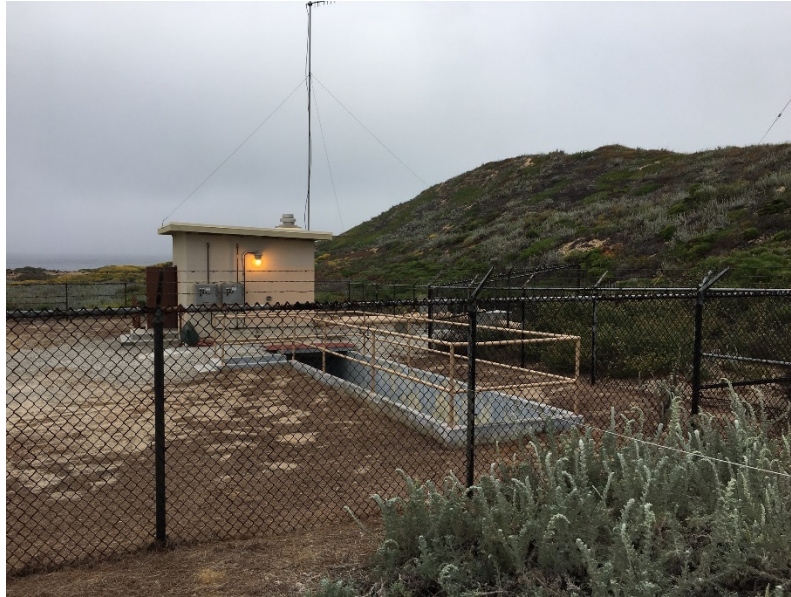
## 4.8 ORD VILLAGE

The Ord Village Lift Station is a dry pit/wet well lift station with a building. Valves and pipes on the discharge side are outside the building. Electrical cabinets are both inside and outside of the building. The entire lift station is fenced in.

The Ord Village Lift Station is the only District lift station located on the west side of Highway 1, the Union Pacific Railroad (UPRR), and Beach Range Road. This lift station, which was initially a sewage treatment plant that provided wastewater treatment for Fort Ord and was constructed prior to 1960, is situated near the shoreline of Monterey Bay. Lift station reliability is critical because, if an overflow were to occur, untreated wastewater would quickly reach the sensitive ocean habitat.

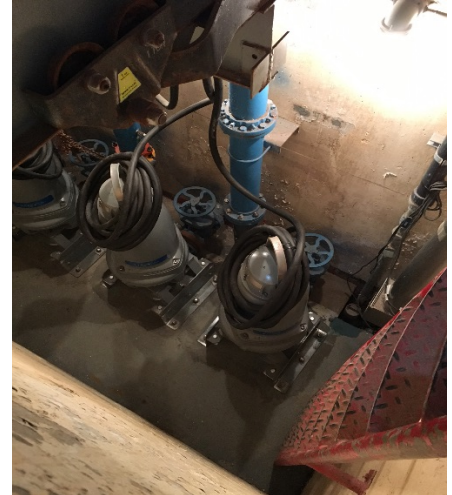
Component
Pumps
Score
1
Reason
No issues related to pumps

The Ord Village Lift Station has three Flygt pumps that replaced three ABS submersible pumps (Model AFP1001-4P) with 58-hp motors. Each of these units has a rated capacity of 280 gpm at 110-ft TDH. A bimetallic thermal switch is provided in the upper portion of the stator winding of each pump to protect against damage caused by high temperatures. The pumps are designed to shut off at a temperature of  $140^{\circ}\text{C} \pm 5^{\circ}\text{C}$ . In addition, each pump has an electrical probe in the oil reservoir connected to a solid-state device mounted in the control panel. A low voltage, low amperage signal communicated between the solid-state device and the probe warns of water in the oil reservoir and provides an indication of early seal failure, resulting in activation of a warning light in the control panel and/or pump shutdown.

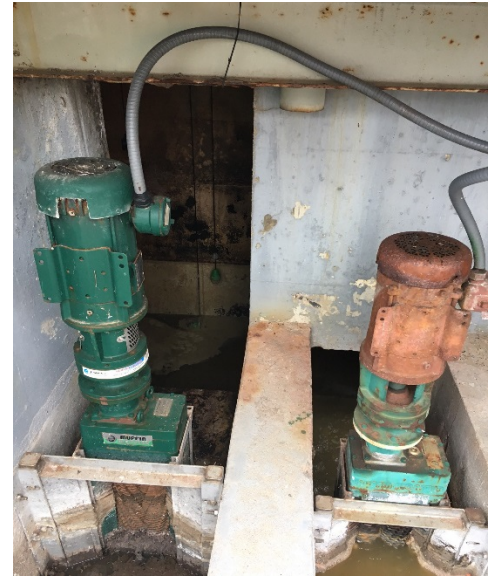
Component
Muffin Monster Comminutors
Score
3
Reason
One comminator is highly corroded and recommended to be replaced.

Prior to being converted to a lift station, the Ord Village facility was a wastewater treatment plant. Two open influent channels enter the lift station wet well. Each influent channel is fitted with a Muffin Monster comminator. The comminutors have 3-hp electric motors with 18-inch helical stack cutters to grind solids into smaller portions for easy passage through the pumps. One of these is highly corroded and is recommended to be replaced (see photo above).

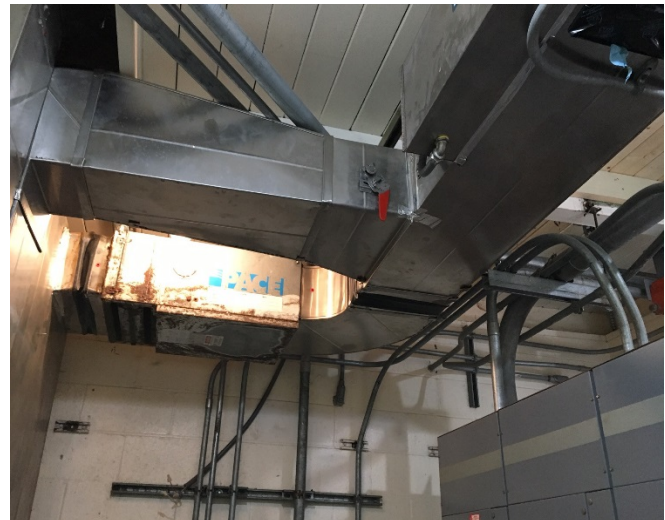
Component
Metal Ducting
Score
3
Reason
Signs of dampness and corrosion. Recommended replacement.

A heating, ventilation, and air conditioning (HVAC) system is also provided to provide ventilation in the below ground areas and to dehumidify the air within the lift station control building (to reduce corrosion and to increase personnel safety). The HVAC system includes a PACE F-1 supply fan, a Baldor 1/3-hp, 530 cfs motor, and a Penn EF-1 exhaust fan with 1/4-hp Marathon motor. Stainless steel ducting draws air from the dry well and

the lift station control room and exhausts the air outside the building. In several locations, especially near the exit wall, the ducting shows signs of dampness and corrosion and is recommended to be replaced.

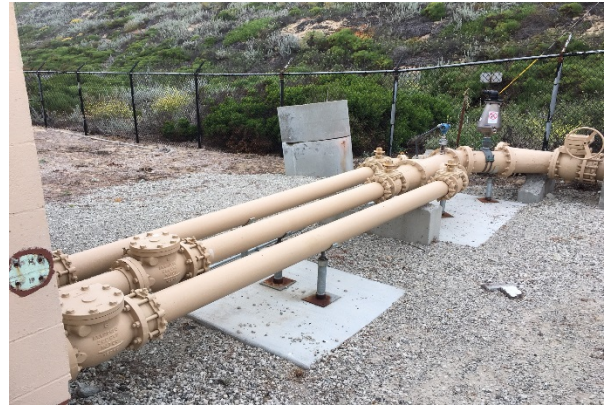
Component
Piping and Valves
Score
1
Reason
New pipes and valves

Piping and valves on the discharge side of the pump station are new.

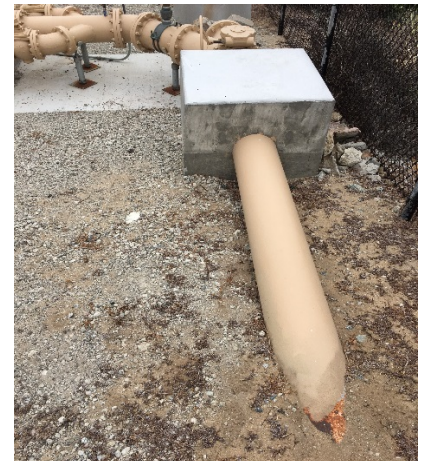
Component
Pipe at end of discharge line
Score
3
Reason
Corrosion – recommended recoat or replacement.

In general, piping and valves appear to be adequate. There does, however, appear to be corrosion at the end of the discharge line, and it is recommended to recoat or replace this section. The extent of exterior corrosion on the pipe is unknown beyond the limits shown in the photo above.

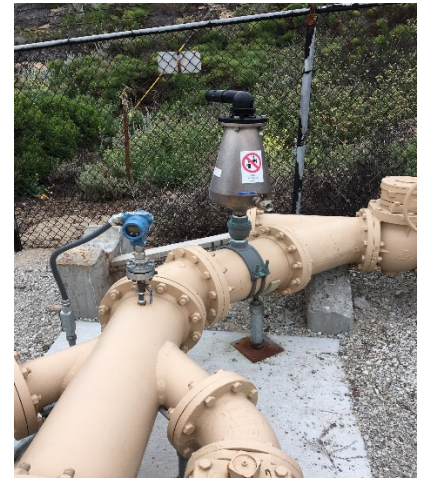
Component
Air Lock issues - Piping / Valves
Score
3
Reason
Force main causing air issues in piping

For this station and for the Gigling Lift Station, even with new pumps installed, there are air lock issues due to problems with the force main. The District reported breaks in the force main. Due to this, the District has been monitoring pressure. There is a lot of bleeding, and sometimes the District will lift up the check valve and backflush before it will prime again. Problems with water hammer have been partially solved by the air release valve. Condition assessment of the force main will require flow handling or bypass. For cost efficiency, condition assessment should be coordinated with other activities at the lift station that necessitate flow handling or bypass.

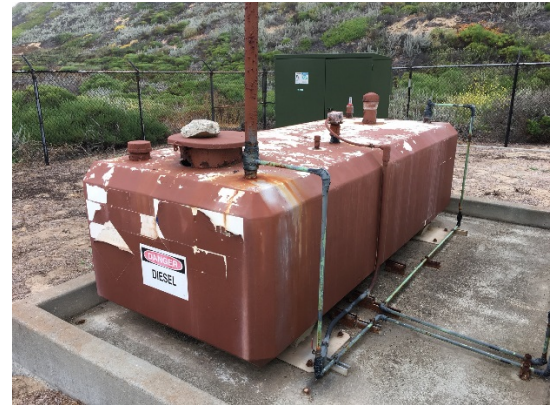
Component
Concrete Slabs on grade
Score
1
Reason
Appear to be in good condition

Concrete slabs-on-grade are provided for the generator, fuel storage tank, and outdoor electrical facilities.

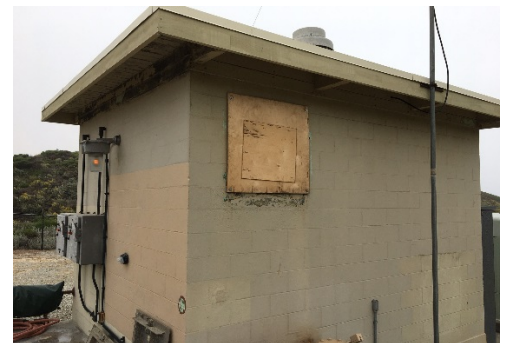
Component
Wall Penetration Replacement
Score
3
Reason
Wall appears to have a boarded up louver or duct penetration. Repair of this location is recommended.

One wall appears to have a boarded up louver or duct penetration with a wood plank and may need to be replaced.

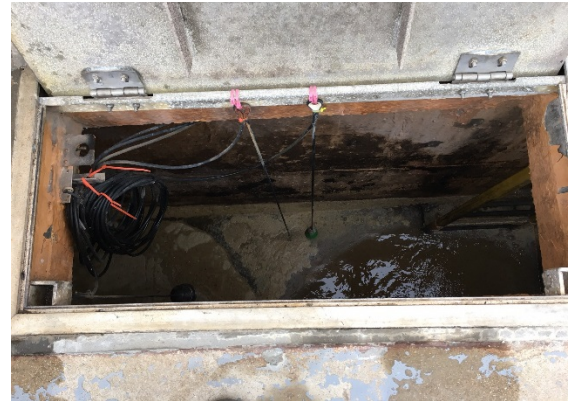
Component
Wet Well Hatch
Score
3
Reason
Operator mentioned wet well is difficult to clean. Larger hatch is recommended.

Dimensions of the wet well are 12-ft long, 6-ft wide, and 11-ft deep. The wet well structure appears to be in good condition, but the operator mentioned it is difficult to clean. A larger hatch is recommended.

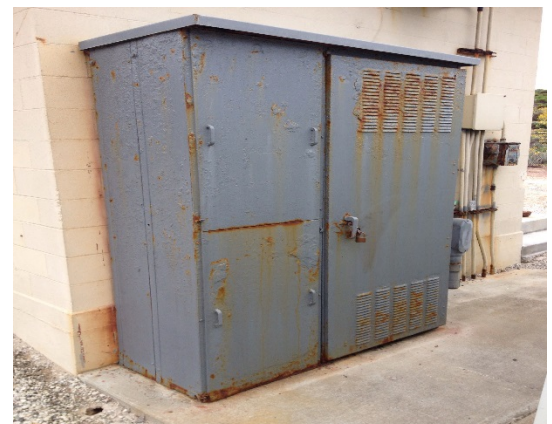
Component
Service entrance switchboard
Score
3
Reason
Heavily rusted

The service entrance switchboard consists of a utility underground pull section, and a PG&E metering compartment and main breaker. The switchboard, mounted on a pad outside the building, is heavily rusted. It is recommended to replace the rusted mild-steel main service entrance enclosure located on the west side of the pump building with a stainless steel enclosure.

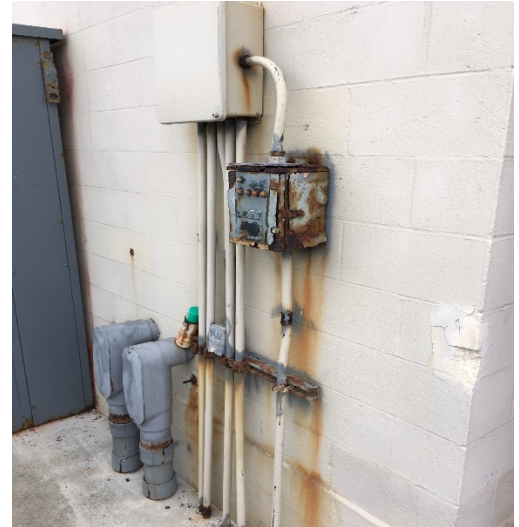
Component
Fuel tank leak detection panel
Score
5
Reason
Heavily rusted. Functionality in doubt.

The fuel tank leak detection panel, also mounted outside, is very heavily rusted, and its functionality is in doubt. Exterior conduits and conduit supports are heavily rusted. Equipment that is mounted inside the building shows some minimal surface rust on up to 10% of the overall surface area.

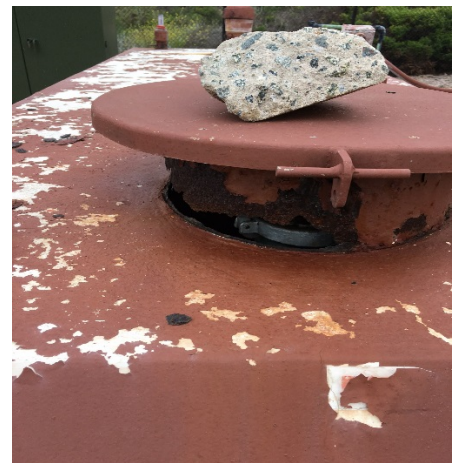
Component
175 kW Caterpillar diesel generator
Score
3
Reason
Muffler is rusted through

The site is equipped with a 175 kW Caterpillar diesel generator and an Olympian automatic transfer switch. The generator is reportedly in good operating condition, but the muffler is rusted, and the straps that hold the muffler to the enclosure are rusted through.

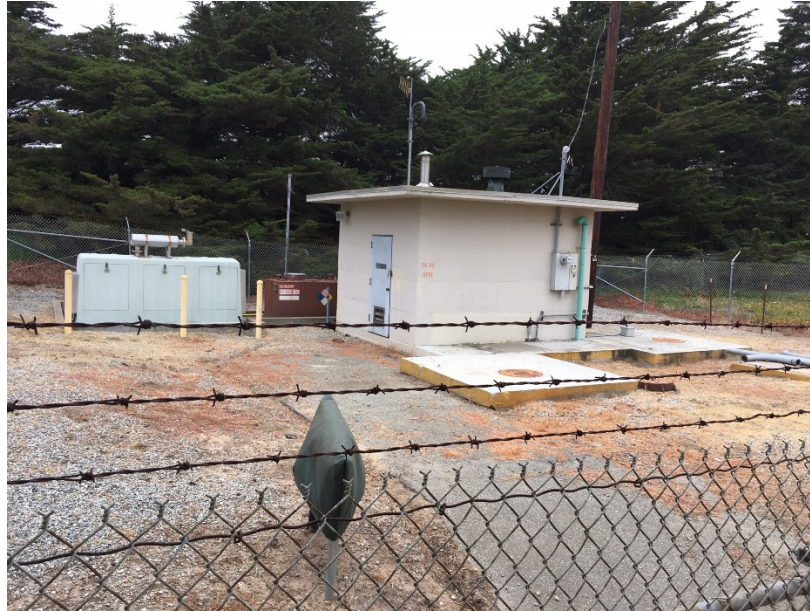
## 4.9 BOOKER

The Booker Lift Station is a dry pit/wet well lift station with a building. Valves and pipes on the discharge side are below the building. Electrical cabinets are both inside the building. The entire lift station is fenced in.

Booker Lift Station was constructed in approximately 1966 and was upgraded in 1997. The lift station has a total capacity of 760 gpm with two pumps, but only one operable pump was reported from District staff. It is a dry pit/wet well type lift station and is controlled by a sonic level sensor. The service area is planned to be redeveloped, and major rehabilitation or replacement of the lift station is recommended.

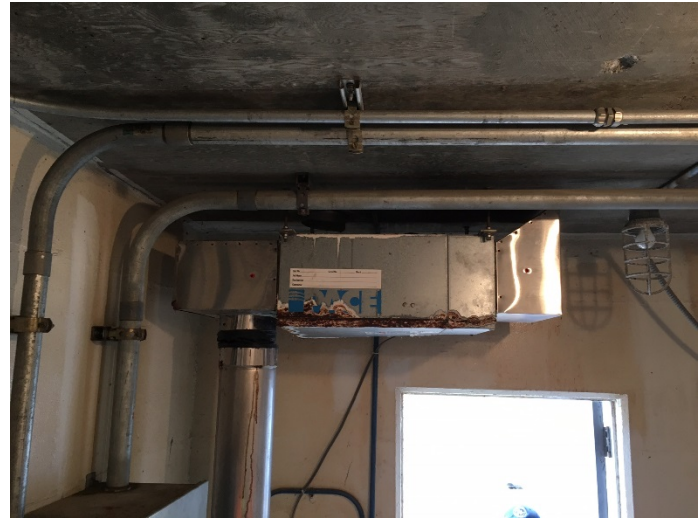
Component
Redesign of HVAC system
Score
5
Reason
Exhaust fan discharges into the building. Strong odor inside the building. Potentially hazardous condition.

The wet well and dry well vents are connected via a single duct to an exhaust fan that is mounted inside the pump station building. The exhaust fan discharges into the building, not outside. This creates a strong odor problem inside the building, essentially negates the attempt to ventilate the dry well, and potentially creates a hazardous condition inside the pump station building. The ventilation system needs to be redesigned to effectively achieve the pump station’s ventilation goals.

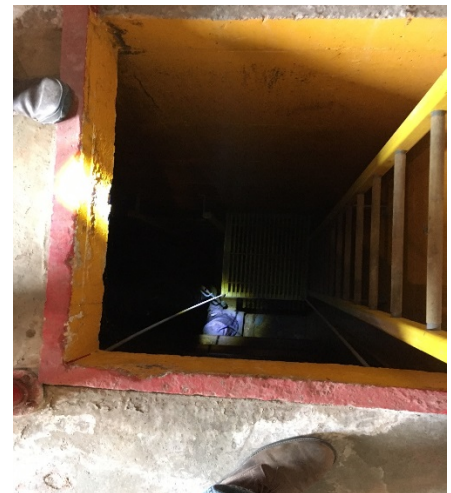
Component	Score	Reason
Dry Pit Dimensions	3	Too deep for valve stems and good access
Component	Score	Reason
Dry Pit Hatch Upgrade	3	Access Hatch too small
Component	Score	Reason
Dry Pit Stairs	3	Stairs preferred over ladder

Both the wet well and the dry pit are deep. If the line in the street is not as deep, it is recommended to build a shallower wet well and dry pit during an upgrade. Access is also limited. It is recommended to widen the access hatch during an upgrade, and construct stairs that lead down to the dry pit.

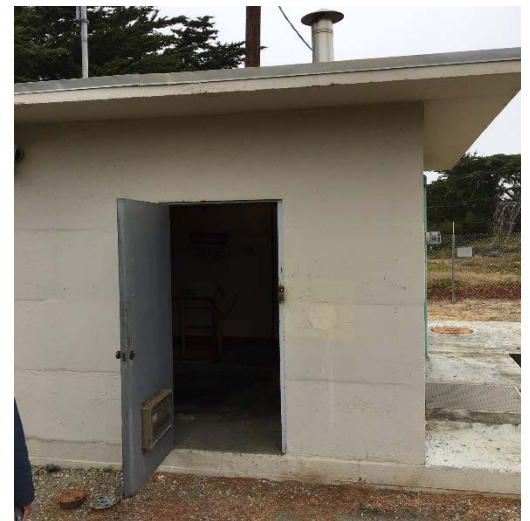
Component
Door
Score
1
Reason
Appears to be in decent condition.

The door appears to be in decent condition. For information on hatches see Wet Well / Dry Pit in Section 4.9.1. There are no windows.

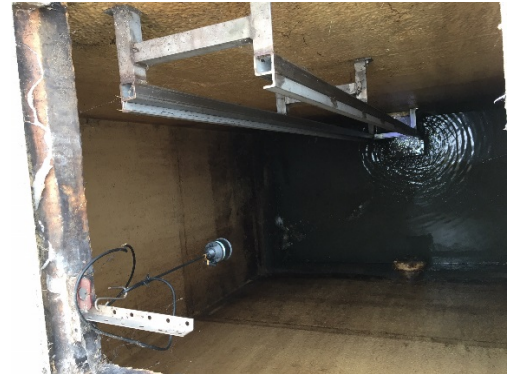
Component
Wet well coating
Score
2
Reason
Appears to be in decent condition.

The coatings on the wall appear to be in good condition. Wet well dimensions are 13-ft long, 6-ft wide, and 20-ft deep.

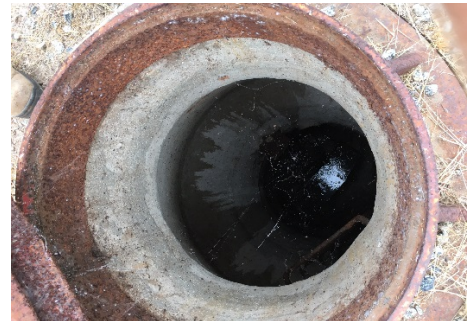
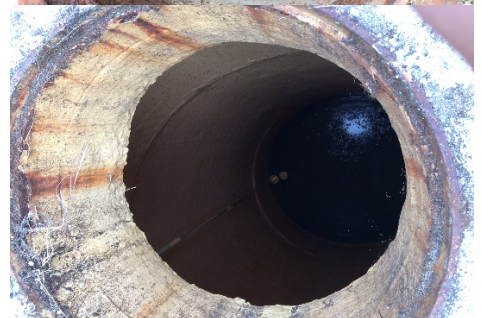
Component
Manhole 1
Score
1
Reason
Walls appear to be in good working condition.
Component
Manhole 2
Score
1
Reason
Walls appear to be in good working condition.

On both sides of the wet well there are manholes. The walls appear to be in good working condition.

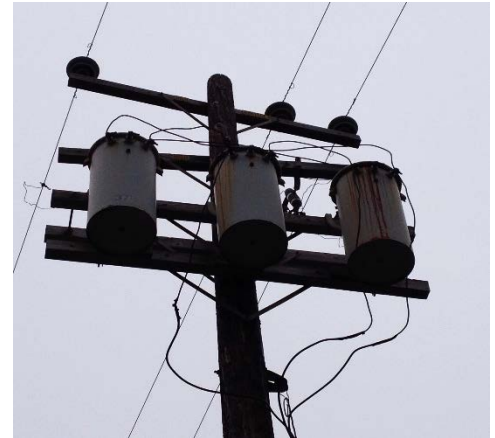
Component
Pole mount transformer
Score
3
Reason
Electrical service should be upgraded to meet PG&E's current standard for a 480V system.

The lift station electrical distribution system is fed from three single-phase pole-mount PG&E transformers, located within the lift station fence. The service is rated at 200-amps, 480 volts, three-phase, three-wire. A surge protection capacitor is mounted at the service panel, perhaps as an attempt to provide capacitive grounding to the otherwise ungrounded system. The electrical service should be upgraded to meet PG&E's current standard for a 480V system and to create a safer system for District personnel to operate and maintain.

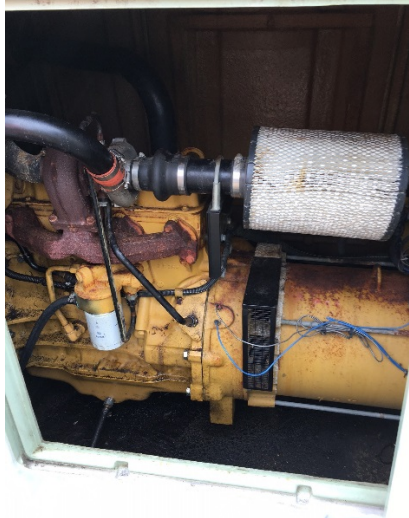
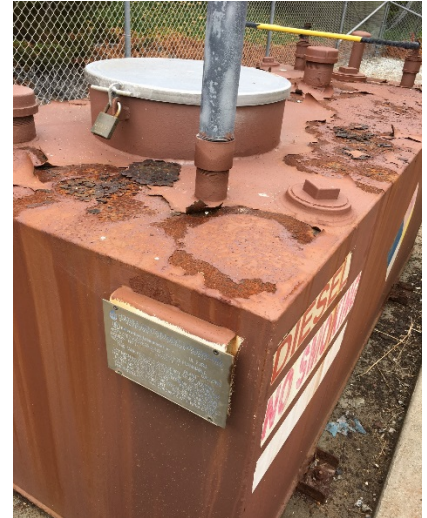
Component
Generator
Score
4
Reason
Reported to have engine valve problems and not in operating condition.
Component
250 gallon bulk diesel fuel tank
Score
4
Reason
Heavily rusted

The generator is reported to have engine valve problems and to not be in operating condition. The 250-gallon bulk diesel fuel tank site is heavily rusted. These elements should be replaced.

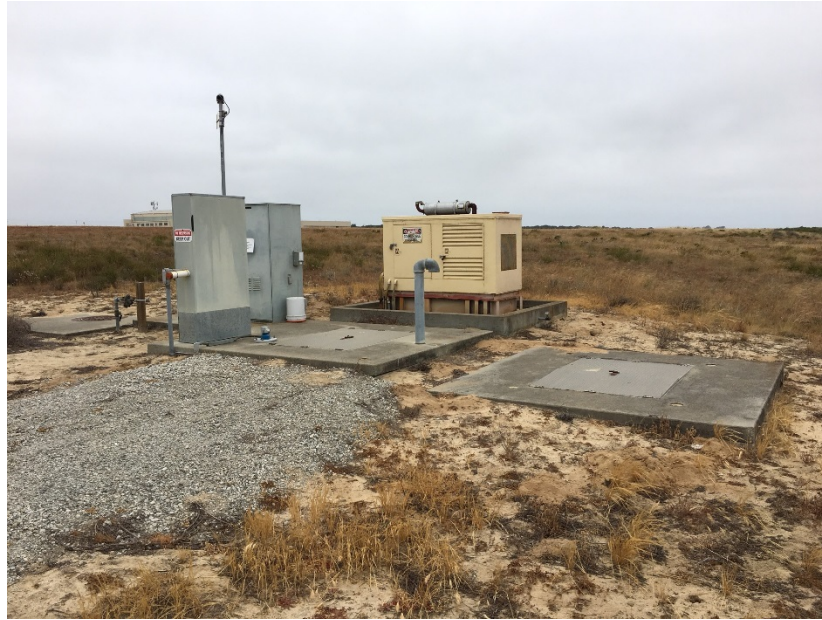
The Fritzche Lift Station is a wet well submersible lift station with no building. Valves and pipes on the discharge side are below grade. Electrical cabinets are mounted at grade. The lift station is not fenced in, though it is inside an airfield, which has perimeter fencing and security.

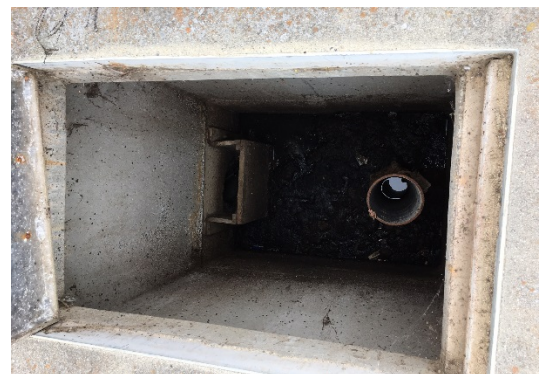
Component
Oil Separator
Score
3
Reason
Needs to be cleaned on a regular basis.

There is an oil separator that appears to be clogged. Cleaning of the oil separator on a regular basis is recommended.

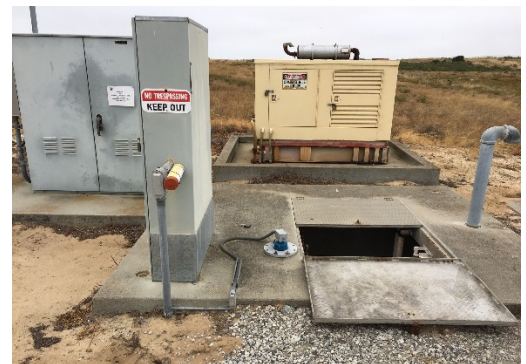
Component
Concrete Slabs
Score
2
Reason
Appear to be on grade and in decent condition

Concrete slabs appear to be on grade and in decent condition.

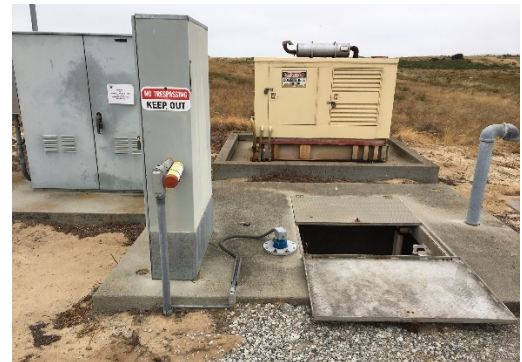
Component
Pad mount transformer
Score
1
Reason
Appear to be on grade and in decent condition

Drawings were not available to show the layout of the site electrical distribution system. Conclusions were drawn from what could be observed above ground. The lift station electrical distribution system is apparently fed from a 12kV distribution system that is owned by the airport, and likely feeds other adjacent equipment installations. The pump station appears to be fed by its own 208Y/120V, 3-phase, four-wire pad-mount transformer.

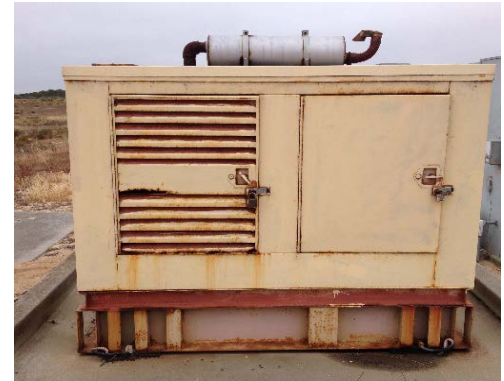
Component
Generator
Score
4
Reason
Enclosure and exposed exhaust system heavily rusted.

The generator enclosure and exposed exhaust system components are heavily rusted. The subbase fuel tank has minor-to-moderate rust. It is recommended for the generator to be replaced.

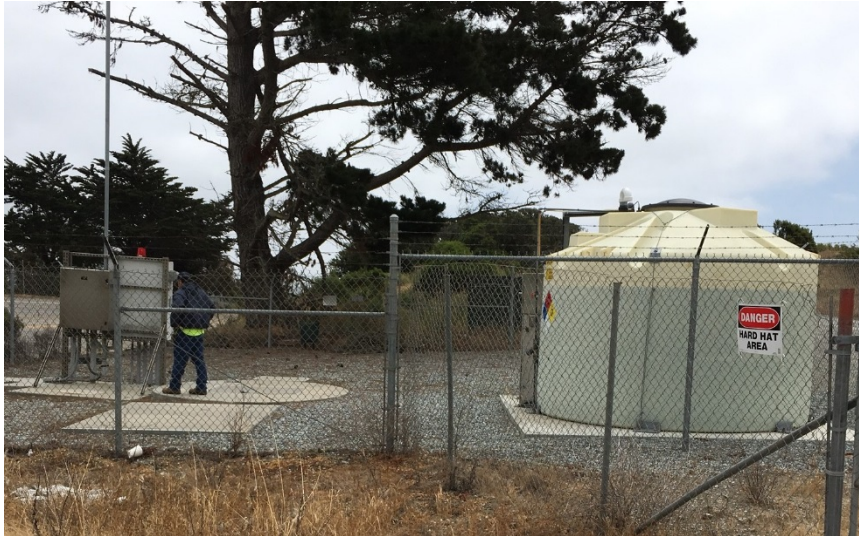
The East Garrison Lift Station is a wet well submersible lift station with no building. Valves and pipes on the discharge side are below grade. Electrical cabinets are above grade. The lift station is fenced in.

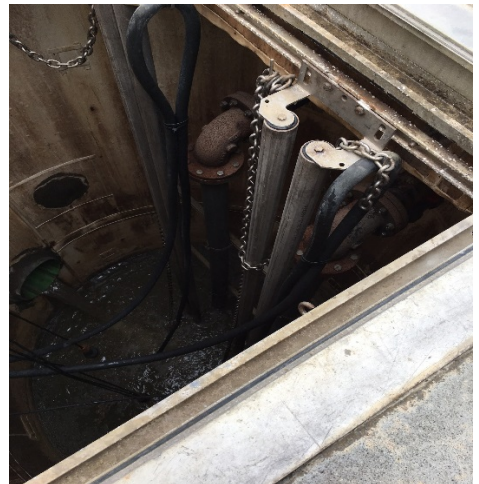
Component
Piping in wet well
Score
4
Reason
Corrosion Issues. Recommended replacement.

Piping appears to have corrosion issues within the wet well, and it is recommended to be replaced.

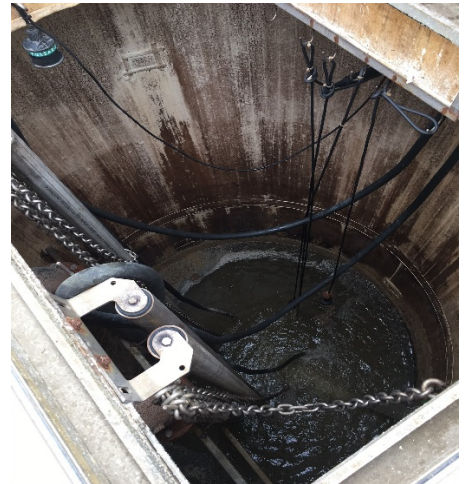
Component
Wet well liner
Score
1
Reason
No issues observed.

The wet well appears to have a liner rather than coating. No issues observed. Wet well dimensions are 8-ft in diameter and 18-ft deep.

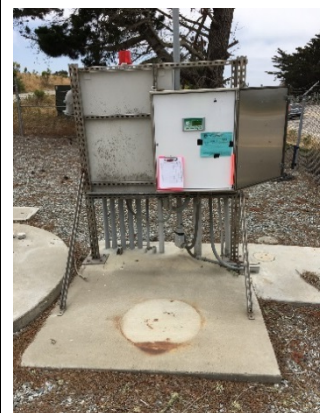
Component	Score	Reason
Meter/main panel	1	No issues observed.
Component	Score	Reason
Pump control panel	2	Shows minor weathering, otherwise appears to be in good condition.
Component	Score	Reason
PVC conduits between the electrical panels and the wet well	3	Appear to be shifting due to subgrade settlement.

The electrical equipment consists of a meter/main panel, and a pump control panel. The pump control panel contains a Zenith Pulsar level controller and combination full-voltage, non-reversing two motor starters. The panels show some minor weathering, but are otherwise appear to be in good condition. The concrete pad on which the electrical panels are mounted appears to be shifting due to subgrade settlement. The PVC conduits between the electrical panels and the wet well may be stressed or broken due to this settlement. It is recommended that the concrete pad and any broken conduits be replaced, and the electrical panels remounted.

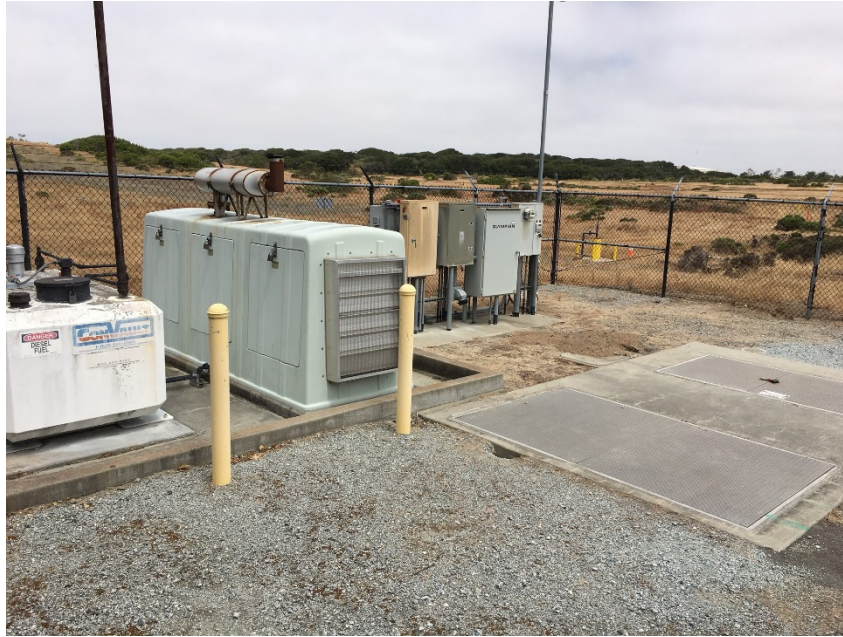
The Reservation Lift Station is a wet well submersible lift station with no building. Valves and pipes on the discharge side are below grade. Electrical cabinets are above grade. The lift station is fenced in.

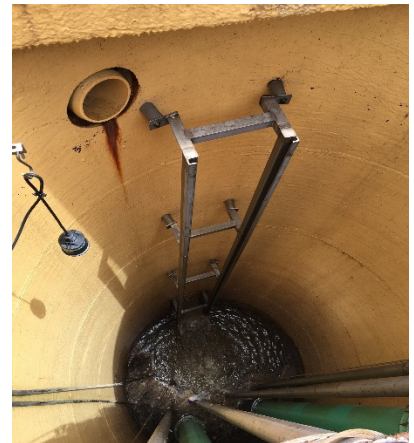
Component
Wet Well Coating
Score
3
Reason
Rust bleed below a drain line

The wet well coating appears to be in good condition, though there is rust bleed below a drain line that is recommended to be recoated. The wet well is 8-ft in diameter and 24-ft deep.

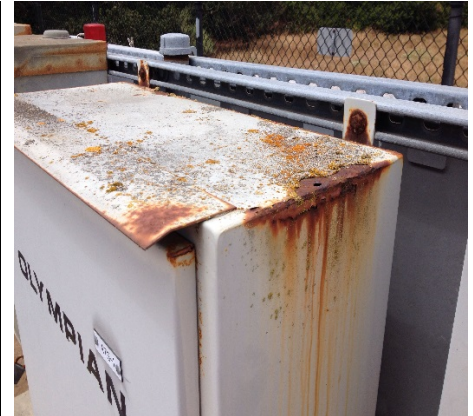
Component	Score	Reason
Meter/main panel	1	No issues observed.
Component	Score	Reason
Automatic transfer switch	3	One area on the enclosure top surface that is rusted through.
Component	Score	Reason
Manual Transfer Switch	1	No issues observed.
Component	Score	Reason
Pump control panel	1	No issues observed.
Component	Score	Reason
480:208/120V unit power center	1	No issues observed.

The electrical equipment consists of a meter/main panel, automatic transfer switch, manual transfer switch, pump control panel, and a 480:208/120V unit power center with stepdown transformer and breaker panel. The pump control panel contains a Zenith Pulsar level controller and combination full-voltage, non-reversing two motor starters. The panels are individually mounted on a unistrut support structure. The panels are weathered, with small areas of light rust but in otherwise good condition. The exception is the automatic transfer switch, which has one area on the enclosure top surface that is rusted through.

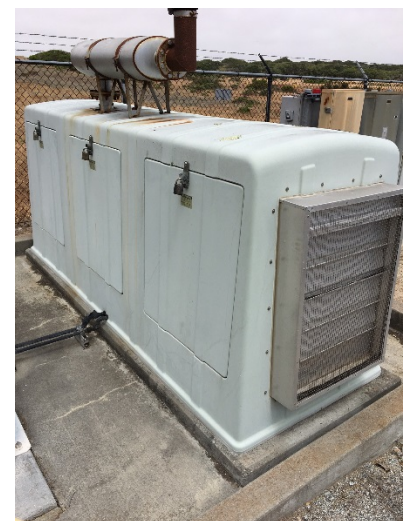
Component
100kW Olympian generator
Score
1
Reason
No issues observed.

The pump station is equipped with a 100kW Olympian generator, which is mounted inside a weather-protective fiberglass enclosure.

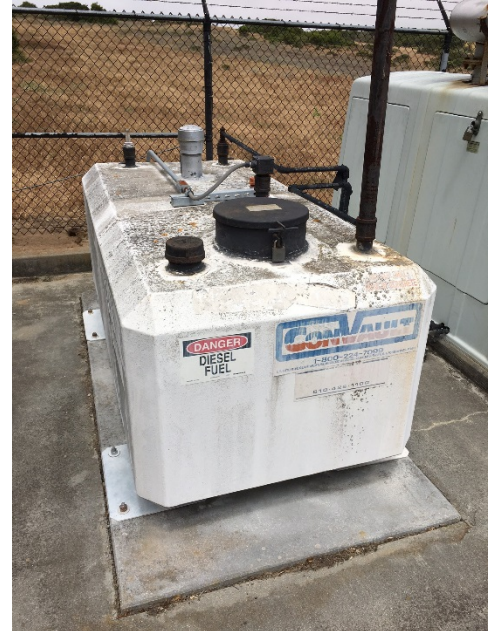
Component
Convault bulk tank
Score
1
Reason
No issues observed.

A Convault bulk tank is located next to the generator. Both the generator and tank appear to be in good condition.
