# Marina Coast Water District Sewer Master Plan

**SEWER  
MASTER PLAN**

Final Draft

**AKEL**  
ENGINEERING GROUP, INC.

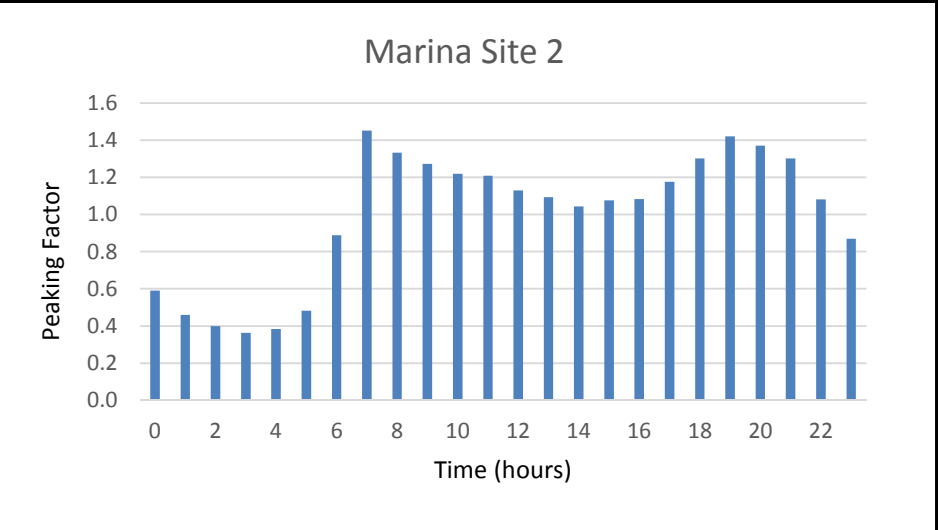
Typical values for peaking factors of 2.0 or less are generally used to estimate peak flows at treatment facilities where flow fluctuations are smoothed out during the time of travel in the sewer, while peaking factors between 3.0 and 4.0 are used to estimate peak flows in the smaller upstream areas of the system where low flow conditions are prone to greater fluctuations. This study developed 24-hour diurnal patterns and peaking factors for dry and wet weather flows for the tributary area to each flow monitor, as shown on [Figure 3.1](#), [Figure 3.2](#), and [Figure 3.3](#).

— Peaking Factor

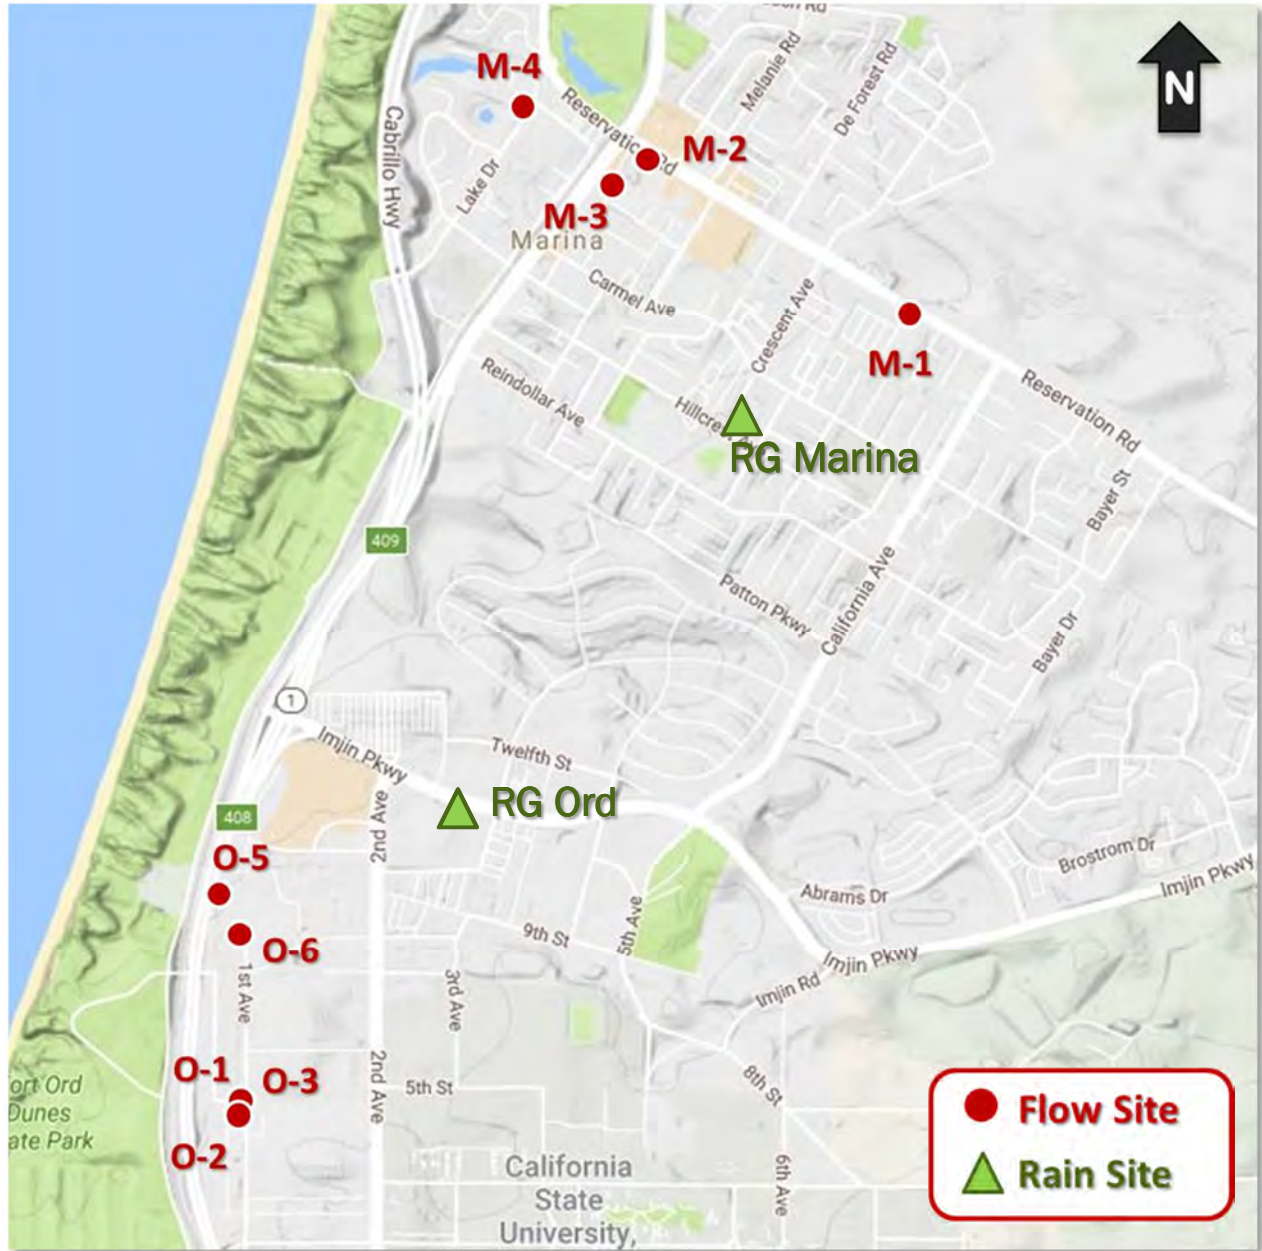
Figure ES-1. Map of Flow Monitoring Sites

Site / Basin	District Manhole No.	Monitored Pipe	Pipe Dia. (in)	Location	Basin Isolation Equation	Basin Area (acres)
M1	K606	SW Inlet	11.5	358 Reservation Road	= $Q_{M1}$	197
M2	L638	SE Inlet	12	210 Reservation Road	= $Q_{M2} - Q_{M1}$	103
M3	G421	SW Inlet	12	3148 Del Monte Boulevard	= $Q_{M3}$	152
M4	E331	South Inlet	10	Robin Drive at Hilo Avenue	= $Q_{M4}$	163
O1	J306	South Inlet	18	Lot northwest of intersection of 1st Avenue and 5th Street	= $Q_{O1}$	879
O2	D452A	South Inlet	12	Open space southwest of intersection of 1st Avenue and 5th Street	= $Q_{O2}$	215
O3	J306	East Inlet	15	Lot northwest of intersection of 1st Avenue and 5th Street	= $Q_{O3}$	243
O5	UVA1	NE Inlet	29.5	Northwest corner VA Clinic parking lot	= $Q_{O5}$	1,518
O6	UVB1	East Inlet	14.5	VA Clinic parking lot, near motorcycle parking	= $Q_{O6}$	235

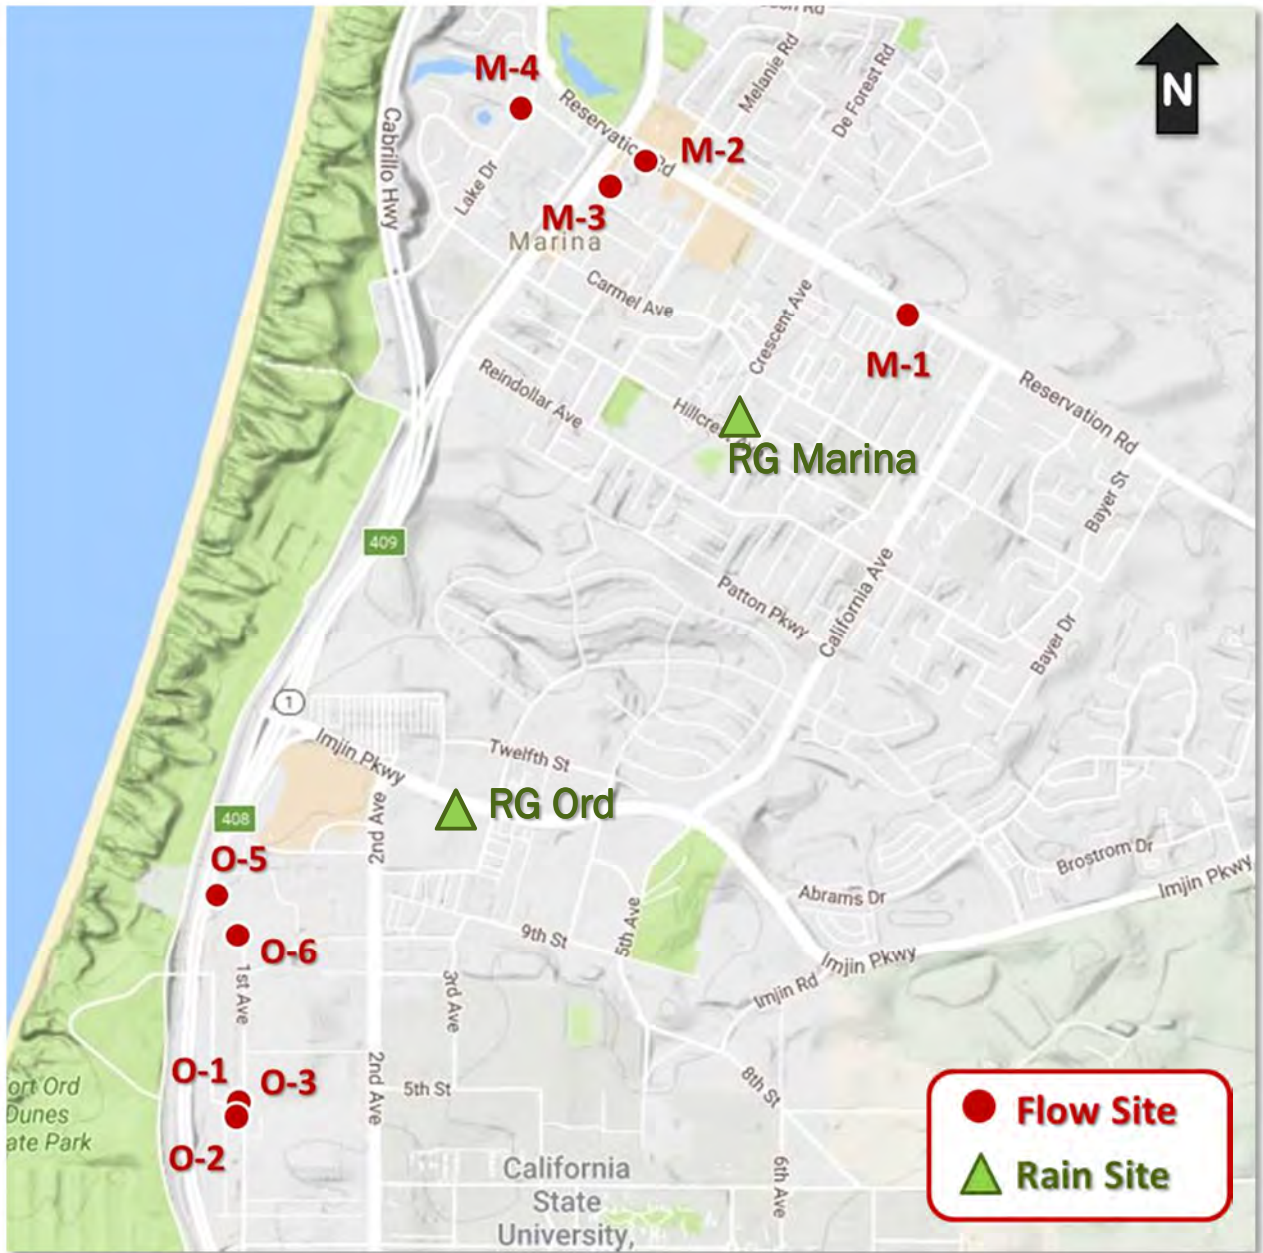
Figure 1-1. Map of Flow Monitoring Sites

The FM sites and associated basins (including basin flow equations) are listed in Table 1-1. The FM sites and associated basins and shown in Figure 1-1 and Figure 1-2, respectively. Detailed descriptions of the individual flow monitoring sites, including photographs, are included in Appendix A.

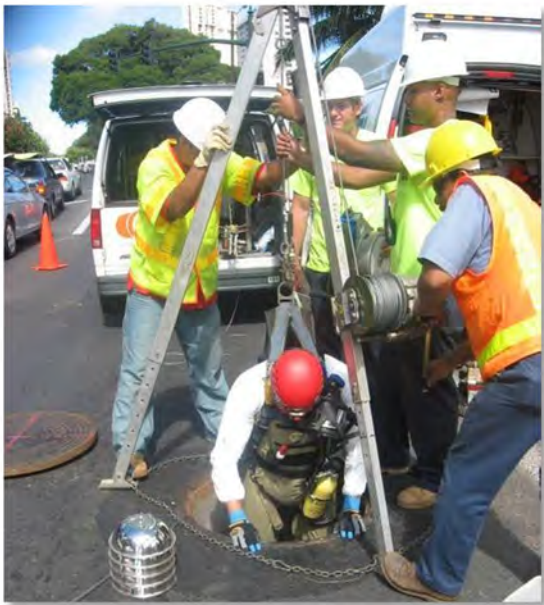
Photo 2-1. Confined Space Entry

A confined space (Photo 2-1) is defined as any space that is large enough and so configured that a person can bodily enter and perform assigned work, has limited or restricted means for entry or exit and is not designed for continuous employee occupancy. In general, the atmosphere must be constantly monitored for sufficient levels of oxygen (19.5% to 23.5%), and the presence of hydrogen sulfide (H<sub>2</sub>S) gas, carbon monoxide (CO) gas, and lower explosive limit (LEL) levels. A typical confined space entry crew has members with OSHA-defined responsibilities of Entrant, Attendant and Supervisor. The Entrant is the individual performing the work. He or she is equipped with the necessary personal protective equipment needed to perform the job safely, including a personal four-gas monitor (Photo 2-2). If it is not possible to maintain line-of-sight with the Entrant, then more Entrants are required until line-of-sight can be maintained. The Attendant is responsible for maintaining contact with the Entrants to monitor the atmosphere using another four-gas monitor and maintaining records of all Entrants, if there is more than one. The Supervisor is responsible for developing the safe work plan for the job at hand prior to entering.

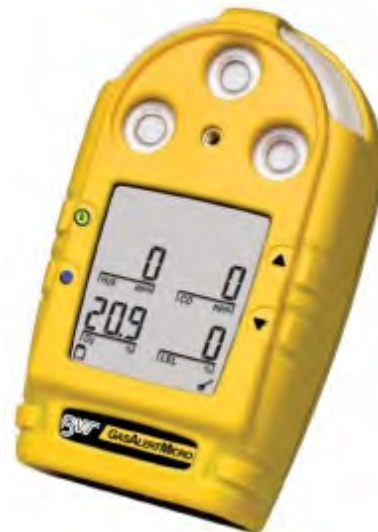
Photo 2-2. Typical Personal Four-Gas Monitor

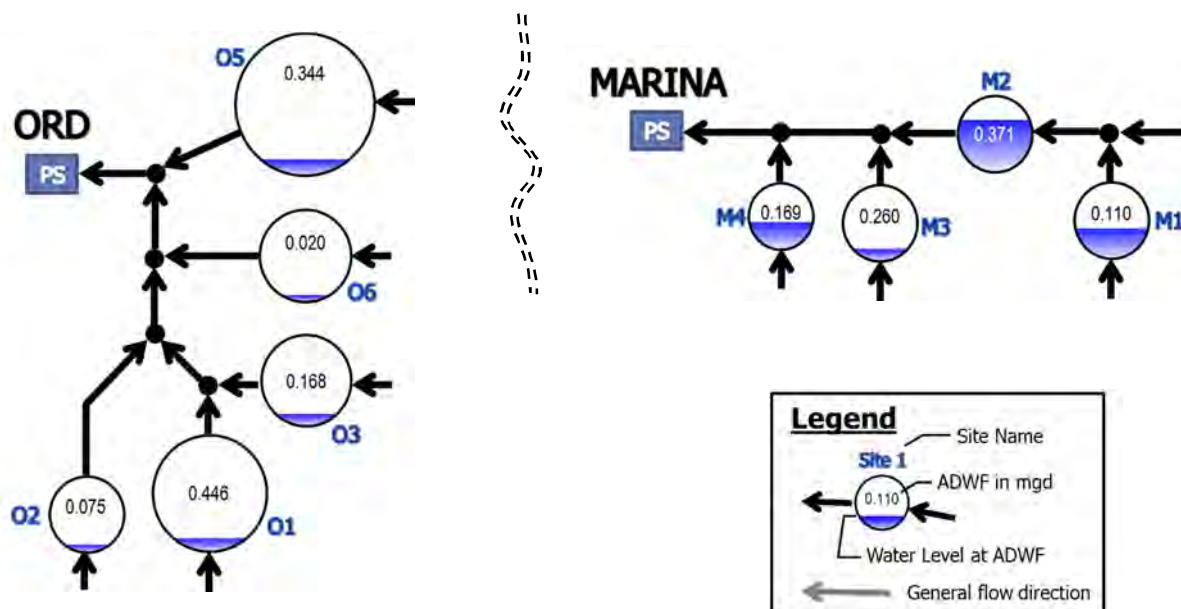
Figure 4-1. Dry Weather Flow Schematic

Table 4-1 summarizes the dry weather flow data measured for this study. ADFW curves for each site can be found in Appendix A. Figure 4-1 shows a schematic diagram of the average dry weather flows and flow levels.

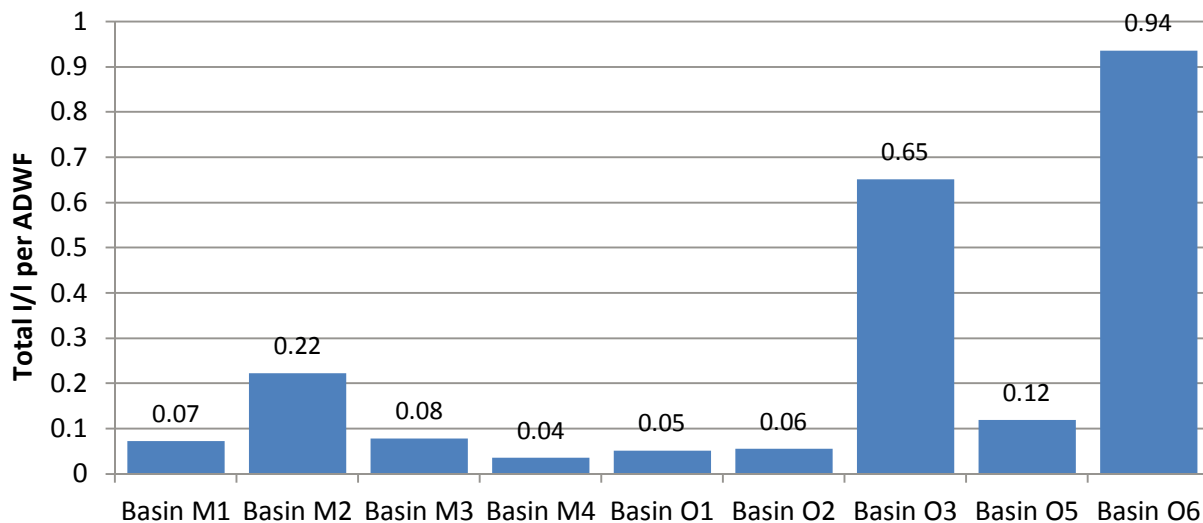
**Figure 5-3. Bar Graph: Total I/I Analysis Results (Avg Ratio, both events)**

Combined I/I analysis considers the totalized volume (in gallons) of both inflow and rainfall-dependent infiltration over the course of a storm event. Table 5-2 and Figure 5-3 summarize the combined I/I flow results. The top ranked basins with the highest normalized combined I/I have been shaded in **RED**. The following inflow analysis results are noted:

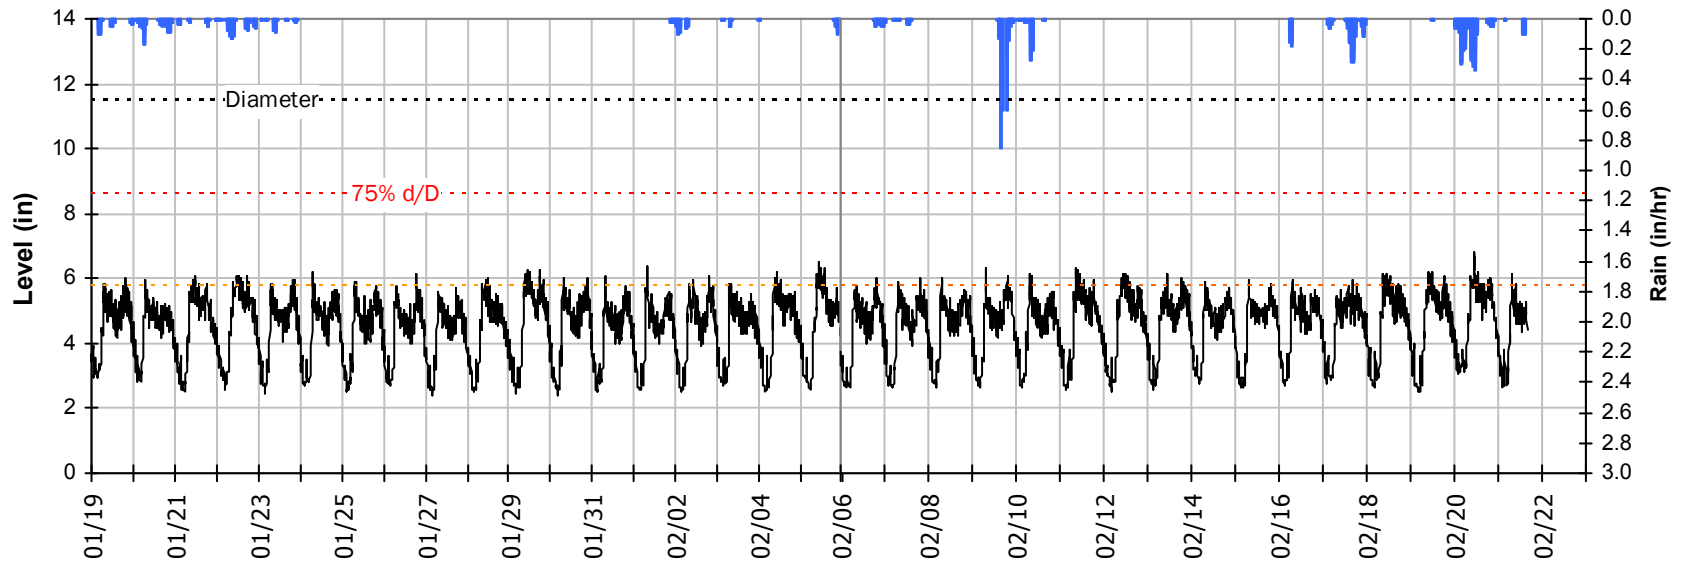
**SITE M1**  
**Site Capacity and Surge Summary**

**Realtime Flow Levels with Rainfall Data over Monitoring Period**

<b>Pipe Diameter:</b>	11.5	inches
<b>Peak Measured Level:</b>	6.79	inches
<b>Peak d/D Ratio:</b>	0.59

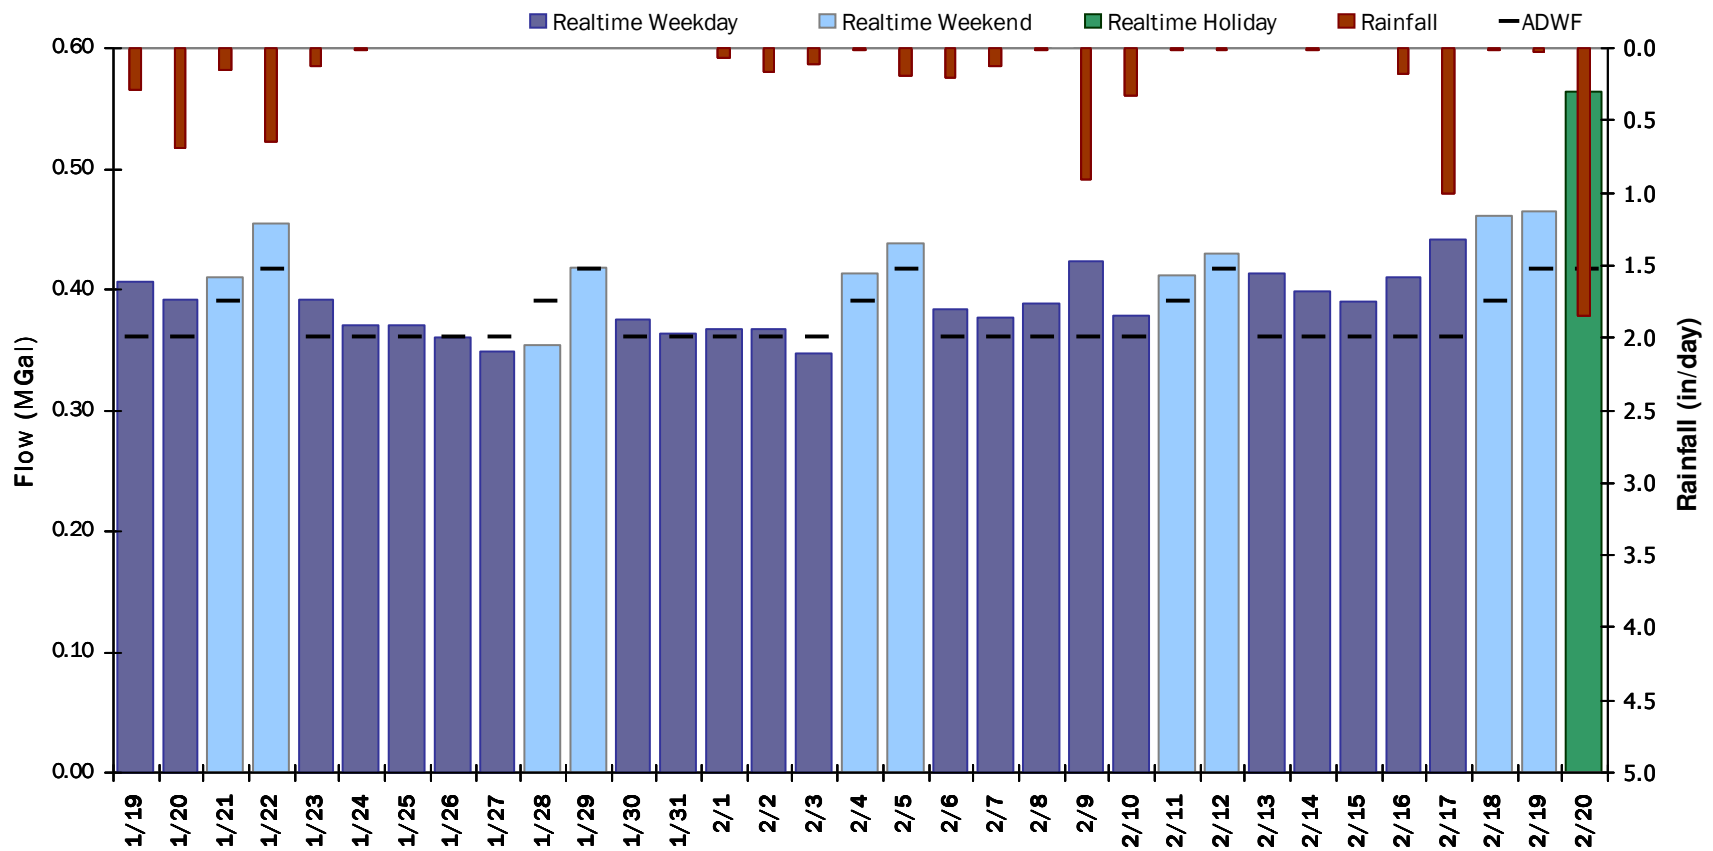
Avg Period Flow: 0.403 MGal    Peak Daily Flow: 0.563 MGal    Min Daily Flow: 0.348 MGal

Total Period Rainfall: 7.11 inches

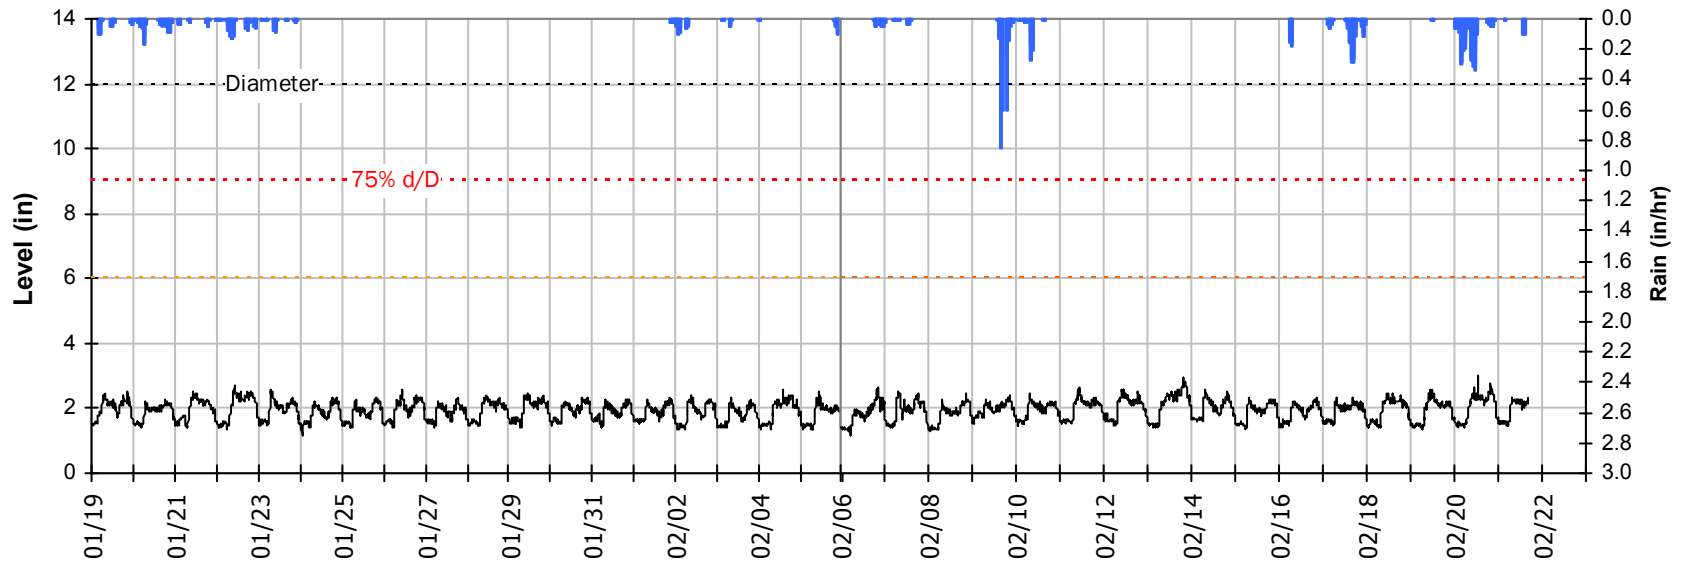
**SITE M3**  
**Site Capacity and Surge Summary**

**Realtime Flow Levels with Rainfall Data over Monitoring Period**

**Pipe Diameter:** 12 inches  
**Peak Measured Level:** 3.01 inches  
**Peak d/D Ratio:** 0.25

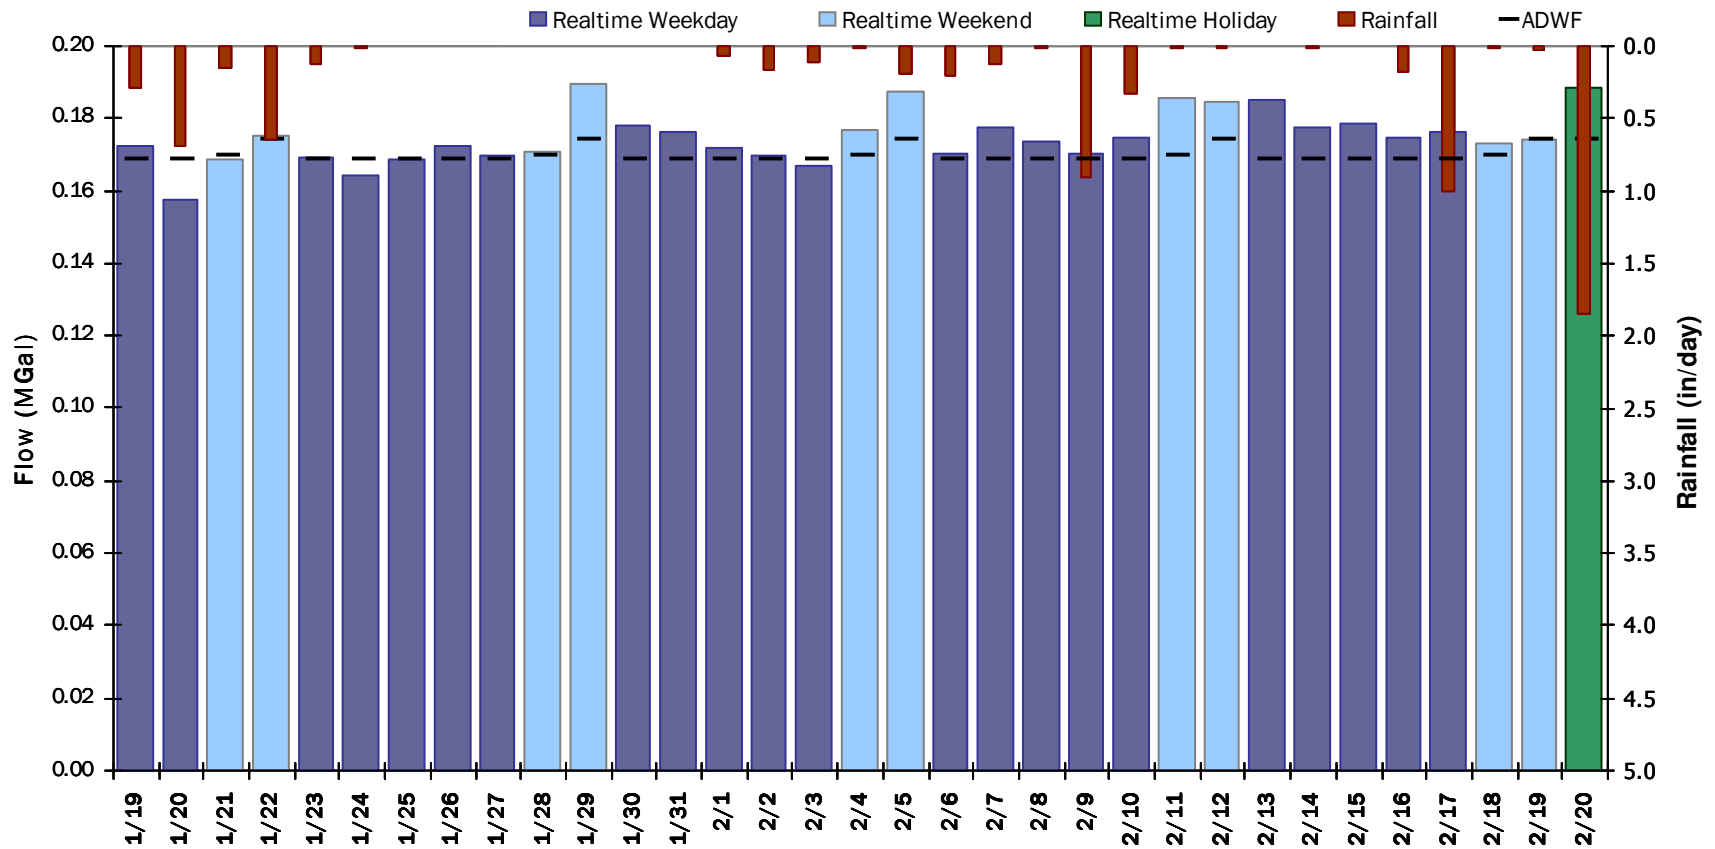
Avg Period Flow: 0.175 MGal    Peak Daily Flow: 0.190 MGal    Min Daily Flow: 0.158 MGal

Total Period Rainfall: 7.11 inches

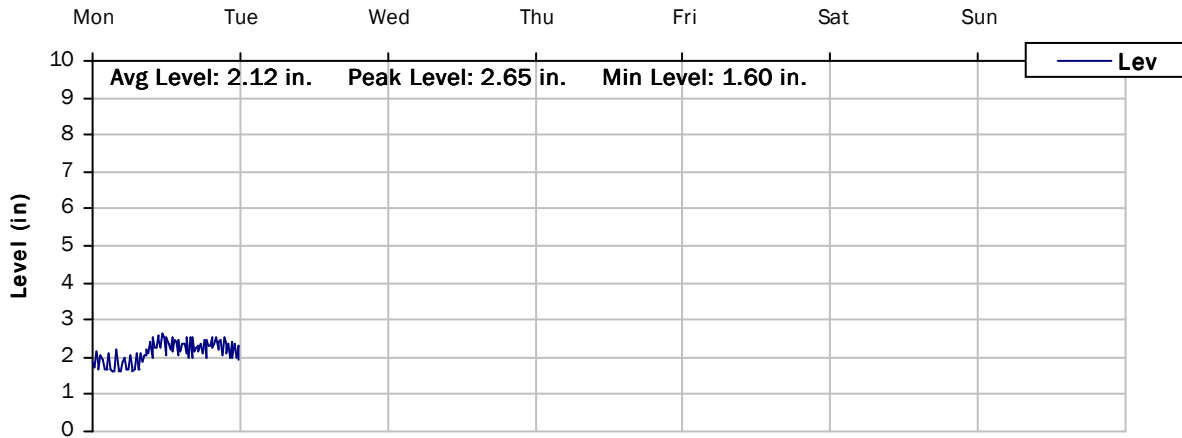
**Weekly Level, Velocity and Flow Hydrographs**

**2/20/2017 to 2/27/2017**

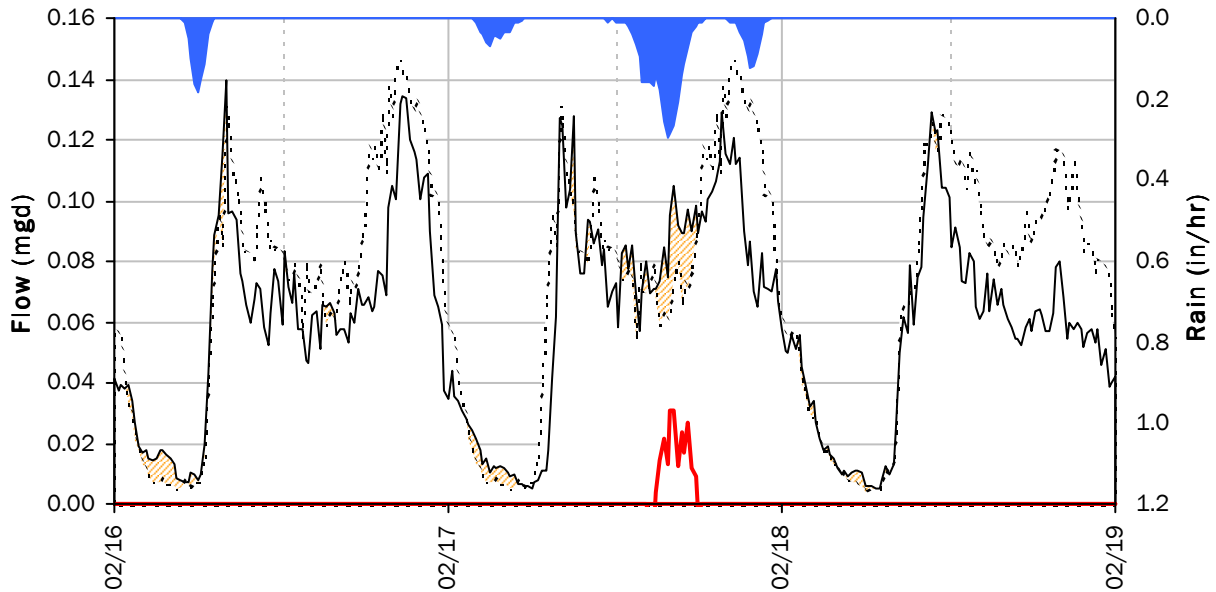
**I/I Summary: Event 3**

**Baseline and Realtime Flows with Rainfall Data over Monitoring Period**

**Event 3 Detail Graph**

**Storm Event I/I Analysis (Rain = 1.20 inches)**

<u>Capacity</u>		<u>Inflow / Infiltration</u>	
<b>Peak Flow:</b>	0.10 mgd	<b>Peak I/I Rate:</b>	0.03 mgd
<b>PF:</b>	1.39	<b>Total I/I:</b>	2,000 gallons
<b>Peak Level:</b>	1.46 in		
<b>d/D Ratio:</b>	0.12

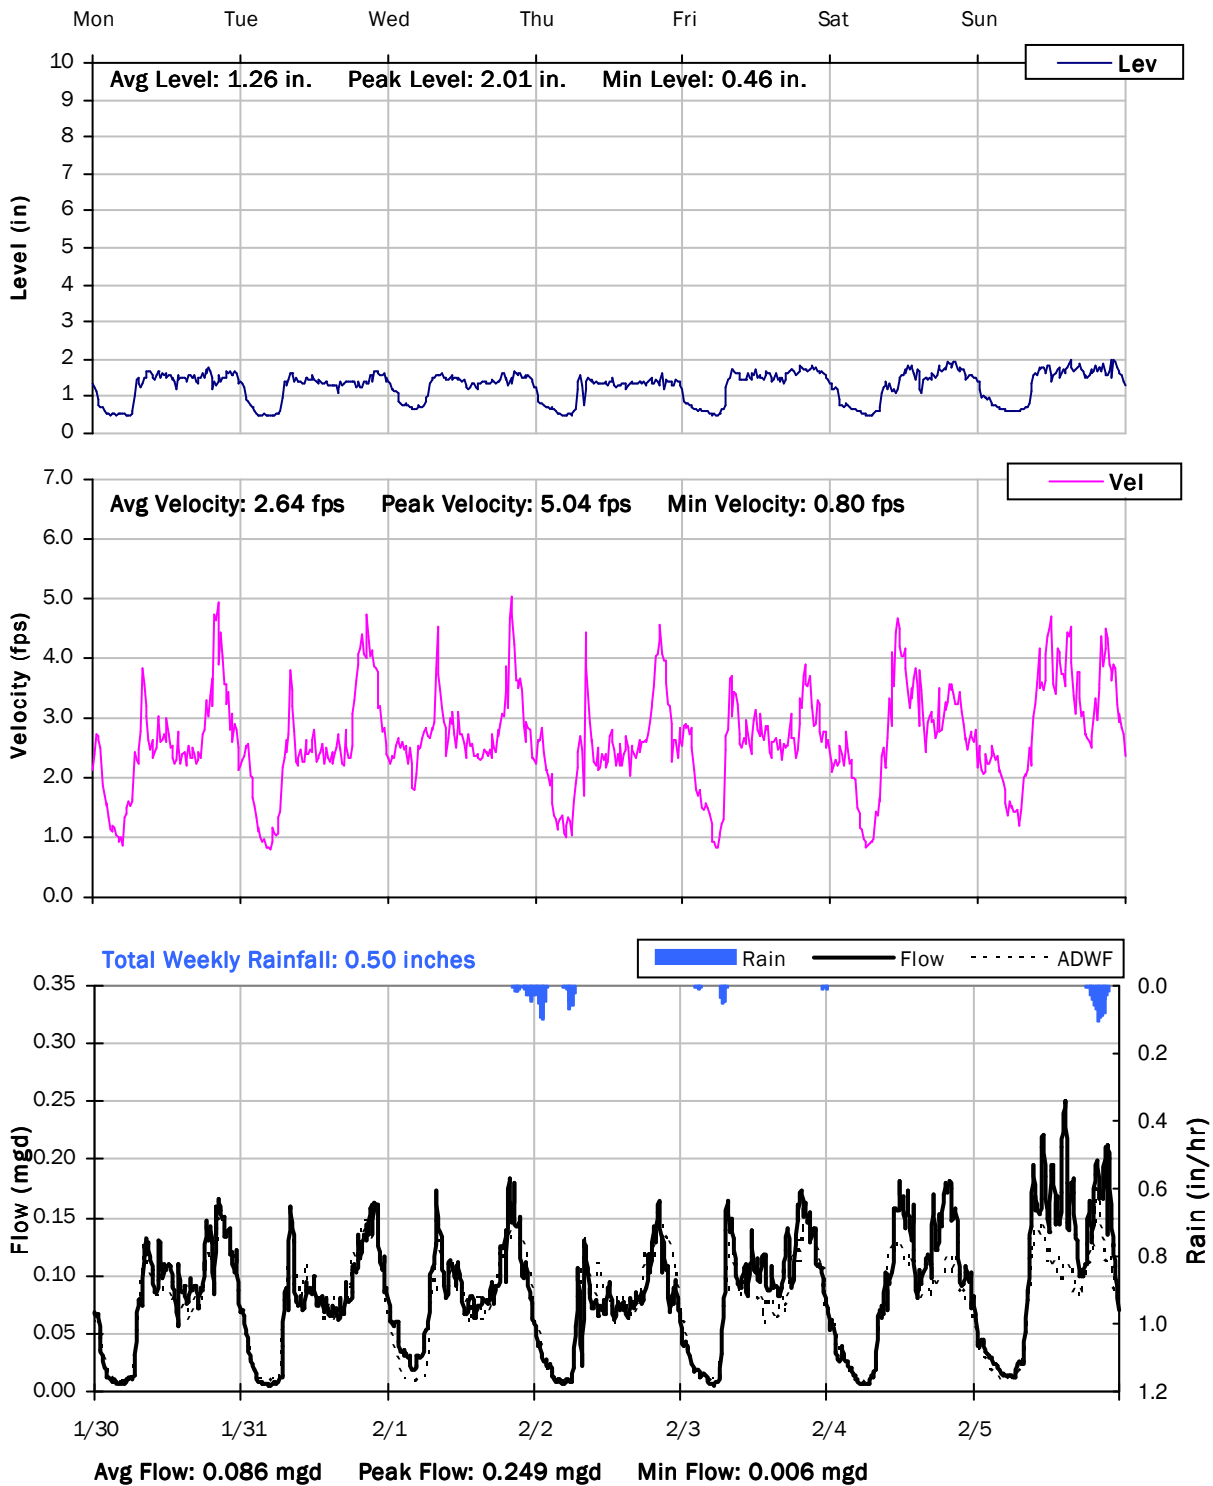
**SITE 02**  
**Weekly Level, Velocity and Flow Hydrographs**  
**1/30/2017 to 2/6/2017**

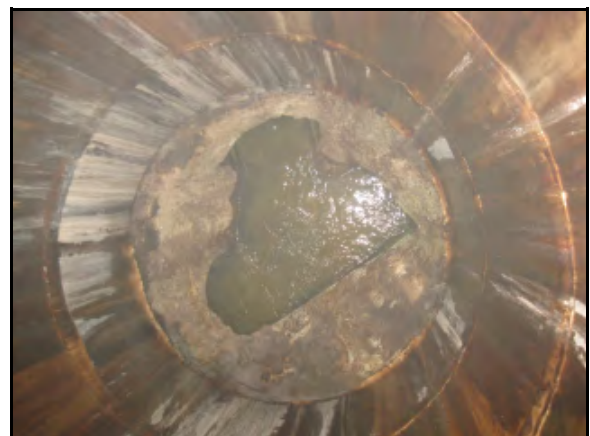
**Plan View**

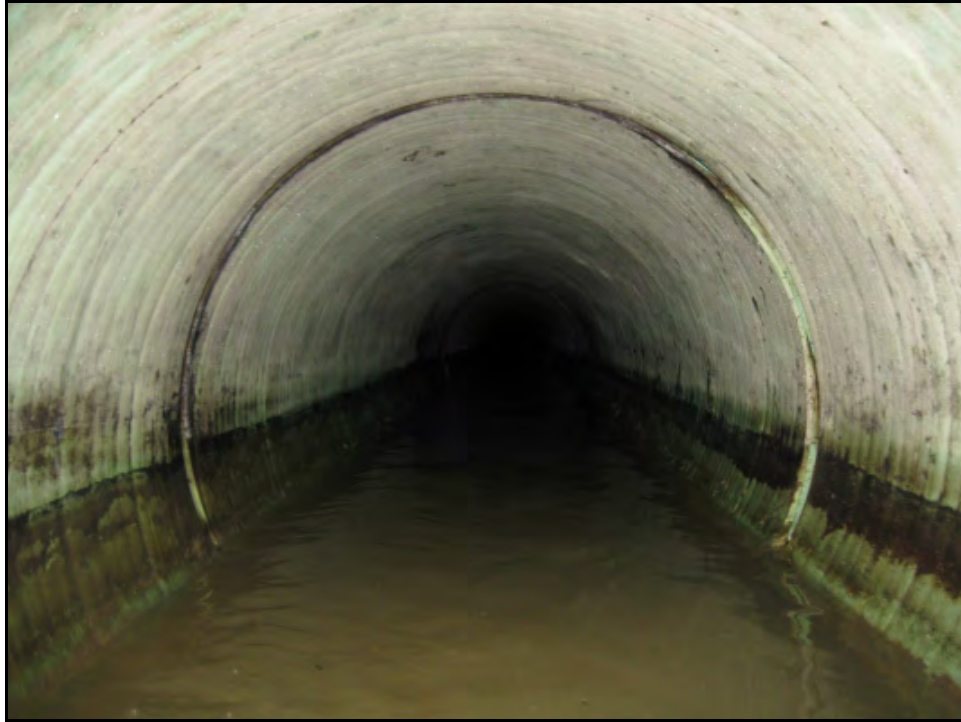
**Effluent Pipe**

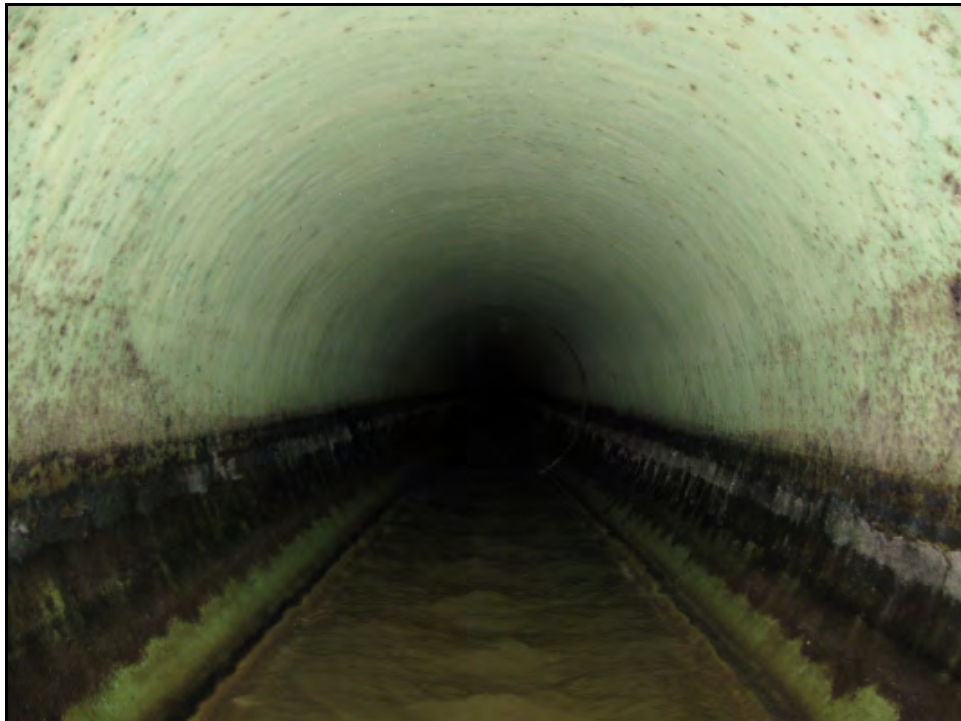
**North Influent Pipe**

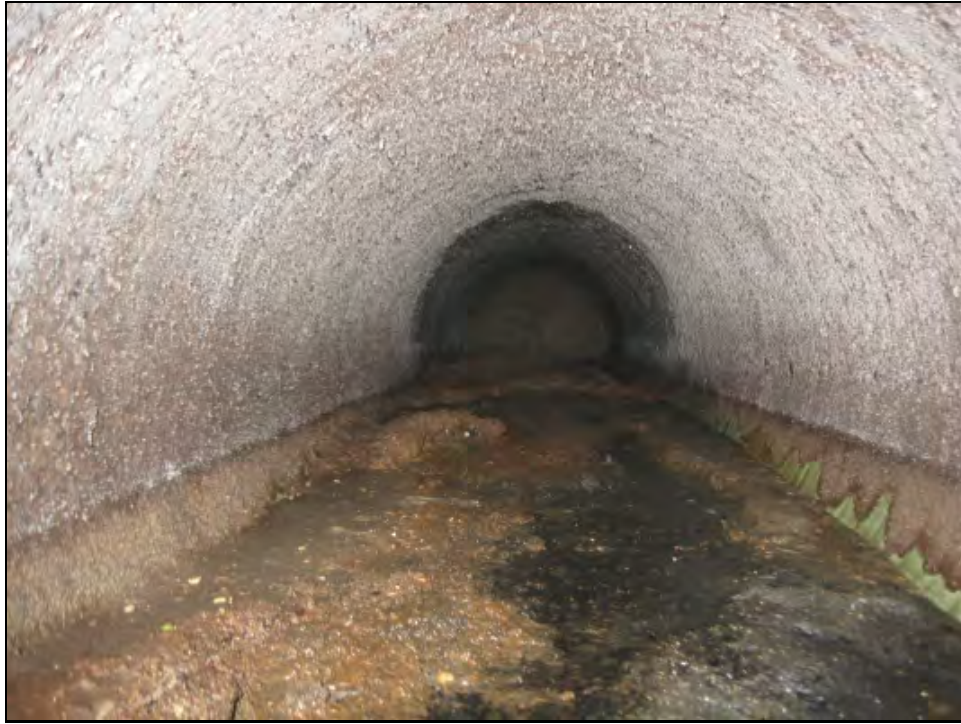
**East Plugged Pipe**

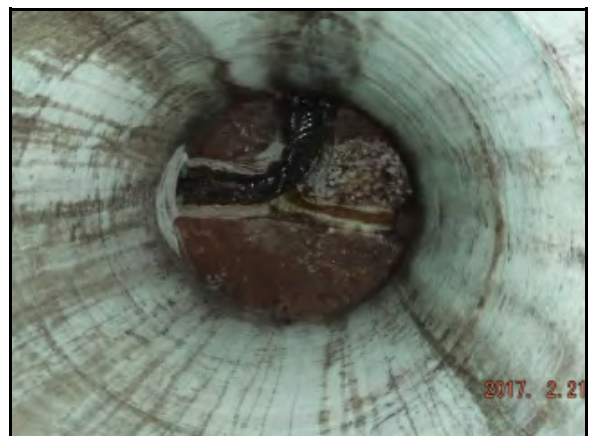
**Plan View**

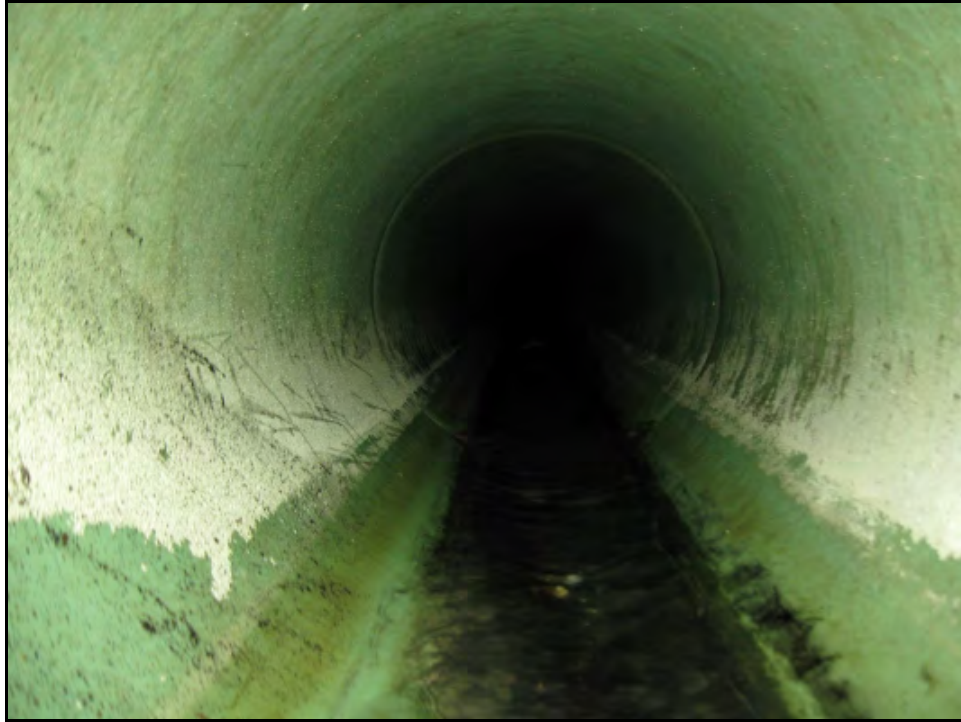
**Effluent Pipe**

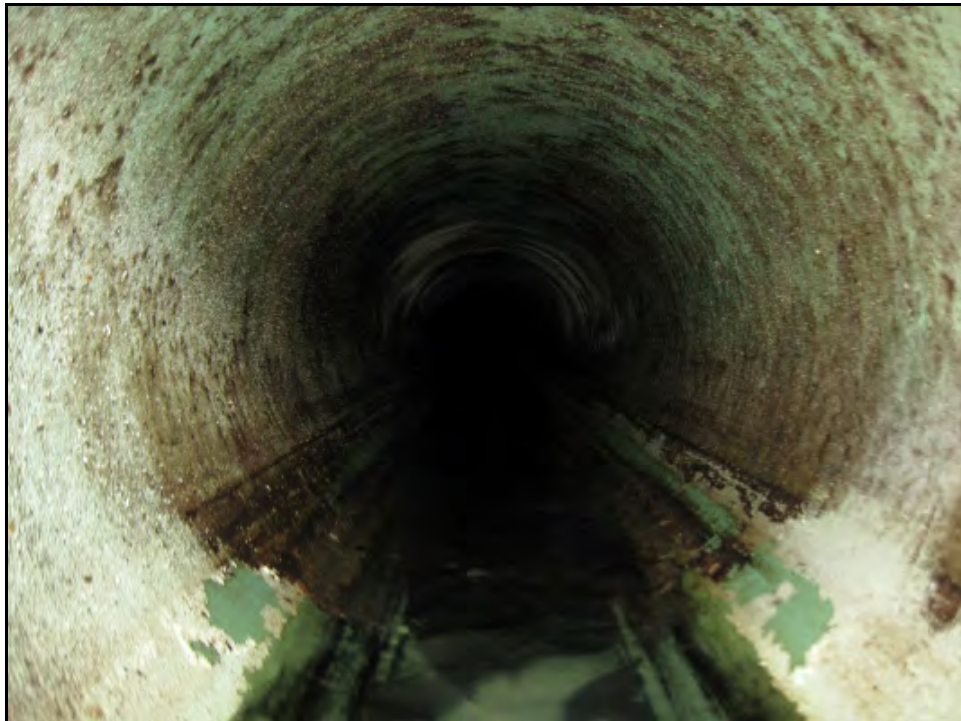
**North Influent Pipe**

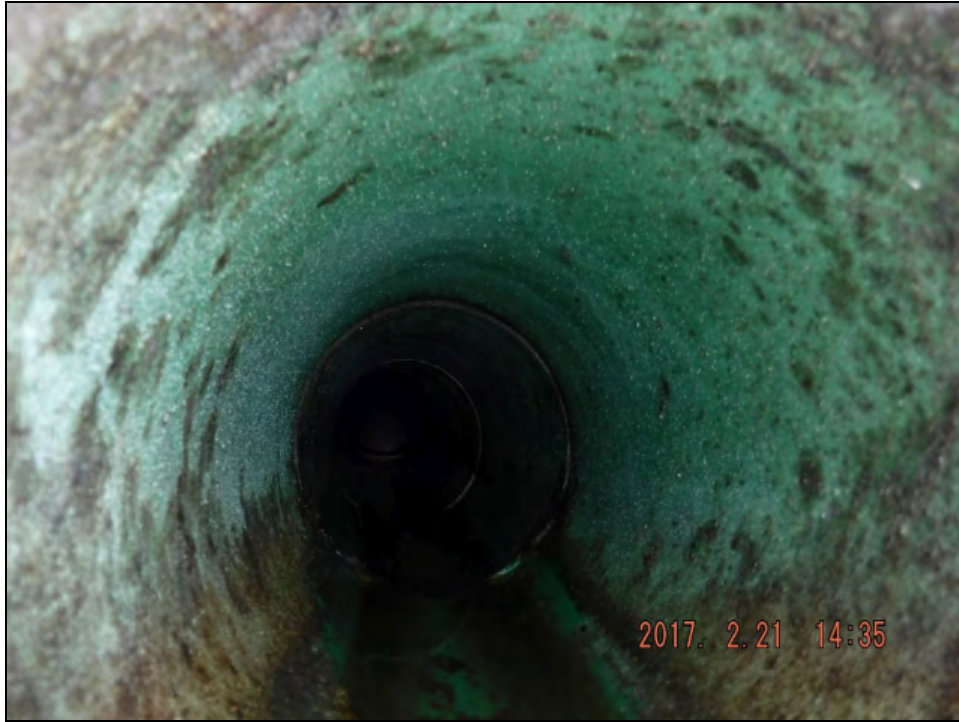
**East Influent Pipe**

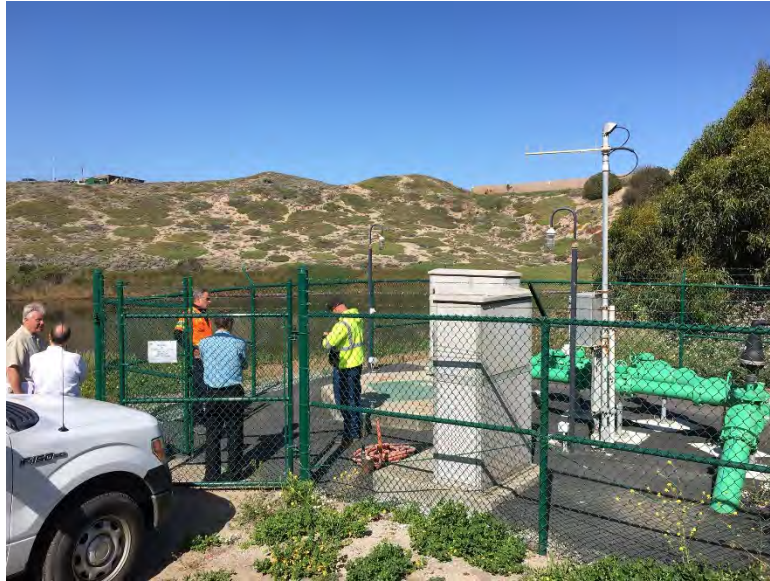
The Dunes Lift Station is a wet well submersible lift station with no building. Valves and pipes are above grade. Electrical cabinets are also above grade. The entire lift station is fenced in.

The Dunes Lift Station is located at Dunes Drive, next to the Marina Dunes Resort, west of Highway 1. The lift station was originally built in 1969, with the pumps upgraded in 1987. Capacity with both pumps running is 0.79 MGD.

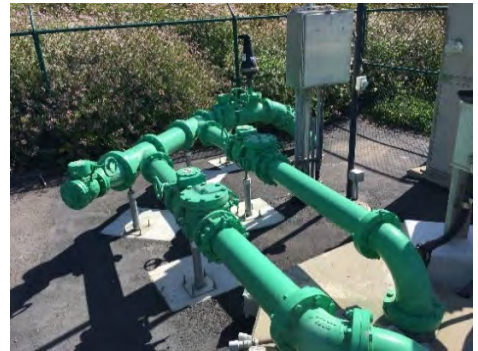
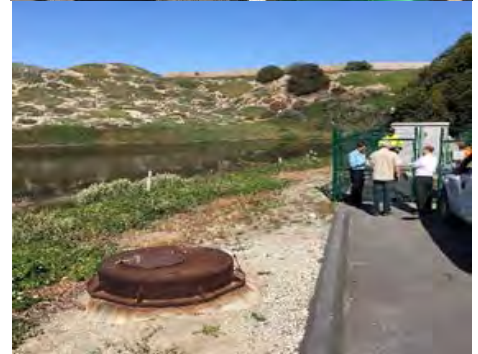
Component
Discharge piping and valves
Score
2
Reason
Recently upgraded and functions well, though access is difficult to remove the valves with a lifting device.

Piping was replaced from the flange out of the wet well up to the ductile iron force main discharge at the intersection nearby. The original pipe routing went up to the old treatment plant, and came back down the hill to a gravity feed. When two pumps were on and stayed on too long it would end up flooding a cleanout near a residence, through the lateral. The piping was rerouted through check valves to a manhole approximately 40 feet near the wet well, which adds capacity.

- Since the valves are located behind the wet well, access is difficult for O&M staff to remove the valves with a lifting device (See Piping / Valves in Section 4.1.1).

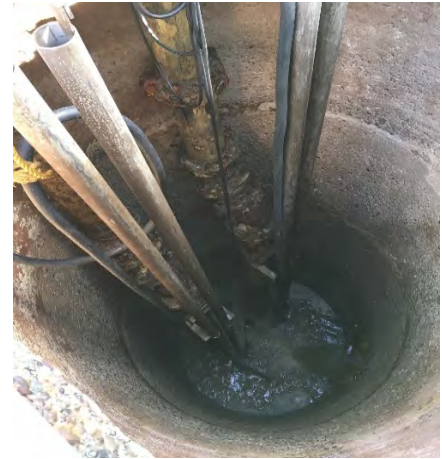
Component
Pump Guide Rails
Score
1
Reason
Appears to be in good condition with no signs of corrosion

Inside the wet well, the stainless steel pump lifting guide rails appear to be in good condition.

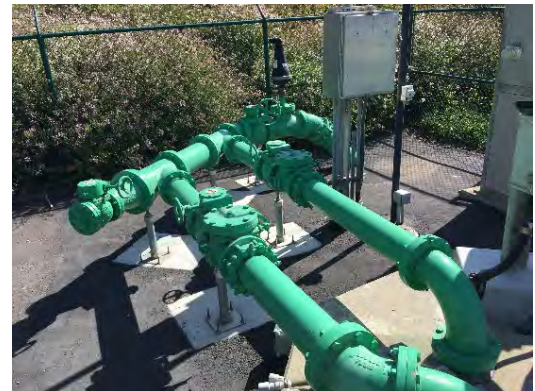
Component
Pipe and Equipment Support
Score
1
Reason
Appear to be in good condition. No issues noted by the operator.

Pipe and equipment support appears to be new and in good working condition.

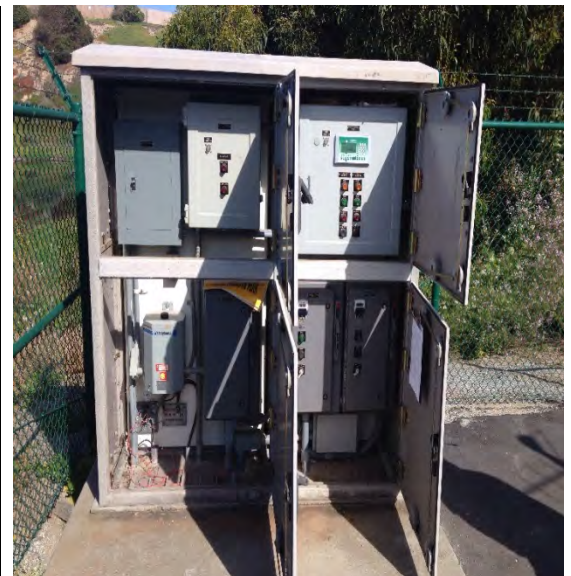
Component	Score	Reason
100 Amp Receptacle for Portable Generator	1	No issues observed.
Component	Score	Reason
Pump Motor Starters	1	No issues observed.
Component	Score	Reason
Pump Control Panel	1	No issues observed.
Component	Score	Reason
480-240/120-volt step-down transformer	1	No issues observed.
Component	Score	Reason
240/120-volt lighting panel	1	No issues observed.
Component	Score	Reason
NEMA 3RX fiberglass enclosures	1	No issues observed.

A 100-amp receptacle for connecting a portable generator is mounted to the exterior of this enclosure. Two pump motor starters, a pump control panel, a 480-240/120-volt step-down transformer, and a 240/120-volt lighting panel are located in another fiberglass outer enclosure located on top of the wet well slab. While the

NEMA 3RX fiberglass enclosures are moderately weathered, the individual painted steel components inside show no signs of weathering or corrosion.

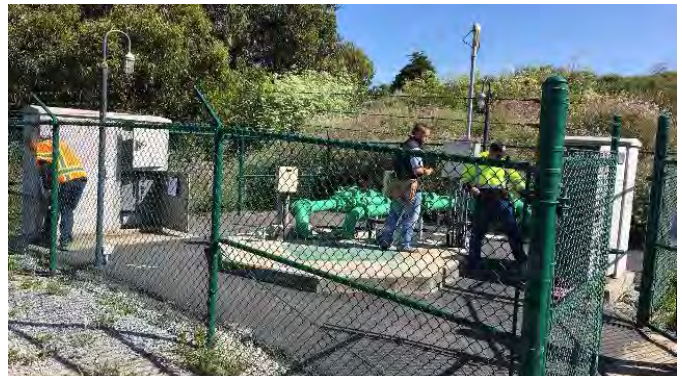
Component
Fence
Score
1
Reason
Appear to be in good condition. No issues from operator.

Security issues have not been a problem at this site, either with theft or vandalism. The lift station is now screened by a coated chain linked fence and three strands of barbed wire at the top after corrosion issues addressed in the 2005 Wastewater Collection System Master Plan<sup>1</sup>.

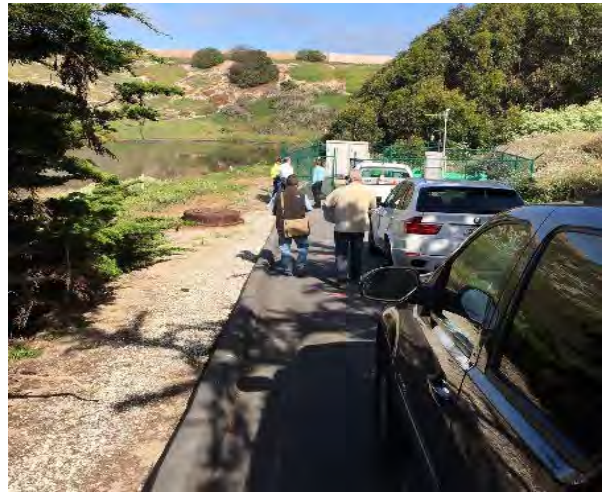
Component
Road Space
Score
2
Reason
There is not sufficient space for vehicle turnaround, but the short length of the access road makes this a minor issue.

The site is paved and is adjacent to an existing storm water detention pond. There is no space for vehicle turnaround, requiring vehicles to exit in reverse, uphill along the access drive onto the street. There is no parking space other than the access road.
