# Marina Coast Water District Sewer Master Plan

**SEWER  
MASTER PLAN**

Final Draft

**AKEL**  
ENGINEERING GROUP, INC.

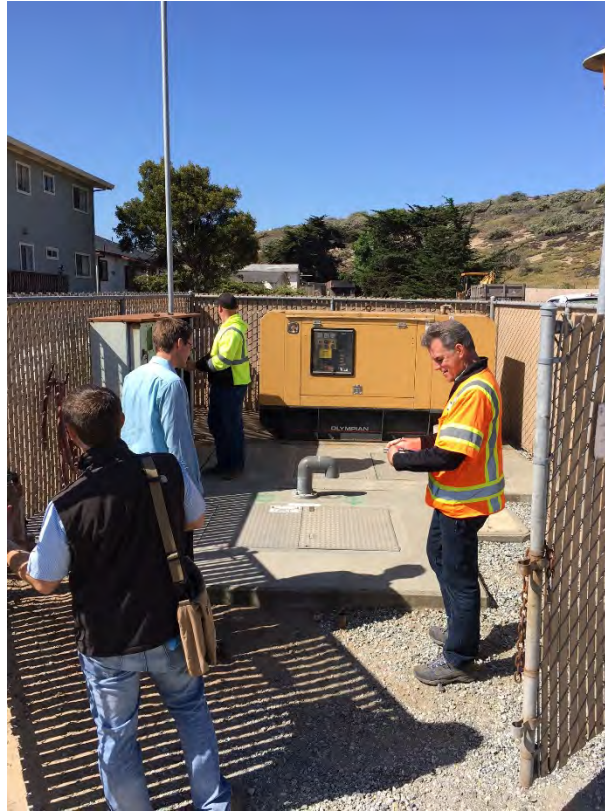
The San Pablo Lift Station is a wet well submersible lift station with no building. Valves and pipes are below grade. Electrical cabinets are above grade. The entire lift station is fenced in.

The lift station is located next to 180 San Pablo Court. A two-story apartment building and some single family homes are located in close proximity to the lift station. The lift station was originally built in 1969 and had a major upgrade in 2000.

For Additional Photo - See Overview Photo at the beginning of Section 4.2

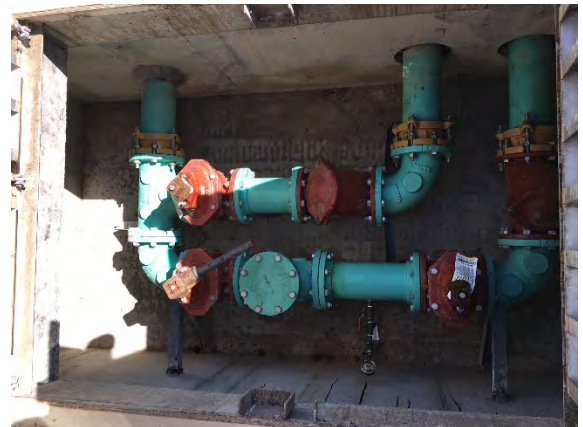
Component
Valve Vault
Score
2
Reason
Valves and piping are in good condition, but valve vault has short clearance to fences.

Within the valve pit, a check valve and gate valve are provided on each discharge pipe. The discharge pipes then combine to form a common 6-inch force main leaving the lift station to the west. The valve pit is located behind the wet well at the rear of the site next to the generator, with very little clearance to the side fences.

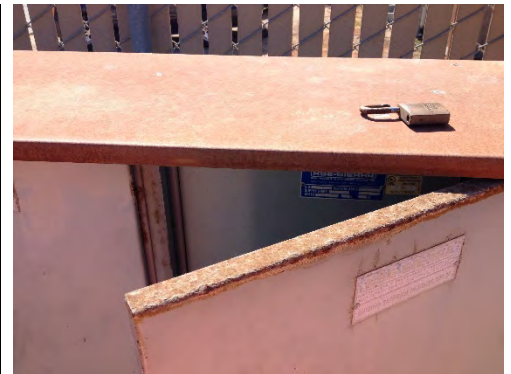
Component
NEMA 3R equipment enclosure
Score
3
Reason
Weathered, faded, and moderate rust.

The exterior surface of the NEMA 3R equipment enclosure is weathered and faded with a uniform layer of light rust on the top surface. The edges around the top of the enclosure and around the access doors have moderate rust, but the enclosure is otherwise in serviceable condition.

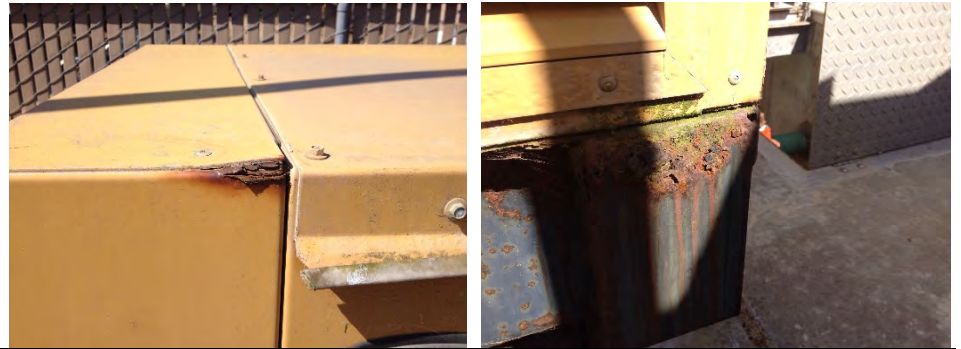
Component
Generator
Score
3
Reason
Moderate to heavy rust

An Olympian model D20P2 diesel engine-generator set, rated at 20 kilowatts/ 25 kilovolt-amps, is located on an adjacent side of the valve pit at the rear of the site. The generator is equipped with a 60-gallon, UL-listed dual-wall subbase tank, and a sound-attenuating enclosure. The generator enclosure and tank have localized areas of moderate-to-heavy rust.

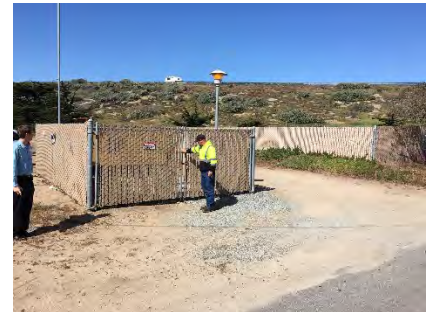
Component
Road Space
Score
2
Reason
Access to valve pit and backup generator is difficult

The site is unpaved and is close to a residential area and San Pablo Court. Since there is adjacent open area to the lift station, there is adequate space for vehicle turnaround. However, access to the valve pit and backup generator is difficult since they are located behind the wet well. The wet well hatch is not strong enough to support a service vehicle (See Hatches in Section 4.2.2), and the gooseneck ventilation outlet on top of the wet well impedes truck access to the back of the site.

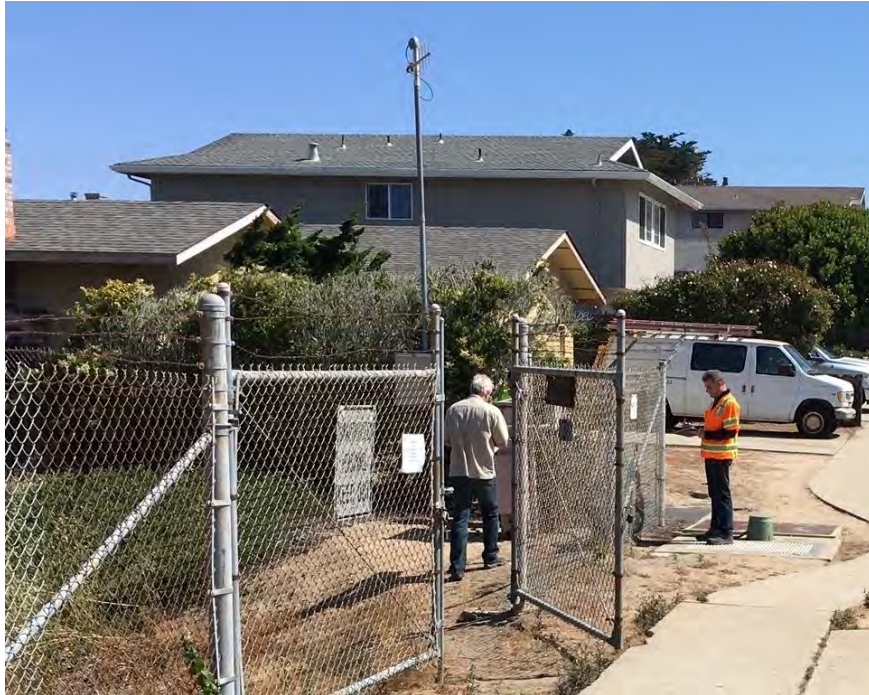
The Crescent Lift Station is a wet well submersible lift station with no building. Valves and pipes are below grade. Electrical cabinets are above grade. While the electrical cabinets are fenced off, the wet well and valve pit are located outside the fence near a residential sidewalk.

The Crescent Lift Station is located at 3009 Crescent Street, next to a storm water detention pond. The lift station was built in 1977 to serve the local residential area along Crescent Street and Vera Lane, where the low ground elevation prevents gravity flow to Reindollar Avenue.

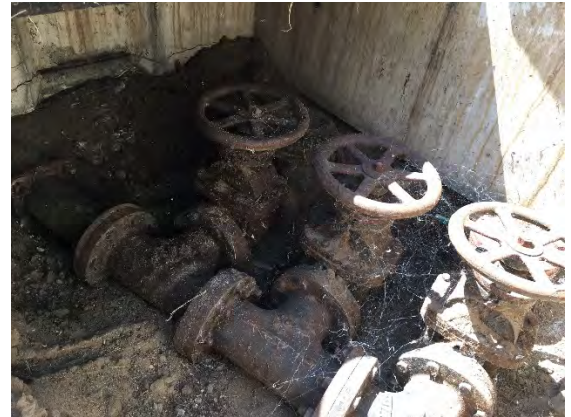
Component
Valve Pit
Score
4
Reason
Valve pit and components within need to be replaced.

The interior of the valve pit shows signs of cracking and surface damage. The valve pit hatch and the hatch rim are rusty. The bottom of the valve pit is filled with sand. The valve pit should be replaced.

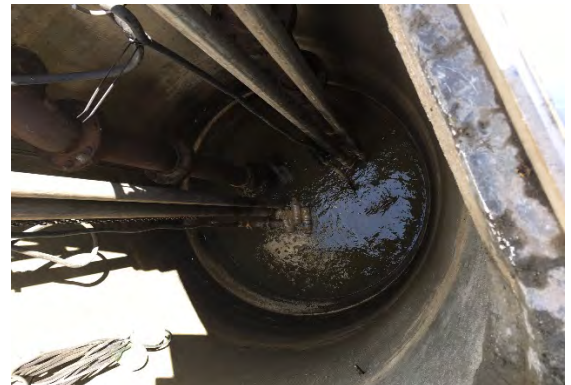
Component
Discharge Pipe and Guide Rails
Score
2
Reason
Discharge pipes show signs of corrosion.

The discharge pipes inside the wet well show signs of corrosion, while the pump lifting guide rails appear to be in good condition.

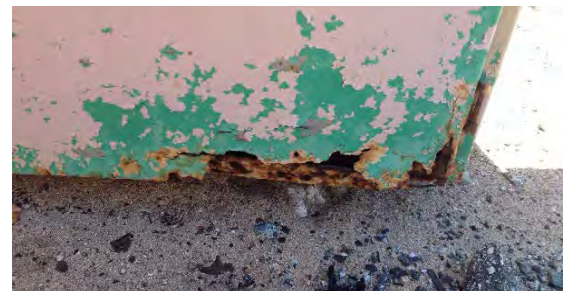
Component
Pump Control Panel
Score
3
Reason
Lower corner of front door is rusted through.

The lower corner of the pump control panel front door is rusted through.

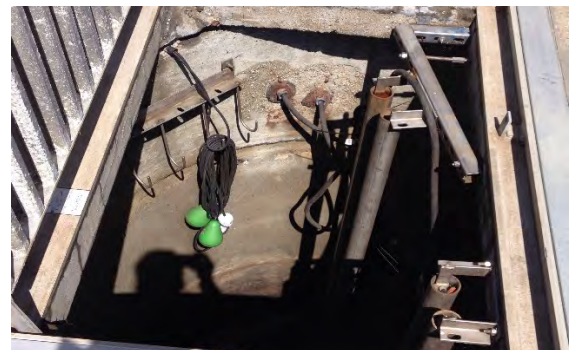
Component
Float Switches
Score
4
Reason
Cables are coiled up and hung above the wet well operating range.

High-level and low-level float switches are installed, but the cables are coiled up and hung on a hook well above the wet well operating range.

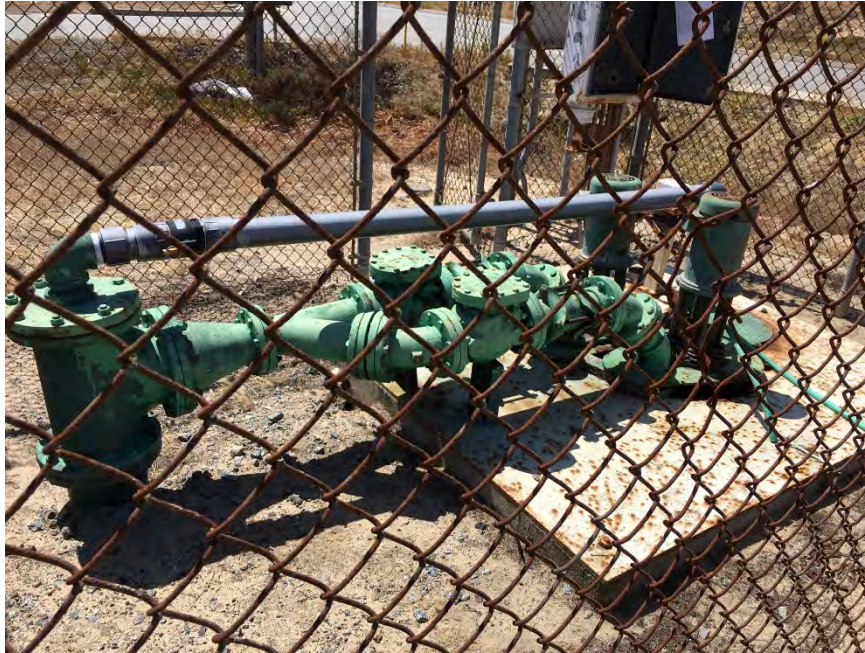
The Neeson Lift Station is a wet well submersible lift station with no building. Valves and pipes are above grade. Electrical cabinets are above grade. The entire lift station is fenced in with limited space.

The Neeson Lift Station is a float actuated duplex package sump type lift station that has one pump and a total capacity of 0.58 MGD (400 gpm). It is recommended that a complete lift station replacement be performed.

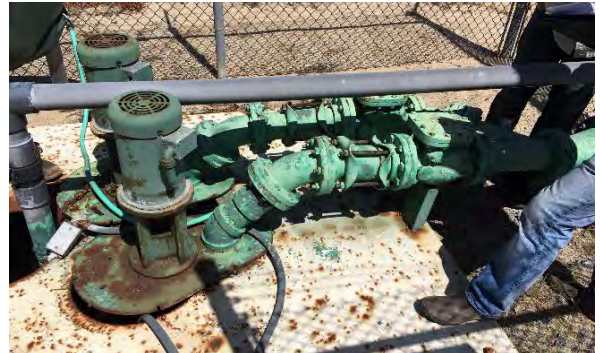
Component
Pump Bypass
Score
5
Reason
Bypass is permanent. Not recommended.

The lift station appears to be in permanent bypass, which is not recommended

Piping and valves show signs of corrosion both inside the well and on the discharge side (For Photo - See Bypass Pump in Section 4.4.1.) of the pump station.

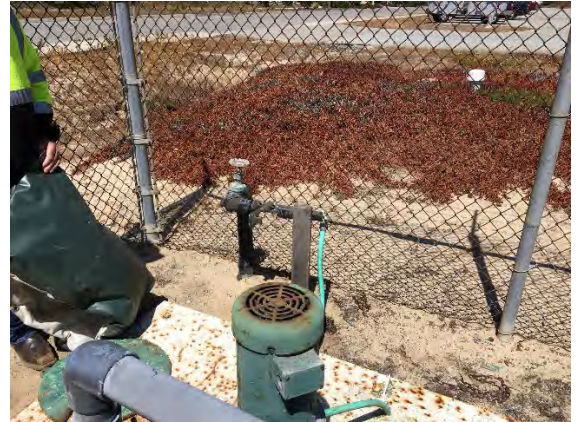
Component
Domestic Water Hose Bib
Score
1
Reason
Backflow Prevention Device was installed.

The domestic water hose bibb within the fence did not have a backflow prevention device accepted by the California Code; this was corrected as of the 2005 Wastewater Collection System Master Plan.

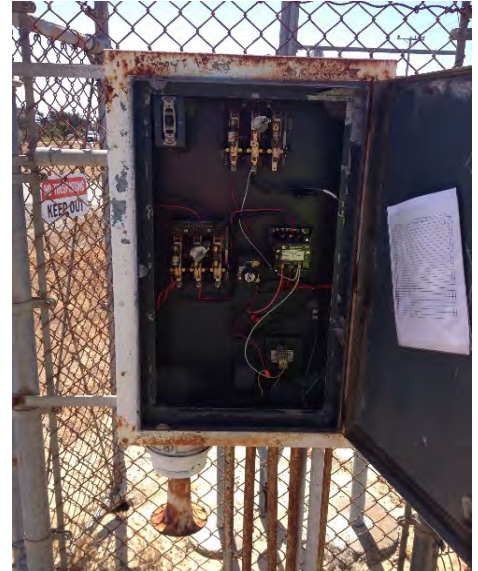
Component
General Electrical Equipment
Score
5
Reason
In poor condition and not functioning.

Electrical equipment appears to be in poor condition and not functioning.

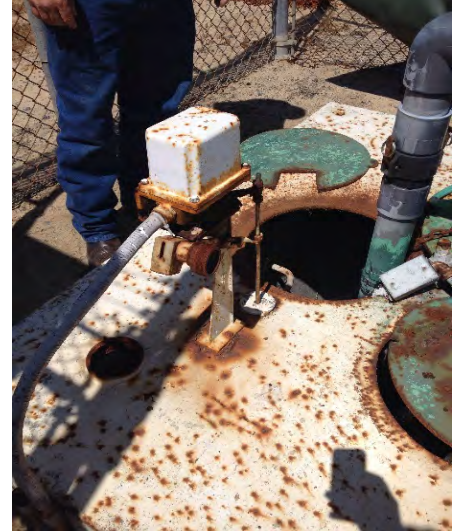
Component
Level Control
Score
4
Reason
Appear to be in poor condition and in need of replacement.

Level control is provided by a float on a vertical rod, which actuates a switch that is mounted above the wet well cover. The level control appears to be in poor condition and in need of replacement.

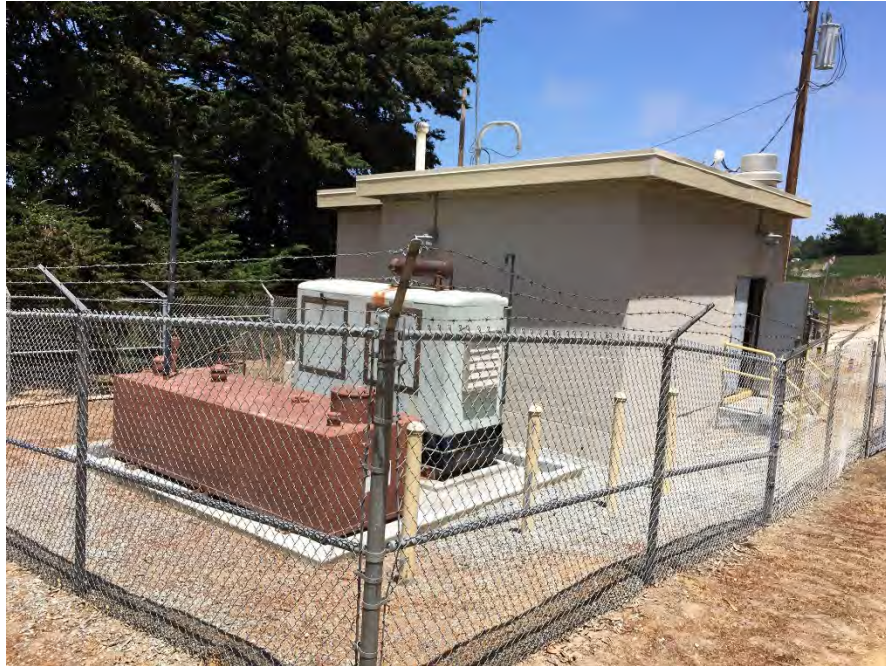
## 4.5 GIGLING

The Gigling Lift Station is a dry pit/wet well lift station with a building. Valves and pipes are in the dry pit below the building. Electrical cabinets are inside the building. The entire lift station is fenced in.

Maximum Capacity is 1.22 MGD (850 gpm).

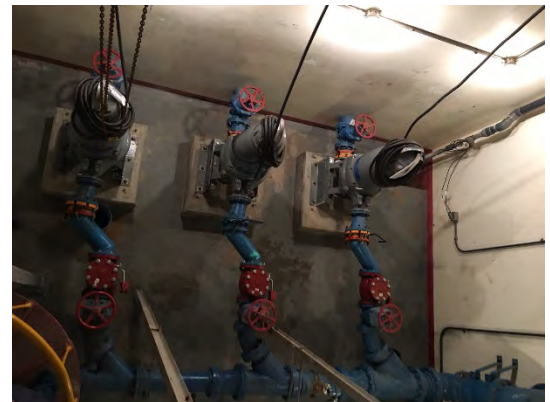
Component
Pumps
Score
1
Reason
No issues observed.

The lift station has three pumps that together run at a maximum capacity of 1.22 MGD (850 gpm), and a TDH of 100 ft. The Flygt submersible pumps were converted to dry pit service. A sump pump in the dry pit has a capacity of 0.07 GPD (50 gpm).

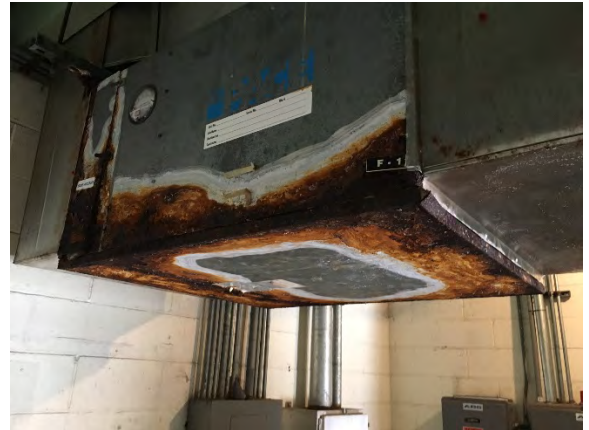
Component
Metal Ducts
Score
3
Reason
HVAC reported to work properly, but there are signs of corrosion.

Though the HVAC was reported to be working properly, there appears to be signs of corrosion.

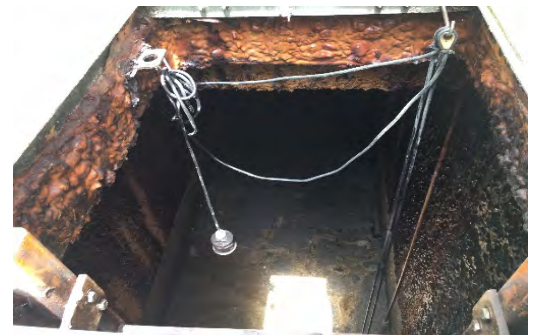
Component
Wet Well Walls
Score
1
Reason
Appear to be in good condition, though covered with an epoxy coating.

The wet well was epoxy coated, and although there is a bumpy coating to the walls, the walls are in good condition, and may have had coating over rough aggregate. The wet well dimensions are 22-ft long, 8-ft wide, and 16-ft deep.

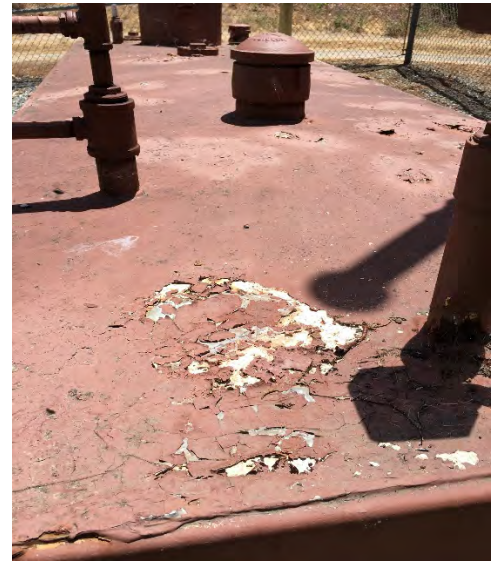
Component
Bulk Tank
Score
3
Reason
Signs of paint deterioration observed.

Signs of paint deterioration were observed on the top of the bulk fuel tank.

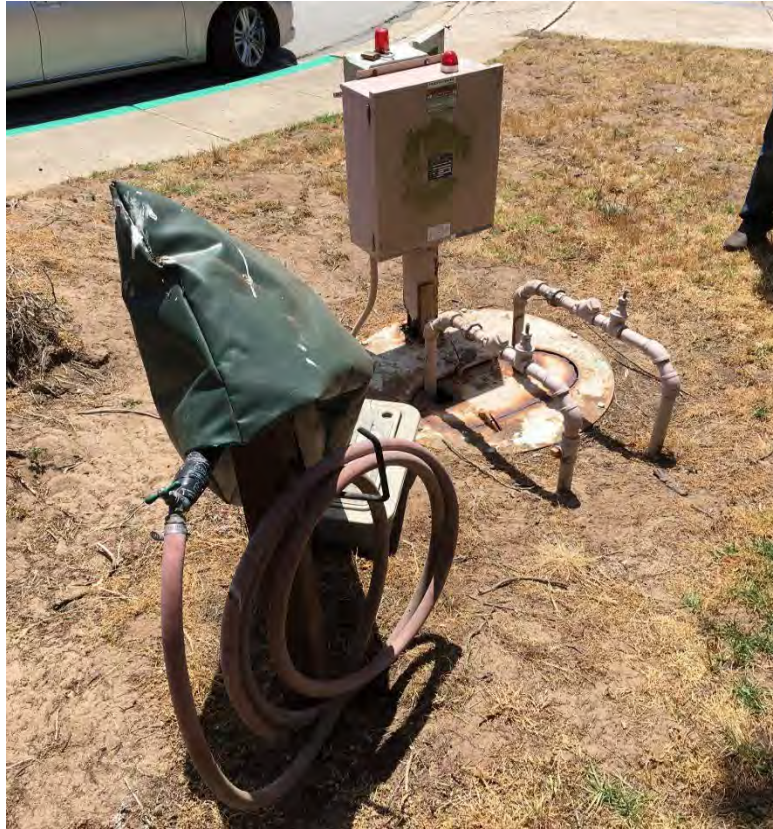
## 4.6 HATTEN

The Hatten Lift Station is a packaged duplex submersible lift station with no building. Valves and pipes are above grade. Electrical cabinets are above grade. The entire lift station has no fence, and is located at the end of the front yard of a residential home. The Hatten Lift Station was construction in 1966, and is controlled by a float system with a capacity of 40 gpm.

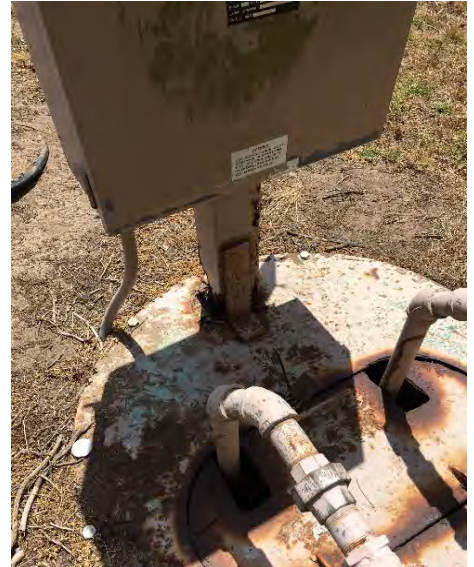
Component
Base Support
Score
5
Reason
Panel is corroded at the base, in danger of falling over. No concrete slab

Structural support is inadequate. It is recommended to have a concrete slab for proper pipe support. In addition, the packaged lift station panel appears to be corroded at the base and is in danger of falling over.

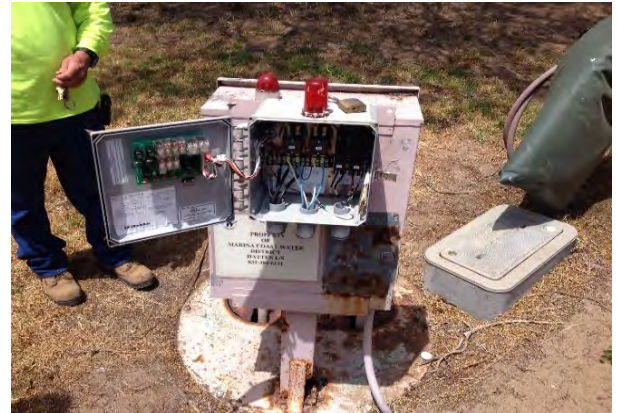
Component
PLC/Telemetry
Score
3
Reason
No PLC/telemetry package. No audible device for alarm notification.

This site is not equipped with the PLC/telemetry package that is present at the other pump stations. The control panel is equipped with two red lights for alarm notification. The presence of an audible device was not noted.

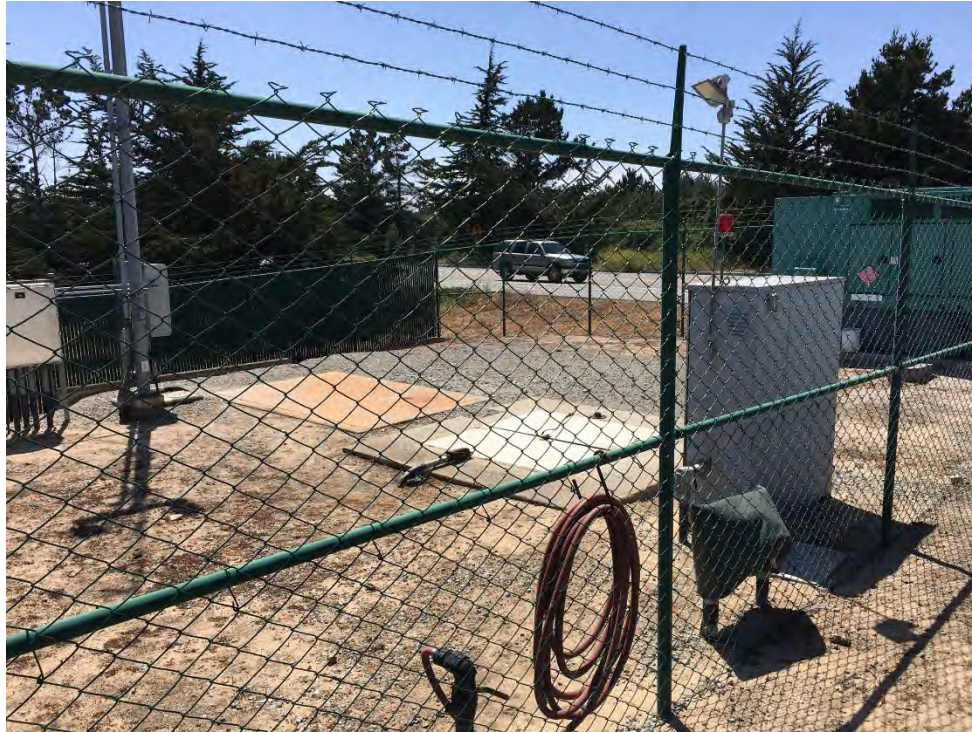
## 4.7 IMJIN

The Imjin Lift Station is a wet well submersible lift station with no building. Valves and pipes are below grade. Electrical cabinets are above grade. The entire lift station is fenced in.

The Imjin Lift Station is currently the largest lift station in the Ord Community sanitary sewer system, and is projected to more than double in size in the future. This key lift station is a critical facility for proper system operation. The Imjin Lift Station was built in 1970, replaced in 1982, and renovated in 2003 with an upgrade of two new 1,490-gpm pumps and associated pump 7 control equipment<sup>2</sup>. It is located alongside Imjin Road east of Abrams Drive. The arrangement of multiple gravity and force main inlets make isolation of the wet well for cleaning or maintenance very difficult.

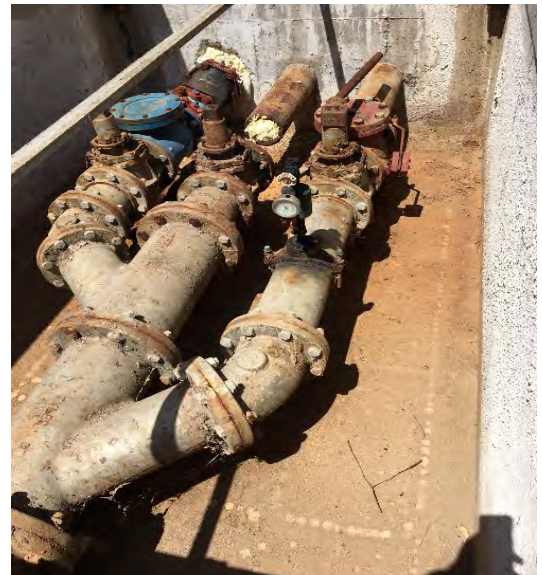
Component
Valve Vault Piping and Valves
Score
4
Reason
High amounts of corrosion. Recommended replacement.

Two new Flygt pumps have a 6-inch diameter ductile iron discharge pipe with a gate valve and a check valve. The discharge pipes combine in a valve pit, and a 10-inch diameter force main conveys flow to the Abrams Trunk Sewer. Only one of the discharge pipes are currently used, thus emergency bypass is not possible. The piping and valves in the valve vault show high amounts of corrosion, and it is recommended to replace all parts within the vault.

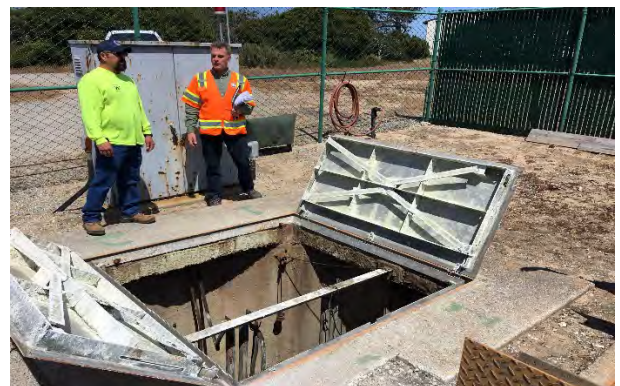
Component
Fall Protection
Score
3
Reason
Fall Protection is recommended for safety.

The wet well hatch cover is in fair condition, but fall protection is recommended.

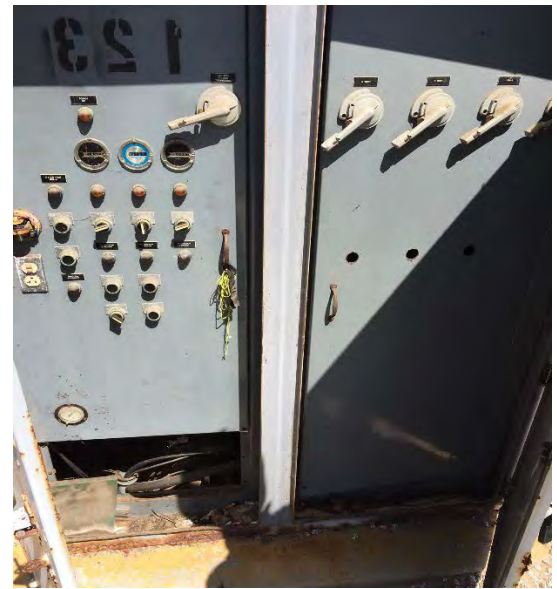
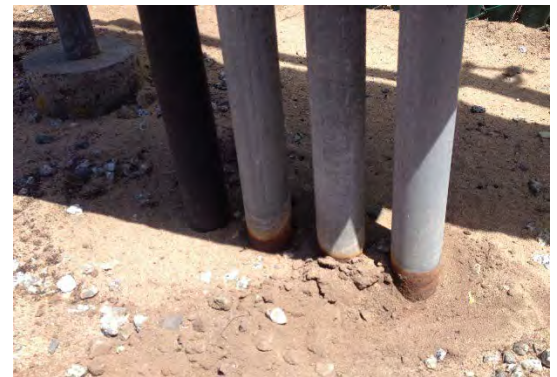
Component	Score	Reason
Meter/main panel	1	No issues observed.
Component	Score	Reason
Automatic Transfer Switch	1	No issues observed.
Component	Score	Reason
Pump Control Panel – prior to 2003 upgrades	3	Consider removing in favor of an underground pullbox or handhole.
Component	Score	Reason
Current Pump Control Panel	3	Conduits have rust where in contact with the soil.
Component	Score	Reason
480:208/120V unit power center	1	No issues observed.

The electrical equipment consists of a meter/main panel, automatic transfer switch, pump control panel, and a 480:208/120V unit power center with stepdown transformer and breaker panel. The pump control panel contains a Zenith Pulsar level controller and combination full-voltage, non-reversing two motor starters. The pump control panel is weathered, but in otherwise good condition. Galvanized conduits extending from underground were not properly wrapped during installation, causing the conduits to rust where in contact with soil.

The pump control panel that existed prior to the 2003 upgrades has been repurposed essentially as a pullbox for the generator and pump motor feeders. It is in fair-to-poor condition, but serves the current purpose. The District should consider removing this panel in favor of an underground pullbox or handhole.

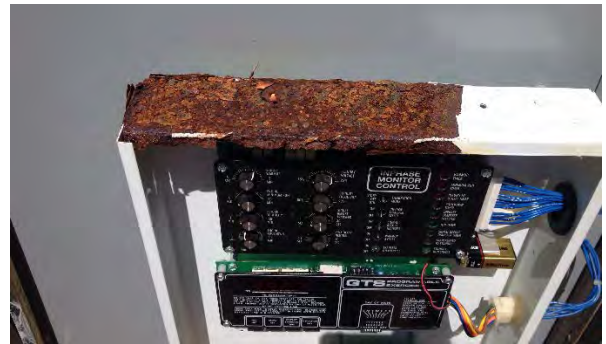
Component
Outer enclosure of the automatic transfer switch.
Score
3
Reason
Severe rust to the metal enclosures that protects the ATS control boards.

The outer enclosure of the automatic transfer switch is rusted through in two places at the drip edge above the door. Water is dripping inside, causing severe rust to the metal enclosure that protects the ATS control boards. It is a matter of time before the rusted metal no longer protects the control boards from the dripping water.

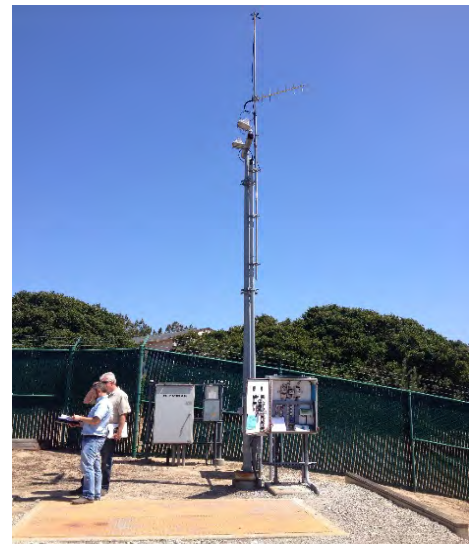
Component
Second Antenna
Score
3
Reason
Unknown purpose from District personnel

A second antenna, appearing similar to a remote cellular antenna, is mounted at the top of the mast. Cabling from this antenna is routed in underground conduit, and could not be traced. The antenna cable was not observed in any of the equipment enclosures. District personnel also were unsure of its purpose.

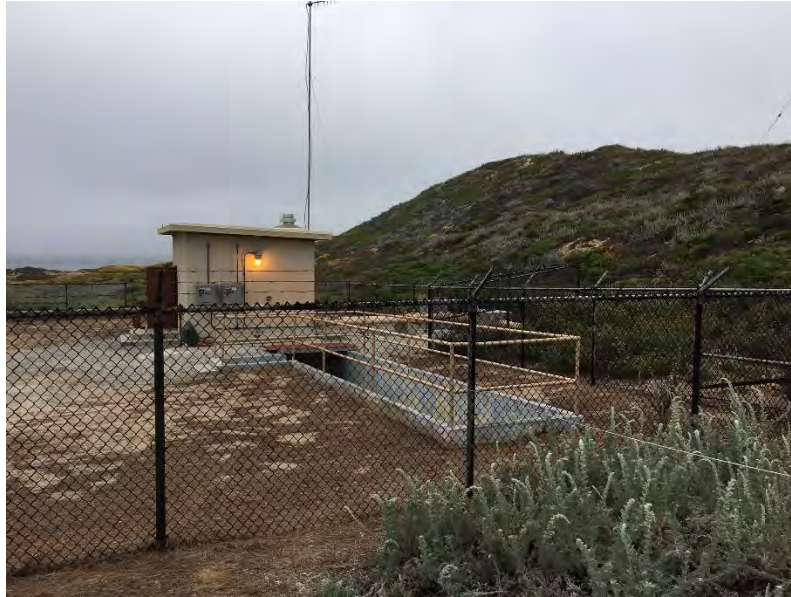
## 4.8 ORD VILLAGE

The Ord Village Lift Station is a dry pit/wet well lift station with a building. Valves and pipes on the discharge side are outside the building. Electrical cabinets are both inside and outside of the building. The entire lift station is fenced in.

The Ord Village Lift Station is the only District lift station located on the west side of Highway 1, the Union Pacific Railroad (UPRR), and Beach Range Road. This lift station, which was initially a sewage treatment plant that provided wastewater treatment for Fort Ord and was constructed prior to 1960, is situated near the shoreline of Monterey Bay. Lift station reliability is critical because, if an overflow were to occur, untreated wastewater would quickly reach the sensitive ocean habitat.

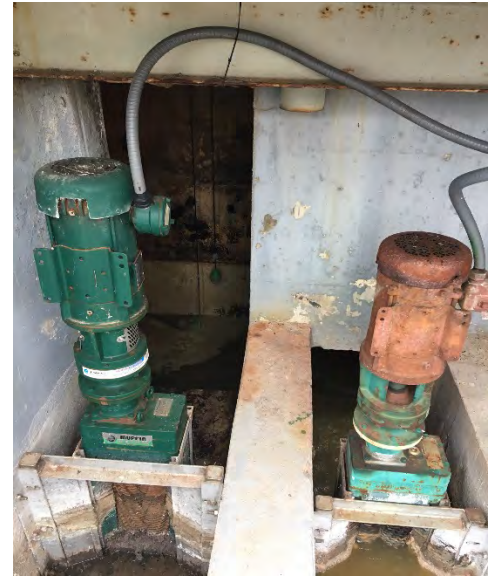
Component
Muffin Monster Comminutors
Score
3
Reason
One comminator is highly corroded and recommended to be replaced.

Prior to being converted to a lift station, the Ord Village facility was a wastewater treatment plant. Two open influent channels enter the lift station wet well. Each influent channel is fitted with a Muffin Monster comminator. The comminutors have 3-hp electric motors with 18-inch helical stack cutters to grind solids into smaller portions for easy passage through the pumps. One of these is highly corroded and is recommended to be replaced (see photo above).

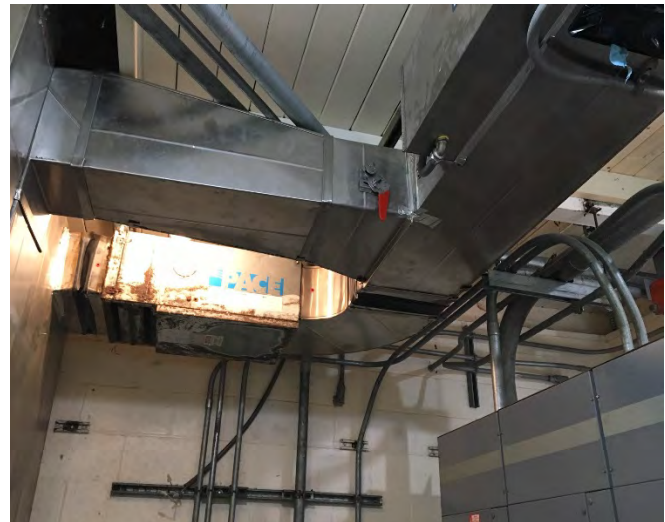
Component
Metal Ducting
Score
3
Reason
Signs of dampness and corrosion. Recommended replacement.

A heating, ventilation, and air conditioning (HVAC) system is also provided to provide ventilation in the below ground areas and to dehumidify the air within the lift station control building (to reduce corrosion and to increase personnel safety). The HVAC system includes a PACE F-1 supply fan, a Baldor 1/3-hp, 530 cfs motor, and a Penn EF-1 exhaust fan with 1/4-hp Marathon motor. Stainless steel ducting draws air from the dry well and

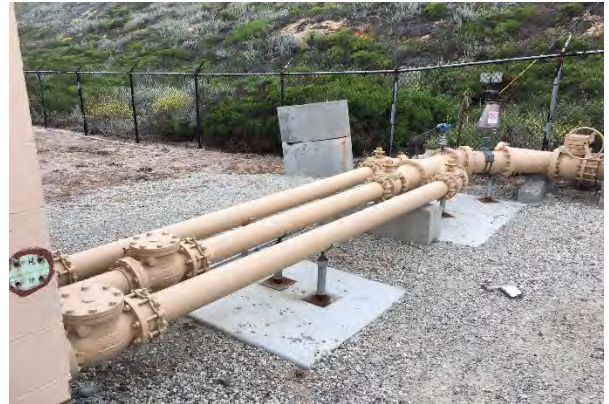
Component
Piping and Valves
Score
1
Reason
New pipes and valves

Piping and valves on the discharge side of the pump station are new.

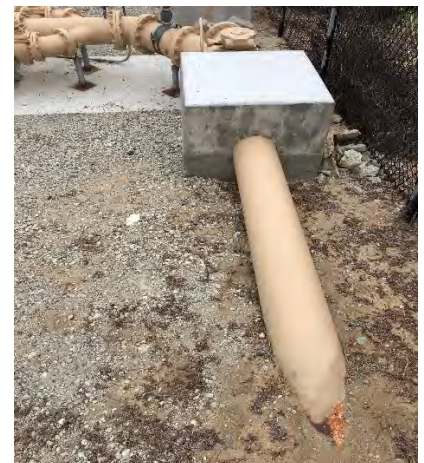
Component
Pipe at end of discharge line
Score
3
Reason
Corrosion – recommended recoat or replacement.

In general, piping and valves appear to be adequate. There does, however, appear to be corrosion at the end of the discharge line, and it is recommended to recoat or replace this section. The extent of exterior corrosion on the pipe is unknown beyond the limits shown in the photo above.

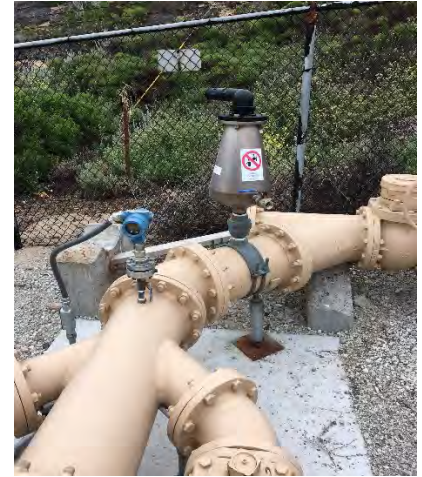
Component
Air Lock issues - Piping / Valves
Score
3
Reason
Force main causing air issues in piping

For this station and for the Gigling Lift Station, even with new pumps installed, there are air lock issues due to problems with the force main. The District reported breaks in the force main. Due to this, the District has been monitoring pressure. There is a lot of bleeding, and sometimes the District will lift up the check valve and backflush before it will prime again. Problems with water hammer have been partially solved by the air release valve. Condition assessment of the force main will require flow handling or bypass. For cost efficiency, condition assessment should be coordinated with other activities at the lift station that necessitate flow handling or bypass.

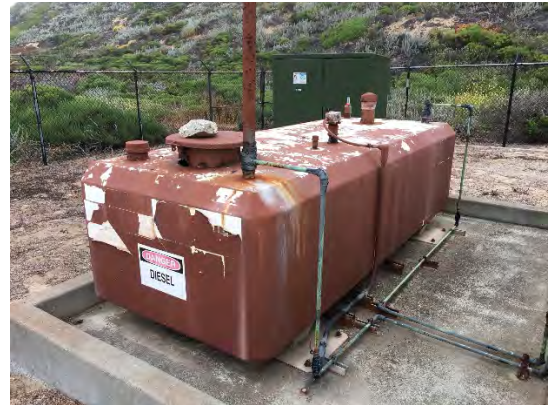
Component
Concrete Slabs on grade
Score
1
Reason
Appear to be in good condition

Concrete slabs-on-grade are provided for the generator, fuel storage tank, and outdoor electrical facilities.

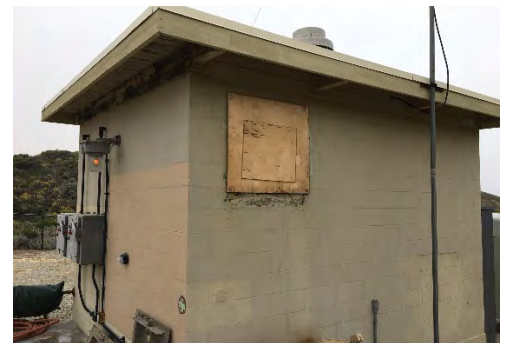
Component
Wall Penetration Replacement
Score
3
Reason
Wall appears to have a boarded up louver or duct penetration. Repair of this location is recommended.

One wall appears to have a boarded up louver or duct penetration with a wood plank and may need to be replaced.

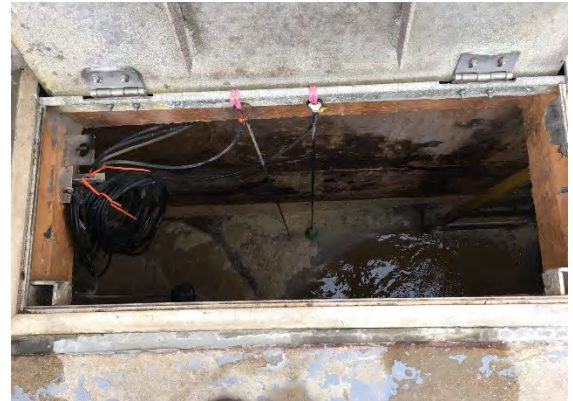
Component
Wet Well Hatch
Score
3
Reason
Operator mentioned wet well is difficult to clean. Larger hatch is recommended.

Dimensions of the wet well are 12-ft long, 6-ft wide, and 11-ft deep. The wet well structure appears to be in good condition, but the operator mentioned it is difficult to clean. A larger hatch is recommended.

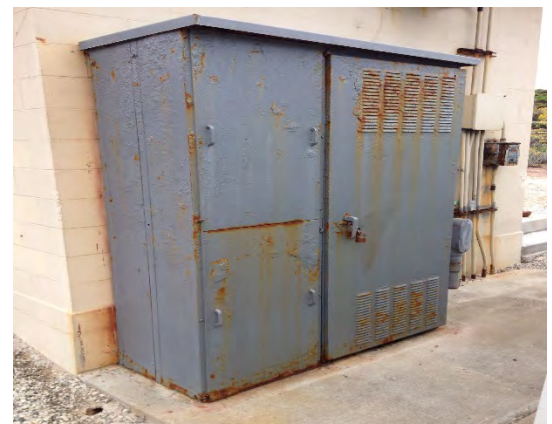
Component
Service entrance switchboard
Score
3
Reason
Heavily rusted

The service entrance switchboard consists of a utility underground pull section, and a PG&E metering compartment and main breaker. The switchboard, mounted on a pad outside the building, is heavily rusted. It is recommended to replace the rusted mild-steel main service entrance enclosure located on the west side of the pump building with a stainless steel enclosure.

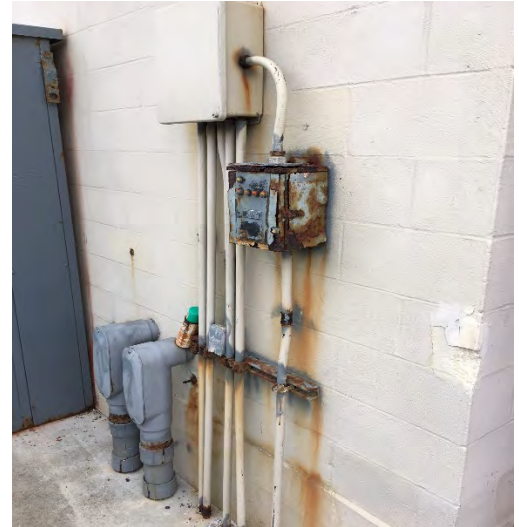
Component
Fuel tank leak detection panel
Score
5
Reason
Heavily rusted. Functionality in doubt.

The fuel tank leak detection panel, also mounted outside, is very heavily rusted, and its functionality is in doubt. Exterior conduits and conduit supports are heavily rusted. Equipment that is mounted inside the building shows some minimal surface rust on up to 10% of the overall surface area.

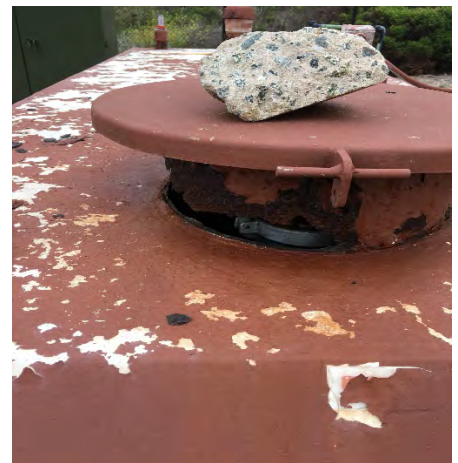
Component
175 kW Caterpillar diesel generator
Score
3
Reason
Muffler is rusted through

The site is equipped with a 175 kW Caterpillar diesel generator and an Olympian automatic transfer switch. The generator is reportedly in good operating condition, but the muffler is rusted, and the straps that hold the muffler to the enclosure are rusted through.

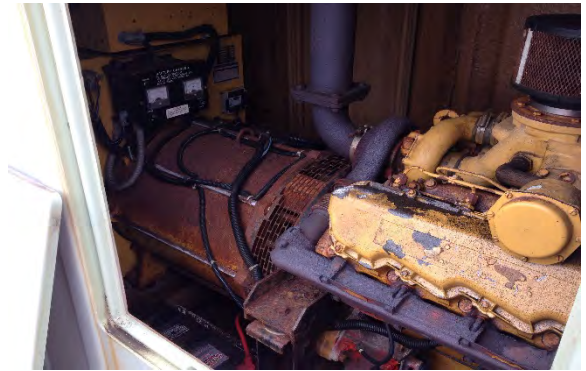
Component
Alternator Housing
Score
4
Reason
Heavily rusted. Small pieces of rusty metal could short out the tank.

The exterior of the alternator housing is heavily rusted, causing one to hypothesize that the housing interior is also heavily rusted, perhaps to the point that small pieces of rusty metal could flake off and potentially short out the generator windings or cause other modes of failure. The fiberglass outer enclosure is heavily weathered. The spill basin on the diesel bulk tank is rusted through, and the paint on the tank is failing. As mentioned above, the leak detection panel is in poor condition, and likely does not function. These elements should be replaced to ensure reliability of the backup power system.

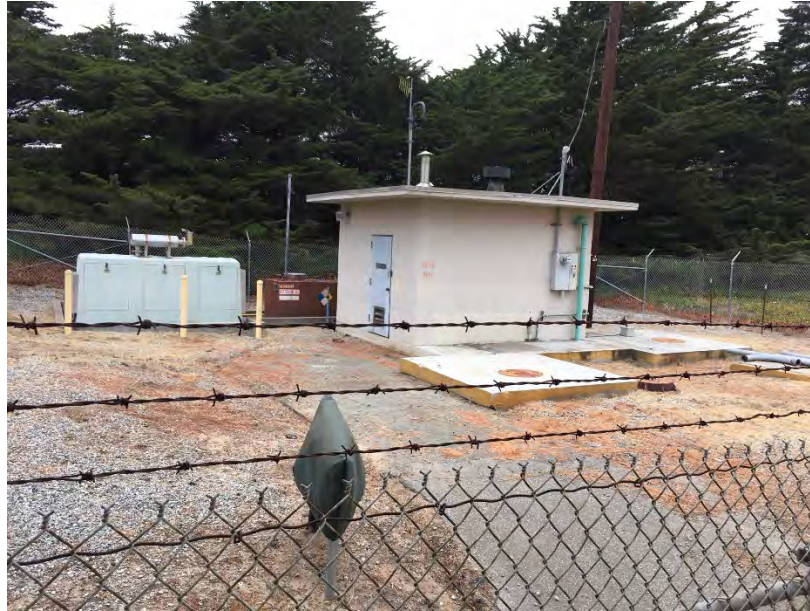
The Booker Lift Station is a dry pit/wet well lift station with a building. Valves and pipes on the discharge side are below the building. Electrical cabinets are both inside the building. The entire lift station is fenced in.

Booker Lift Station was constructed in approximately 1966 and was upgraded in 1997. The lift station has a total capacity of 760 gpm with two pumps, but only one operable pump was reported from District staff. It is a dry pit/wet well type lift station and is controlled by a sonic level sensor. The service area is planned to be redeveloped, and major rehabilitation or replacement of the lift station is recommended.

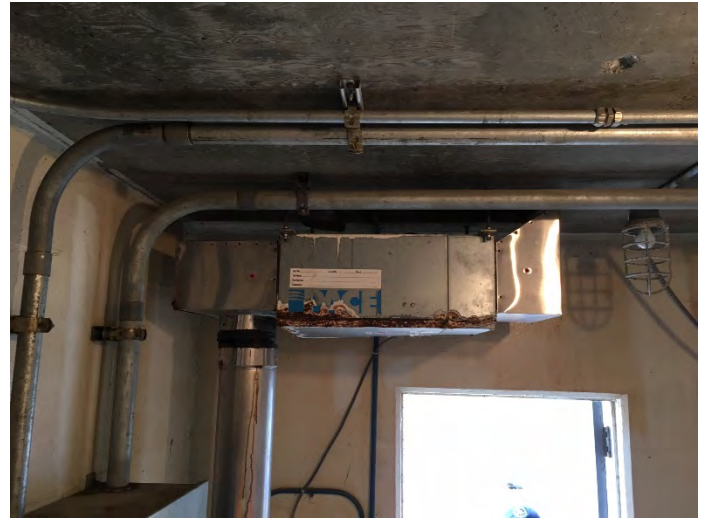
Component
Redesign of HVAC system
Score
5
Reason
Exhaust fan discharges into the building. Strong odor inside the building. Potentially hazardous condition.

The wet well and dry well vents are connected via a single duct to an exhaust fan that is mounted inside the pump station building. The exhaust fan discharges into the building, not outside. This creates a strong odor problem inside the building, essentially negates the attempt to ventilate the dry well, and potentially creates a hazardous condition inside the pump station building. The ventilation system needs to be redesigned to effectively achieve the pump station’s ventilation goals.

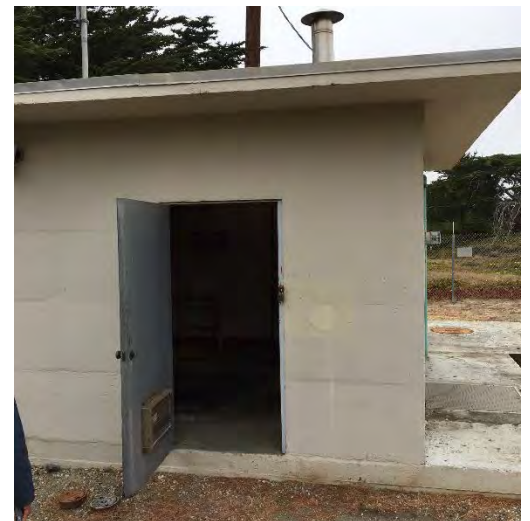
Component
Door
Score
1
Reason
Appears to be in decent condition.

The door appears to be in decent condition. For information on hatches see Wet Well / Dry Pit in Section 4.9.1. There are no windows.

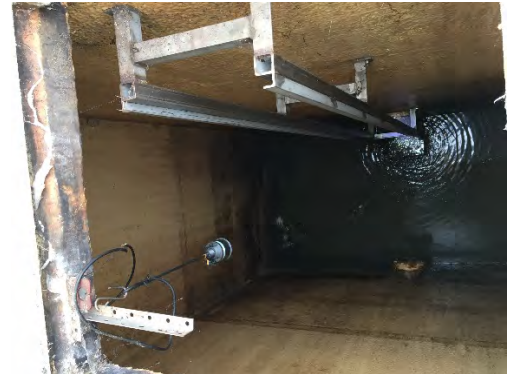
Component
Wet well coating
Score
2
Reason
Appears to be in decent condition.

The coatings on the wall appear to be in good condition. Wet well dimensions are 13-ft long, 6-ft wide, and 20-ft deep.

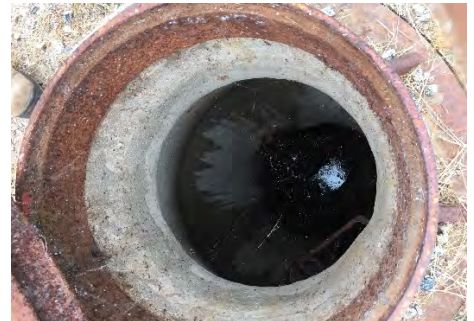
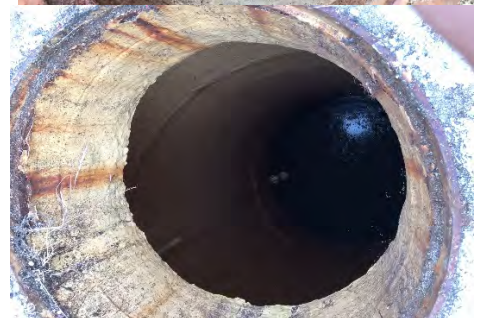
Component
Manhole 1
Score
1
Reason
Walls appear to be in good working condition.
Component
Manhole 2
Score
1
Reason
Walls appear to be in good working condition.

On both sides of the wet well there are manholes. The walls appear to be in good working condition.

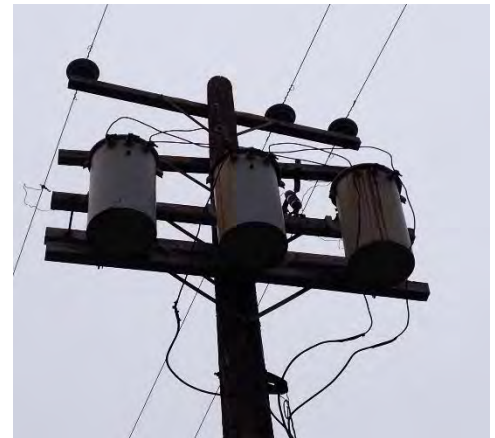
Component
Pole mount transformer
Score
3
Reason
Electrical service should be upgraded to meet PG&E's current standard for a 480V system.

The lift station electrical distribution system is fed from three single-phase pole-mount PG&E transformers, located within the lift station fence. The service is rated at 200-amps, 480 volts, three-phase, three-wire. A surge protection capacitor is mounted at the service panel, perhaps as an attempt to provide capacitive grounding to the otherwise ungrounded system. The electrical service should be upgraded to meet PG&E's current standard for a 480V system and to create a safer system for District personnel to operate and maintain.

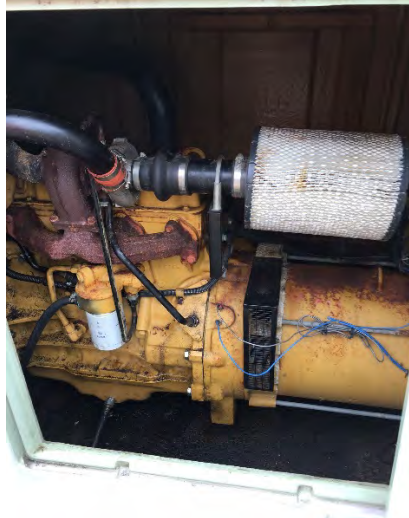
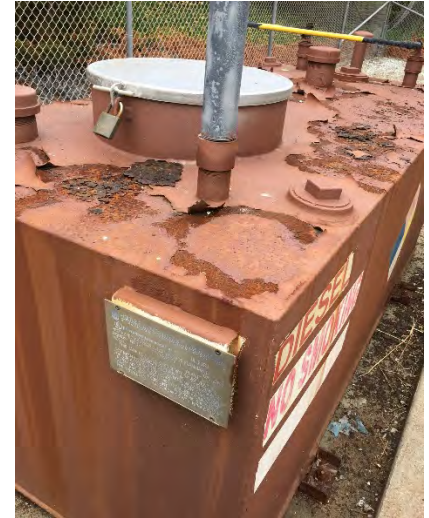
Component
Generator
Score
4
Reason
Reported to have engine valve problems and not in operating condition.
Component
250 gallon bulk diesel fuel tank
Score
4
Reason
Heavily rusted

The generator is reported to have engine valve problems and to not be in operating condition. The 250-gallon bulk diesel fuel tank site is heavily rusted. These elements should be replaced.

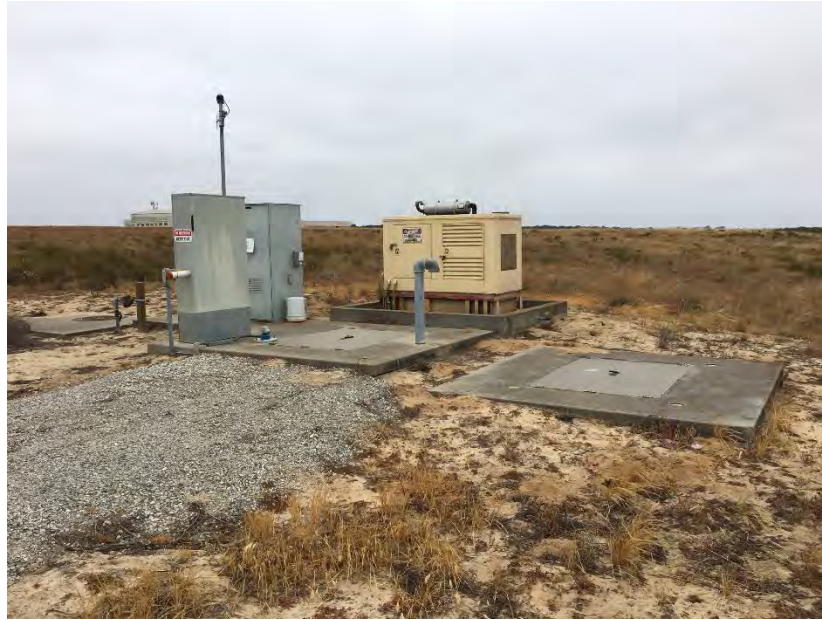
The Fritzche Lift Station is a wet well submersible lift station with no building. Valves and pipes on the discharge side are below grade. Electrical cabinets are mounted at grade. The lift station is not fenced in, though it is inside an airfield, which has perimeter fencing and security.

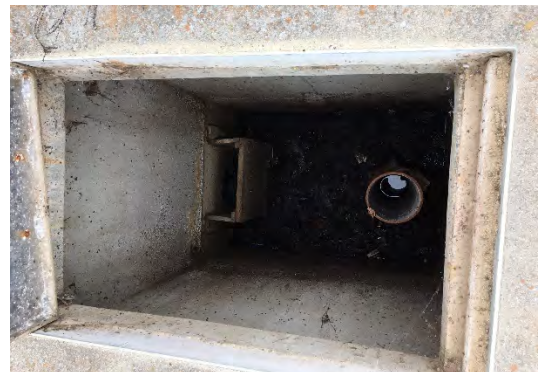
Component
Oil Separator
Score
3
Reason
Needs to be cleaned on a regular basis.

There is an oil separator that appears to be clogged. Cleaning of the oil separator on a regular basis is recommended.

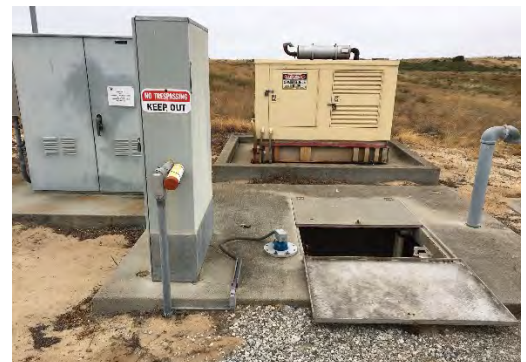
Component
Concrete Slabs
Score
2
Reason
Appear to be on grade and in decent condition

Concrete slabs appear to be on grade and in decent condition.

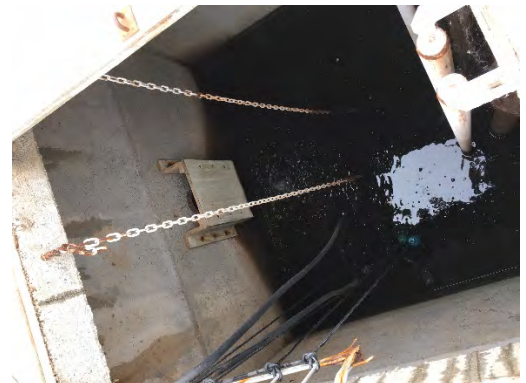
Component
Wet well walls
Score
1
Reason
Appear to be in good condition.

The wet well walls appear to be in good condition. The wet well dimensions are 8-ft long, 8-ft wide, and 11-ft deep.

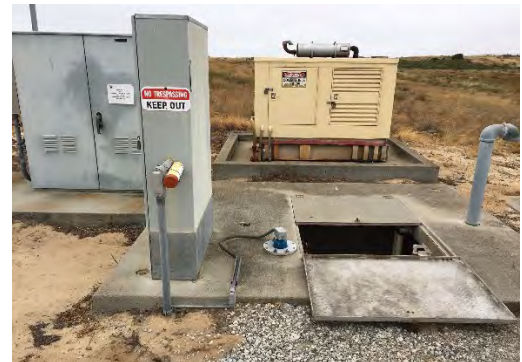
Component
Pad mount transformer
Score
1
Reason
Appear to be on grade and in decent condition

Drawings were not available to show the layout of the site electrical distribution system. Conclusions were drawn from what could be observed above ground. The lift station electrical distribution system is apparently fed from a 12kV distribution system that is owned by the airport, and likely feeds other adjacent equipment installations. The pump station appears to be fed by its own 208Y/120V, 3-phase, four-wire pad-mount transformer.

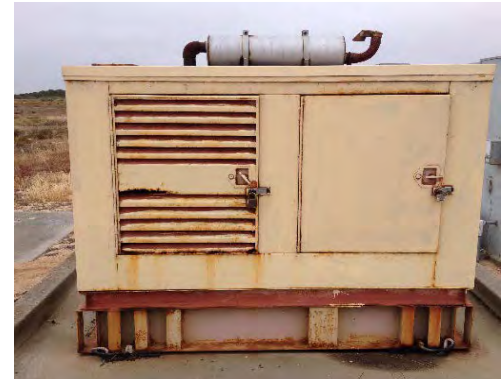
Component
Generator
Score
4
Reason
Enclosure and exposed exhaust system heavily rusted.

The generator enclosure and exposed exhaust system components are heavily rusted. The subbase fuel tank has minor-to-moderate rust. It is recommended for the generator to be replaced.
