# Marina Coast Water District Sewer Master Plan

**SEWER  
MASTER PLAN**

Final Draft

**AKEL**  
ENGINEERING GROUP, INC.

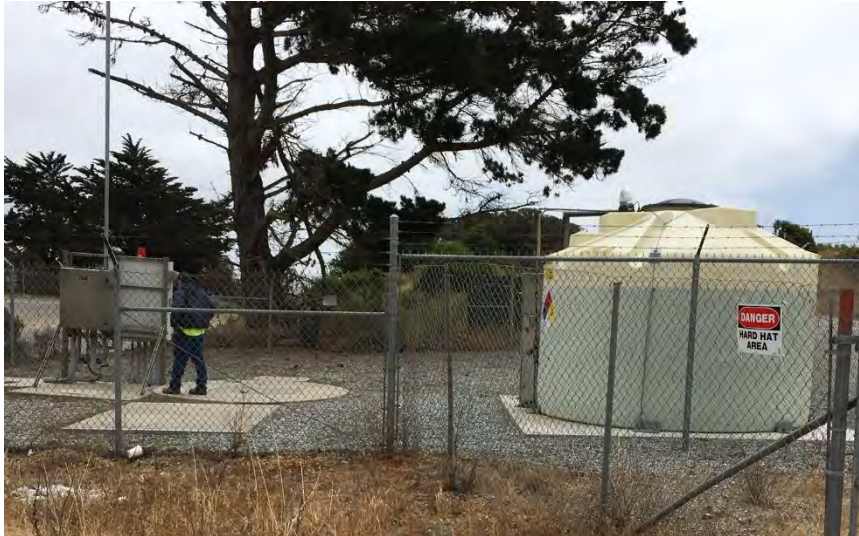
The East Garrison Lift Station is a wet well submersible lift station with no building. Valves and pipes on the discharge side are below grade. Electrical cabinets are above grade. The lift station is fenced in.

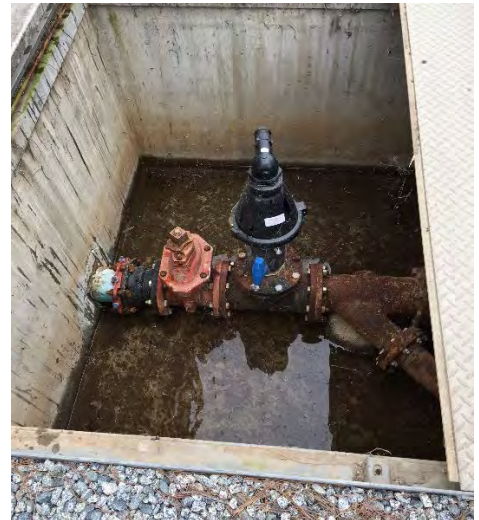
Component
Valve Vault Drainage
Score
4
Reason
Standing water needs to be removed
Component
Valve Vault Pipes and Valves
Score
4
Reason
Piping and Valves heavily corroded.

On inspection the valve vault was seen to have standing water up to the piping. There appeared to be a drain that ran to the wet well, with a closed valve. It is recommended to open the valve and clean out the drain line in order to remove standing water at the valve vault. The piping and valves within the valve vault also appear to be corroded, and are recommended to be replaced.

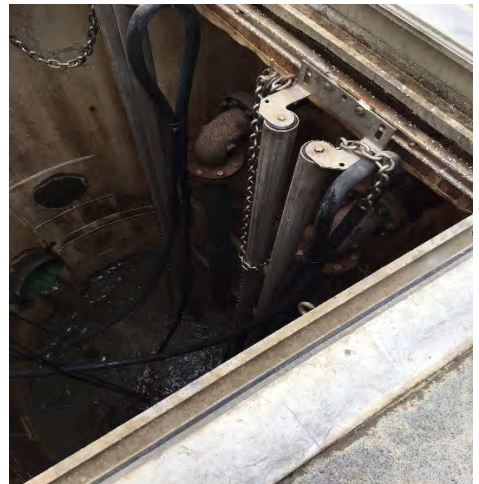
Component
Piping in wet well
Score
4
Reason
Corrosion Issues. Recommended replacement.

Piping appears to have corrosion issues within the wet well, and it is recommended to be replaced.

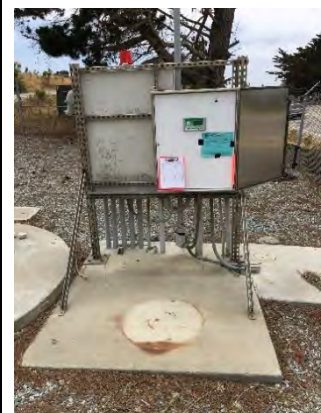
Component	Score	Reason
Meter/main panel	1	No issues observed.
Component	Score	Reason
Pump control panel	2	Shows minor weathering, otherwise appears to be in good condition.
Component	Score	Reason
PVC conduits between the electrical panels and the wet well	3	Appear to be shifting due to subgrade settlement.

The electrical equipment consists of a meter/main panel, and a pump control panel. The pump control panel contains a Zenith Pulsar level controller and combination full-voltage, non-reversing two motor starters. The panels show some minor weathering, but are otherwise appear to be in good condition. The concrete pad on which the electrical panels are mounted appears to be shifting due to subgrade settlement. The PVC conduits between the electrical panels and the wet well may be stressed or broken due to this settlement. It is recommended that the concrete pad and any broken conduits be replaced, and the electrical panels remounted.

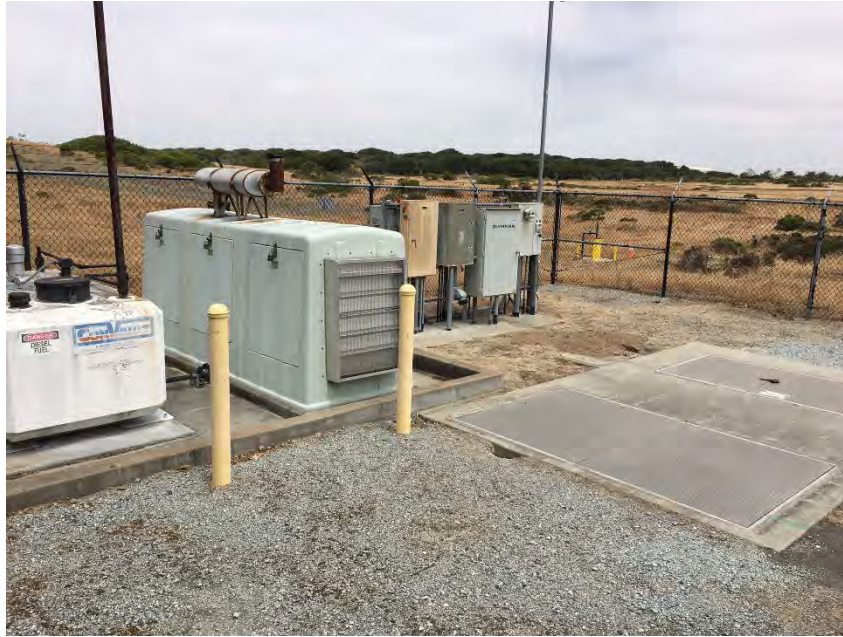
The Reservation Lift Station is a wet well submersible lift station with no building. Valves and pipes on the discharge side are below grade. Electrical cabinets are above grade. The lift station is fenced in.

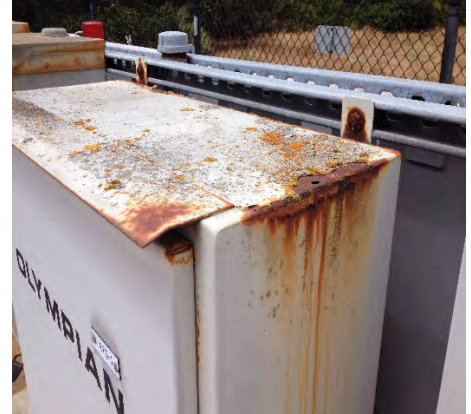
Component	Score	Reason
Meter/main panel	1	No issues observed.
Component	Score	Reason
Automatic transfer switch	3	One area on the enclosure top surface that is rusted through.
Component	Score	Reason
Manual Transfer Switch	1	No issues observed.
Component	Score	Reason
Pump control panel	1	No issues observed.
Component	Score	Reason
480:208/120V unit power center	1	No issues observed.

The electrical equipment consists of a meter/main panel, automatic transfer switch, manual transfer switch, pump control panel, and a 480:208/120V unit power center with stepdown transformer and breaker panel. The pump control panel contains a Zenith Pulsar level controller and combination full-voltage, non-reversing two motor starters. The panels are individually mounted on a unistrut support structure. The panels are weathered, with small areas of light rust but in otherwise good condition. The exception is the automatic transfer switch, which has one area on the enclosure top surface that is rusted through.

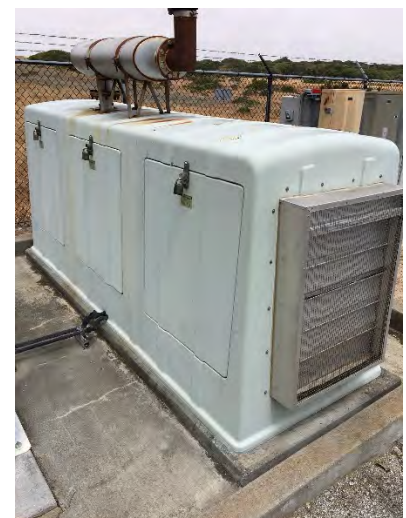
Component
100kW Olympian generator
Score
1
Reason
No issues observed.

The pump station is equipped with a 100kW Olympian generator, which is mounted inside a weather-protective fiberglass enclosure.

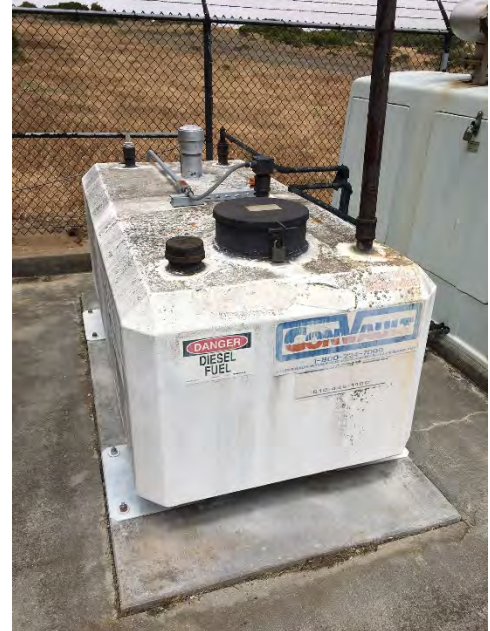
Component
Convault bulk tank
Score
1
Reason
No issues observed.

A Convault bulk tank is located next to the generator. Both the generator and tank appear to be in good condition.

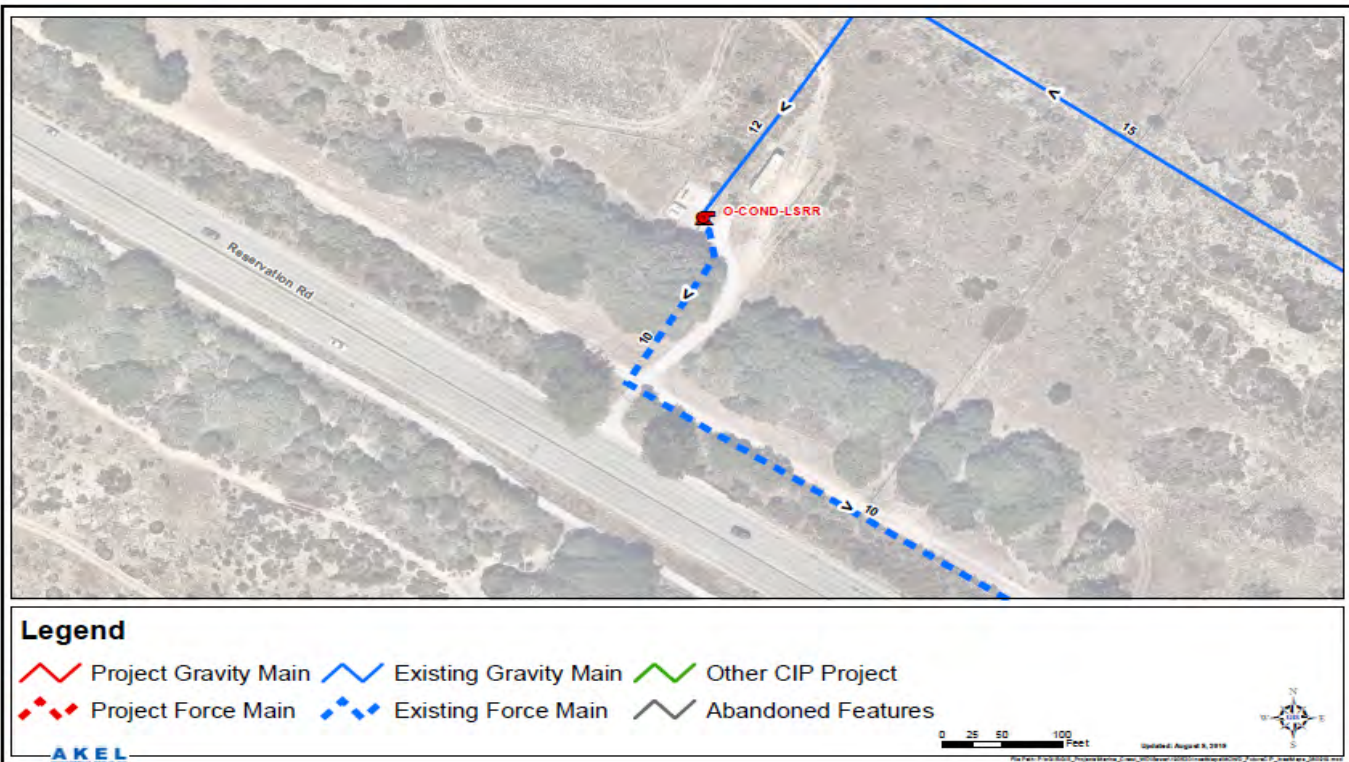
### Reservation Road Lift Station Condition Improvements

This project includes improvements from the 2017 Lift Station Condition Assessment. The improvements include valve vault piping and valves, wet well coating, headworks grinder, electrical transfer switch, and security fencing.
